Prepared By: Larry Ruka, PE Ruka & Associates, Inc.

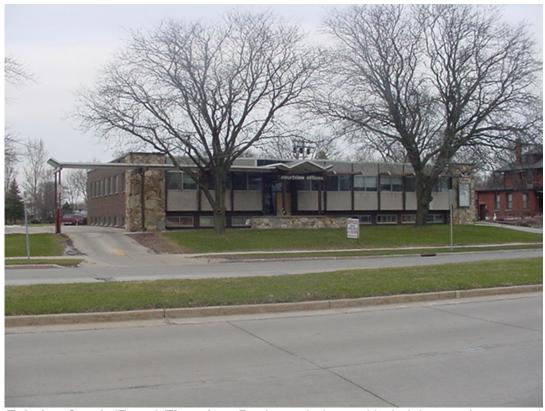
No. 1: Existing South (Front) Elevation: Replace windows with dark bronze frames and tinted glass; Remove vertical wood columns between windows; Remove Wood Sun Shade above windows; Replace Stucco with EIFS (See New South Elevations).

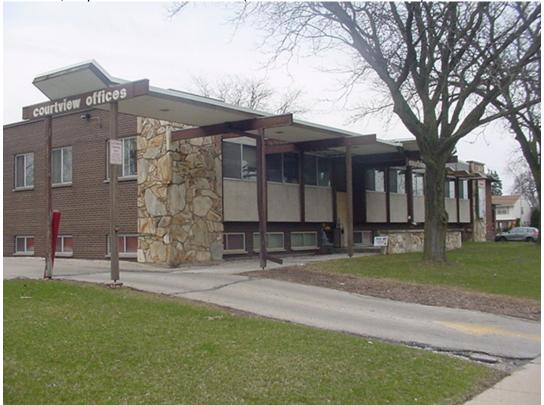
No. 2: Existing Southwest (Front) Corner: Existing canopy to remain; white roof trim and remaining wood beams and posts to be painted brown; underneath canopy to be painted white.

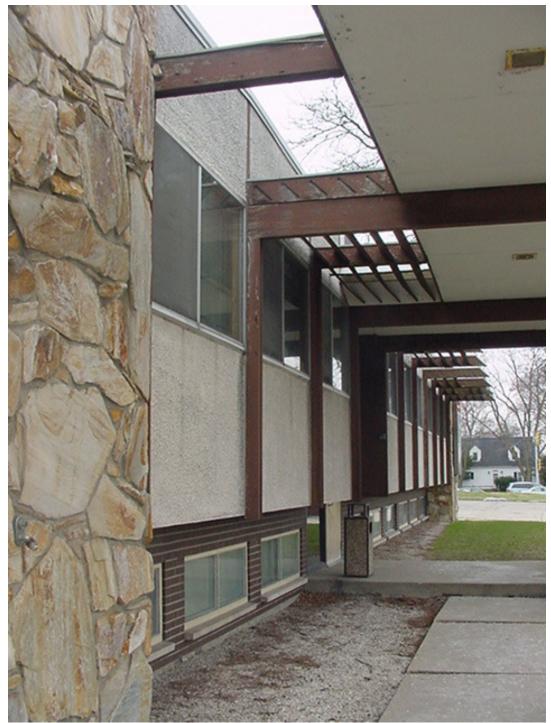
No. 3: Existing South Elevation (Looking East): Sun Shades to Be Removed and Vertical Wood columns between Windows to be Removed; all deteriorating stucco to be removed and replace with EFIS; Windows to be replaced with bronze frames, tinted windows.

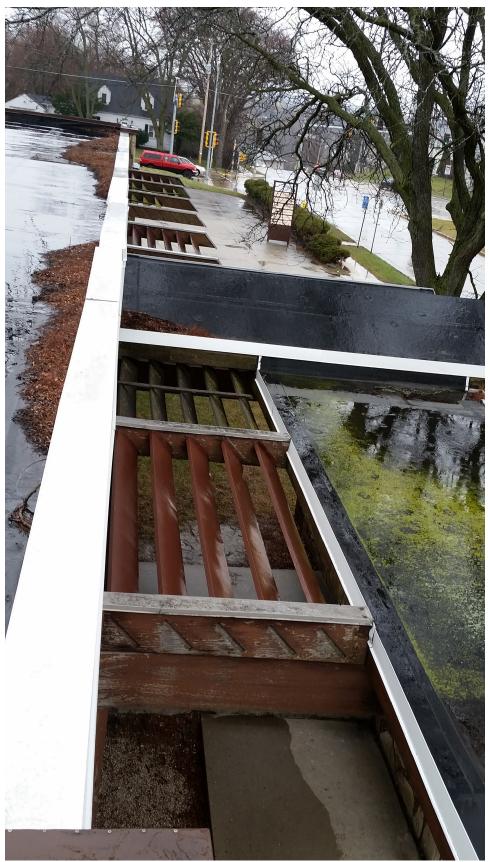
No. 4: Existing South (Front) Sun Shades: Roof View of the Sun Shades beams and wood boards that are to Be Removed.

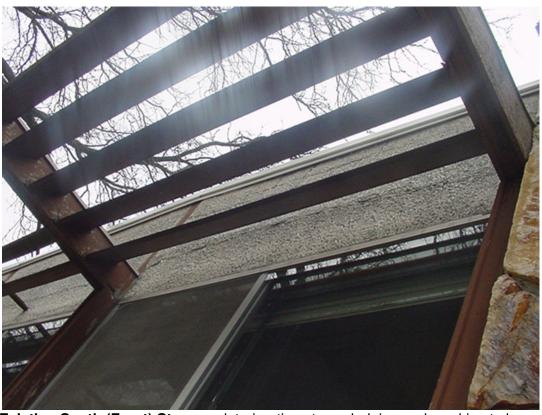
No. 5 Existing South (Front) Stucco: deteriorating stucco bulging and cracking to be removed and replaced with EIFS.

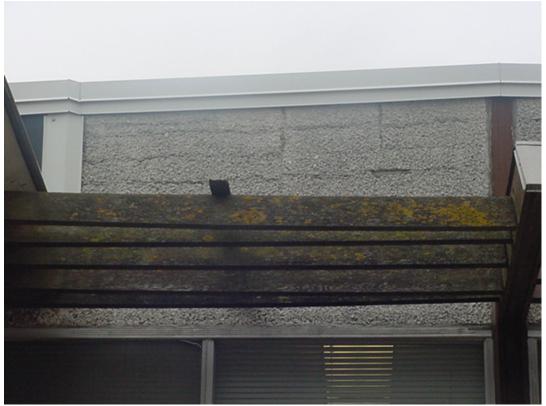
No. 6 Existing South (Front) Stucco: Deteriorating stucco bulging and cracking to be removed and replaced with EIFS.

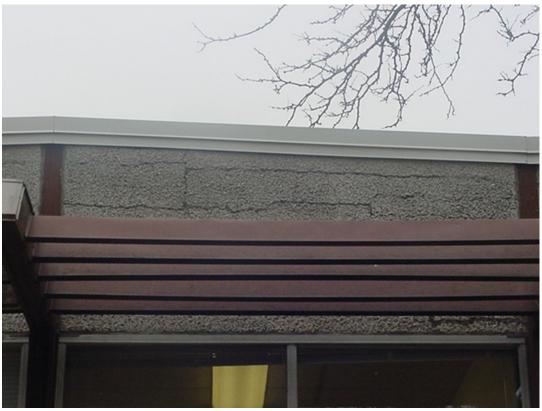
No. 7 Existing South (Front) Stucco: Deteriorating stucco bulging and cracking to be fully removed and replaced with EFIS.

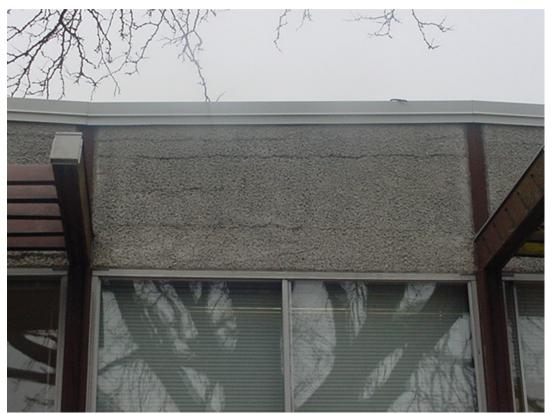
No. 8 Existing South (Front) Stucco: Deteriorating stucco bulging and cracking to be fully removed and replaced with EFIS.

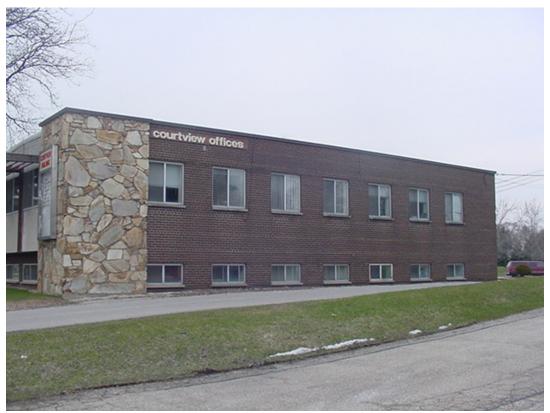
No. 9 Existing East Elevation: Remove existing windows and replace with bronze frames and tinted glass and no other changes.

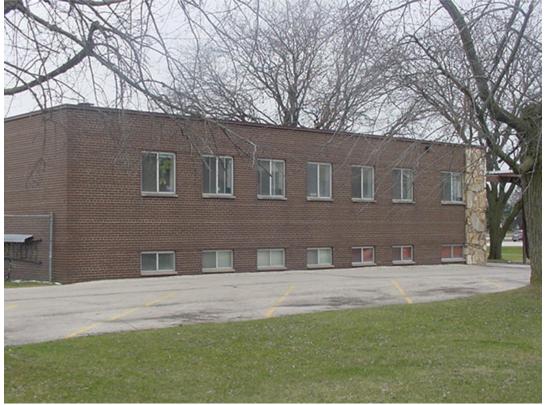
No. 10 Existing West Elevation: Remove existing windows and replace with bronze frames and tinted glass and no other changes.

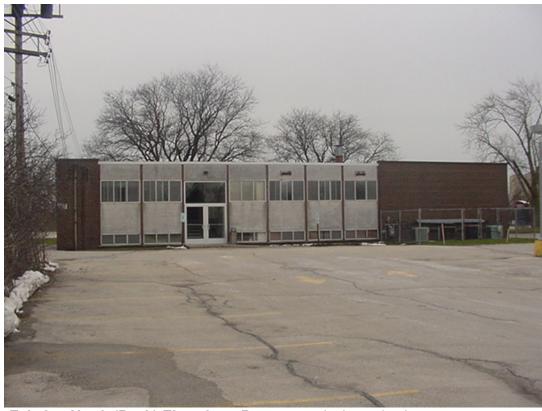
No. 11 Existing North (Back) Elevation: Remove vertical wood columns; remove stucco and replace with EFIS; remove windows and replace with bronze frames and tinted windows; roof cap flashing to be painted bronze; and brick to remain (See New North Elevation).

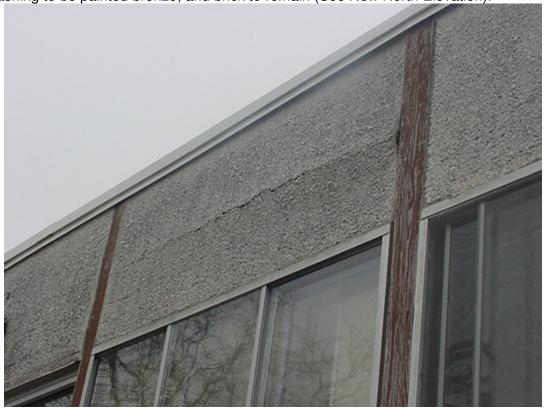
No. 12 Existing North (Back) Stucco: Deteriorating stucco bulging and cracking to be fully removed and replaced with EFIS.

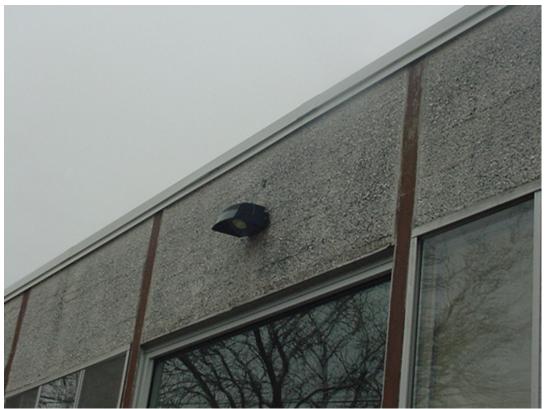
No. 13 Existing North (Back) Stucco: Deteriorating stucco bulging and cracking to be fully removed and replaced with EFIS.

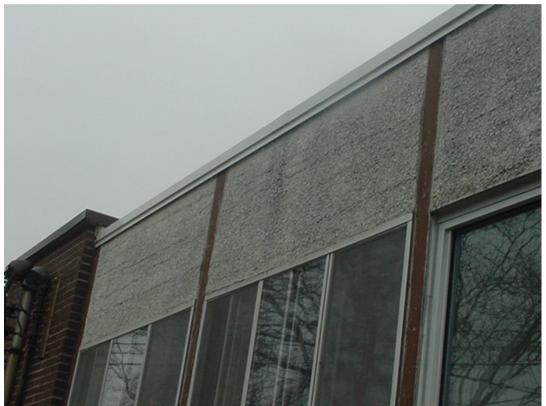
No. 14 Existing North (Back) Stucco: Deteriorating stucco bulging and cracking to be fully removed and replaced with EFIS.

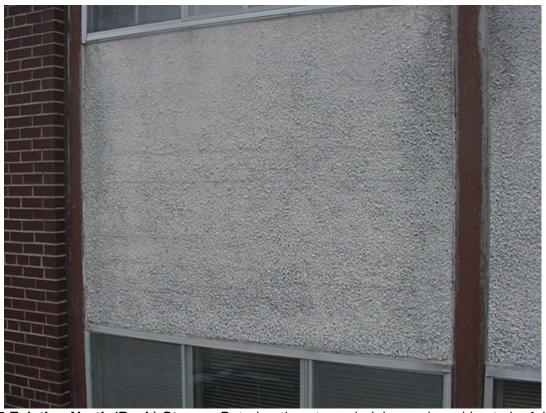
No. 15 Existing North (Back) Stucco: Deteriorating stucco bulging and cracking to be fully removed and replaced with EFIS.

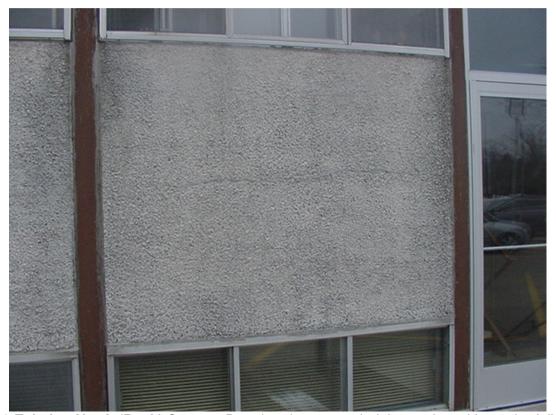
No. 16 Existing North (Back) Stucco: Deteriorating stucco bulging and cracking to be fully removed and replaced with EFIS.
