The Silurian Springhouse was constructed in 1927. It is a one story octagon shaped masonry structure over a naturally occurring spring. There is a pool at the center of the springhouse. There is a lower level that consists of a perimeter corridor around the pool. The corridor contains a water pump to fill the pool, lights and an electric service. The pump is not currently being used and the pool is dry. The pumping system would need replacing if it was desired to fill the pool. The lights do not work due to corrosion from the moisture in the lower level. The spring drains through an underground pipe to an unknown location. The lower level is accessed through a metal sidewalk door over a concrete stair connected to the lower level by a short corridor. The metal sidewalk door is bent and is not watertight. This allows water to enter the lower level every time it rains. The concrete has spalled and the reinforcing bars have rusted in the ceiling over the connecting corridor and in the wall opening into the lower level. These conditions represent substantial structural damage. The access to the lower level needs replacing due to the level of damage. It is acceptable to replace the exis

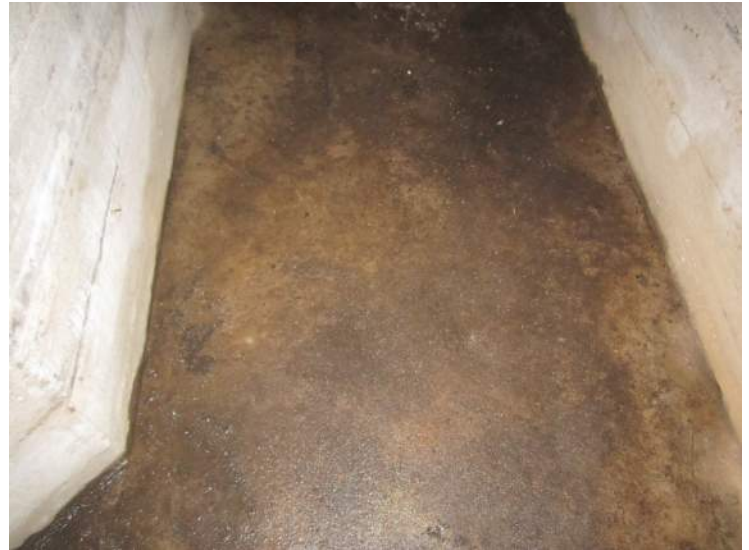
Water on floor of lower level.

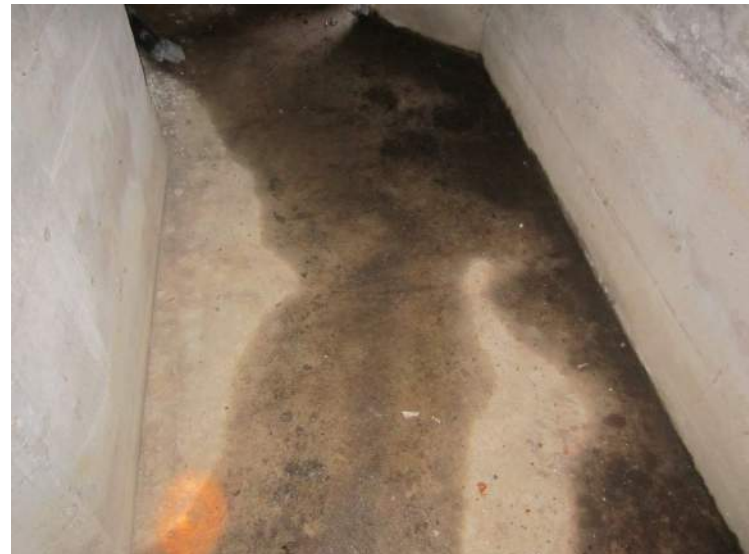
Water on floor of lower level and debris from falling concrete.

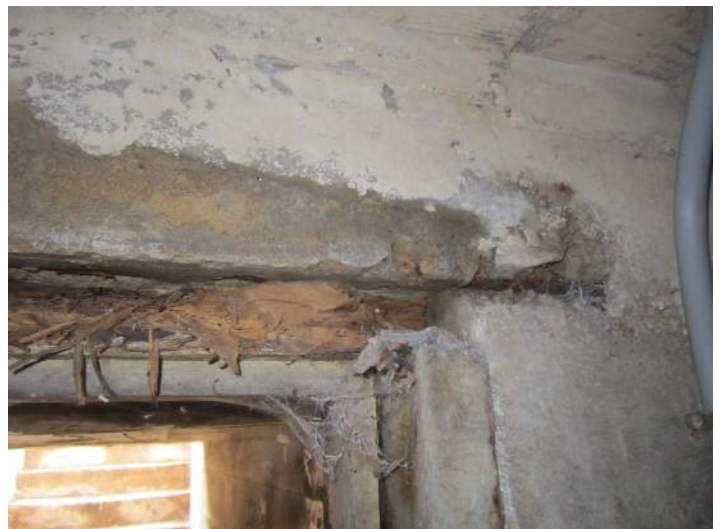
Rusted reinforcing steel.

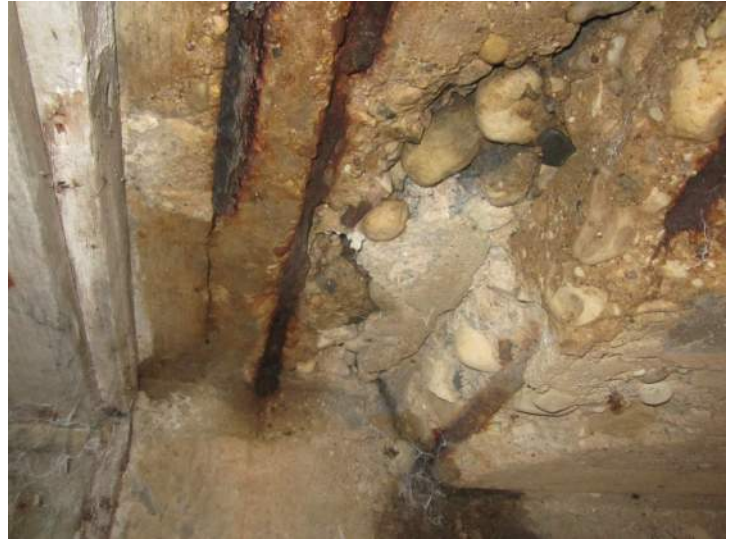
Spalled concrete in ceiling of connector to lower level.

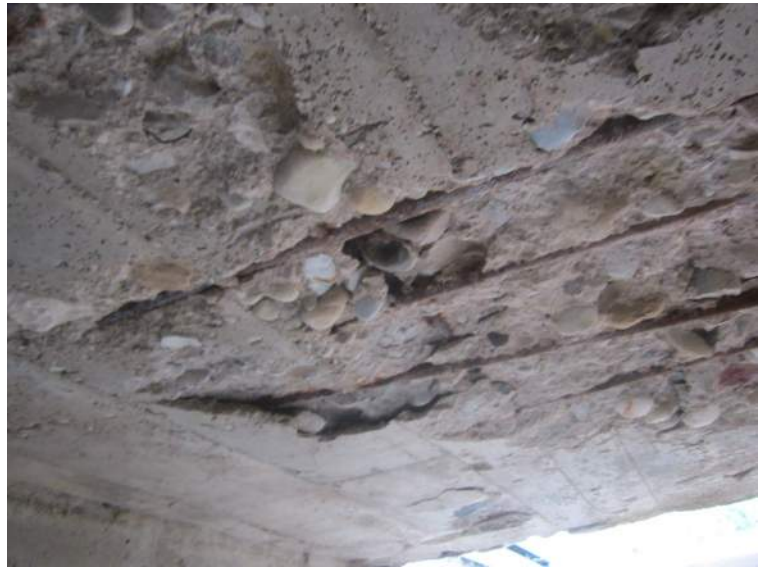
Spalled concrete in ceiling of connector to lower level.
