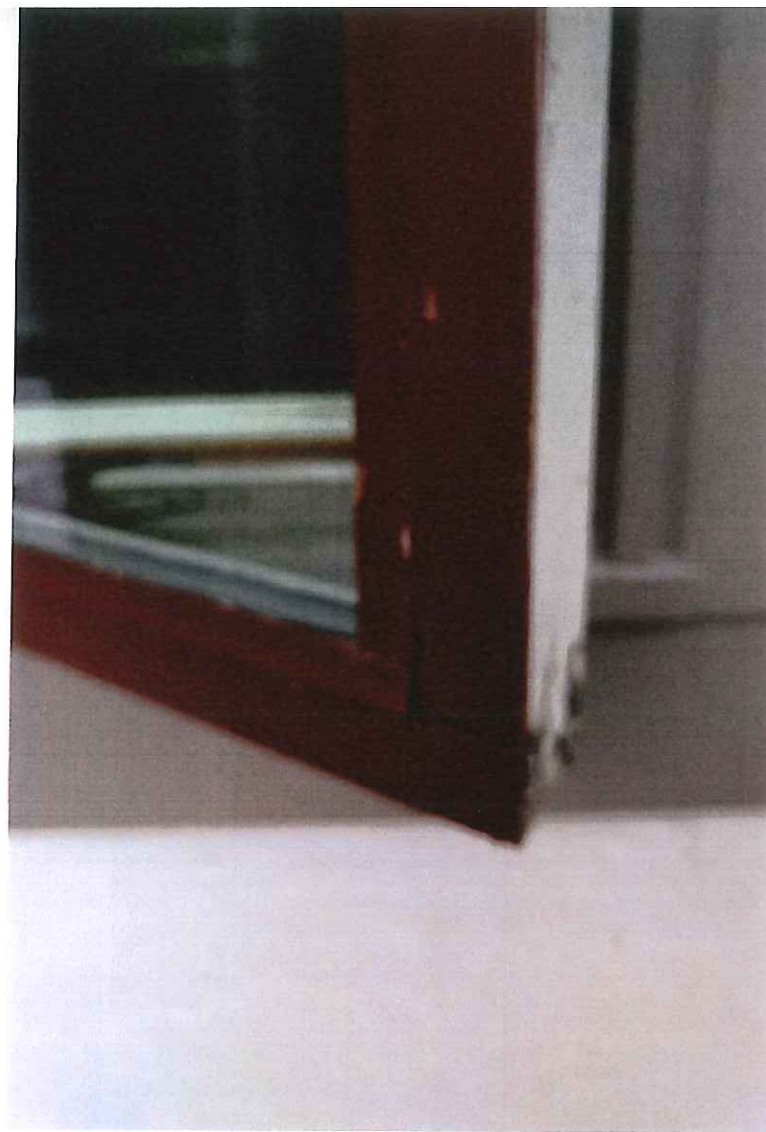
#8

Kitchen encasement  
sash with rot

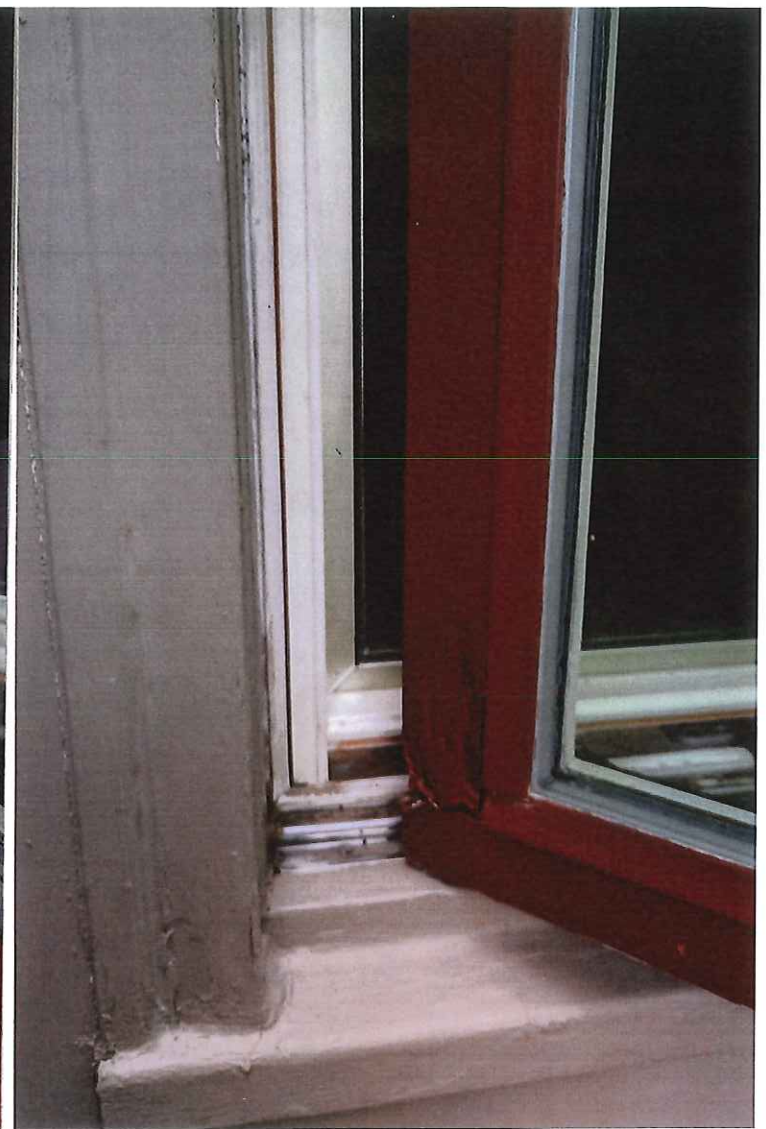
#13

Kitchen encasement  
sash with rot
