# **Saratoga Mill Dam Inspection Report**

**Field File No. 67.23**

**Key Sequence No. 630**

Re: Dam Safety Inspection Report, Saratoga Mill Dam  
WDNR Field File No. 67.23, Key Sequence No. 630

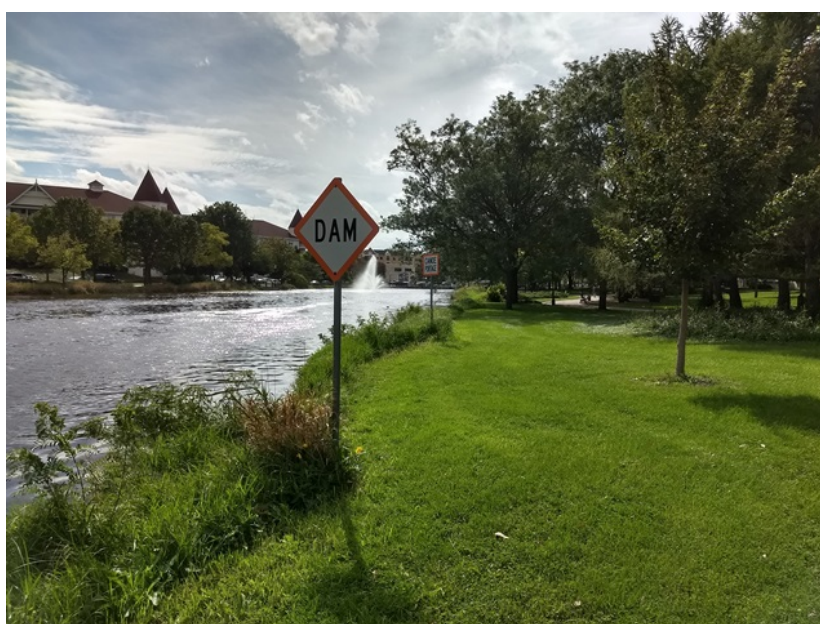
**Saratoga Mill Dam**  
0063010031801.jpg  
Dam Warning Sign and Portage Route

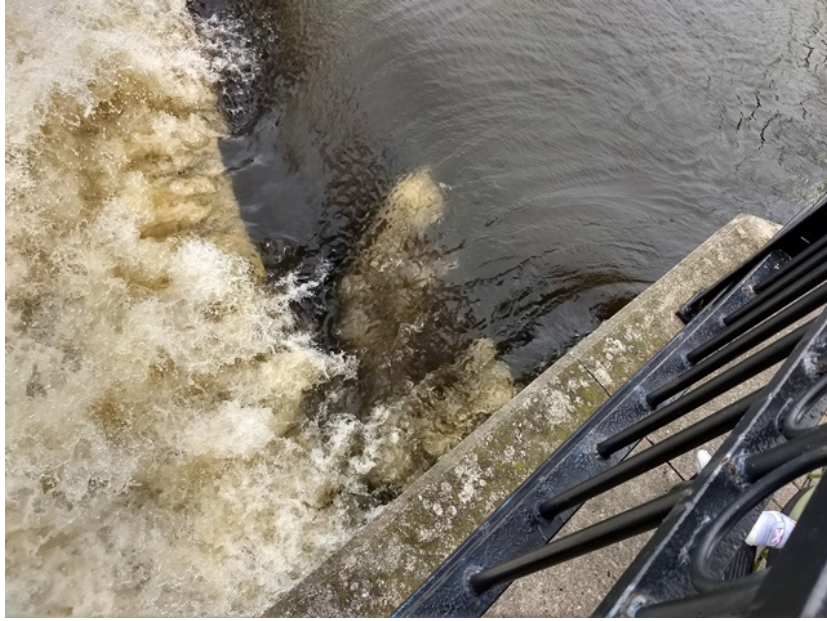
| SPILLWAY--PRINCIPAL - FIXED CREST | | | | | | | | | | Action | | |
|---|--|---|---|---|--|---|---|---|---|---|---|---|
| Condition: * | | Good | | | | | | | | | | |
| Seepage/wetness: | | No wetness observed in either site visit | | | | | | | | | | |

**Saratoga Mill Dam**  
0063010031808.jpg  
Left Abutment
