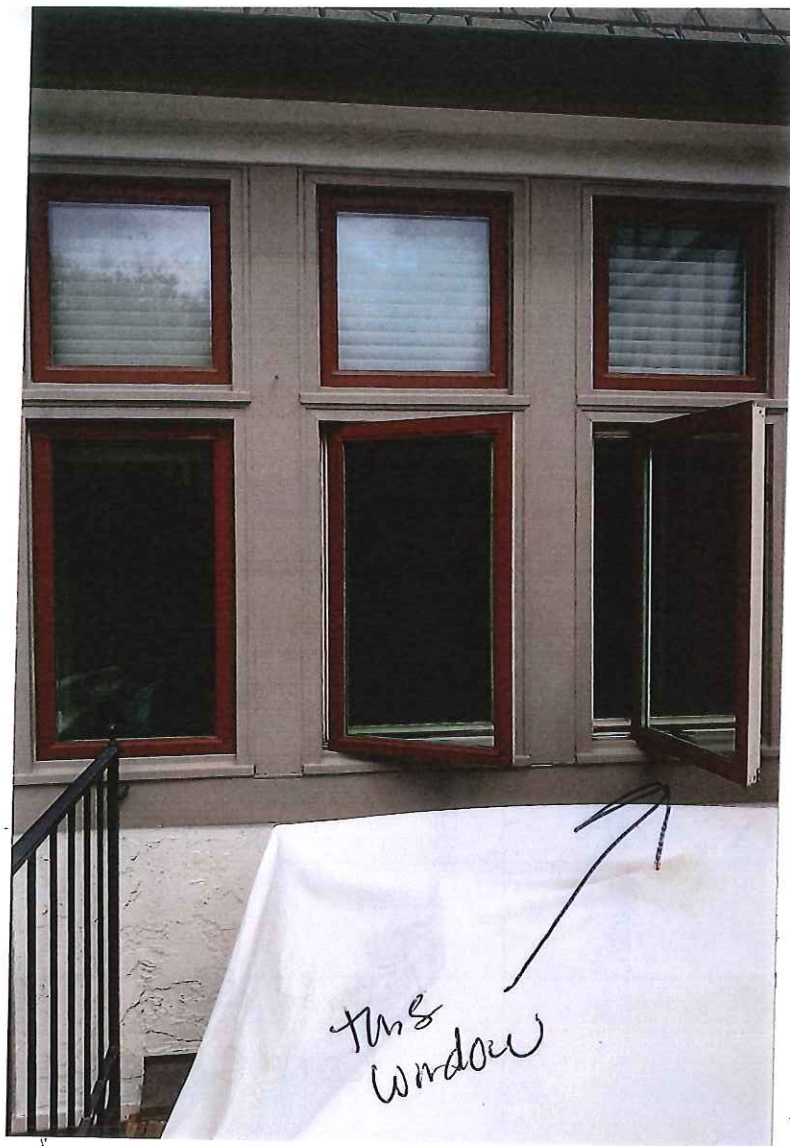
#3

Master bedroom  
Sash to be replaced

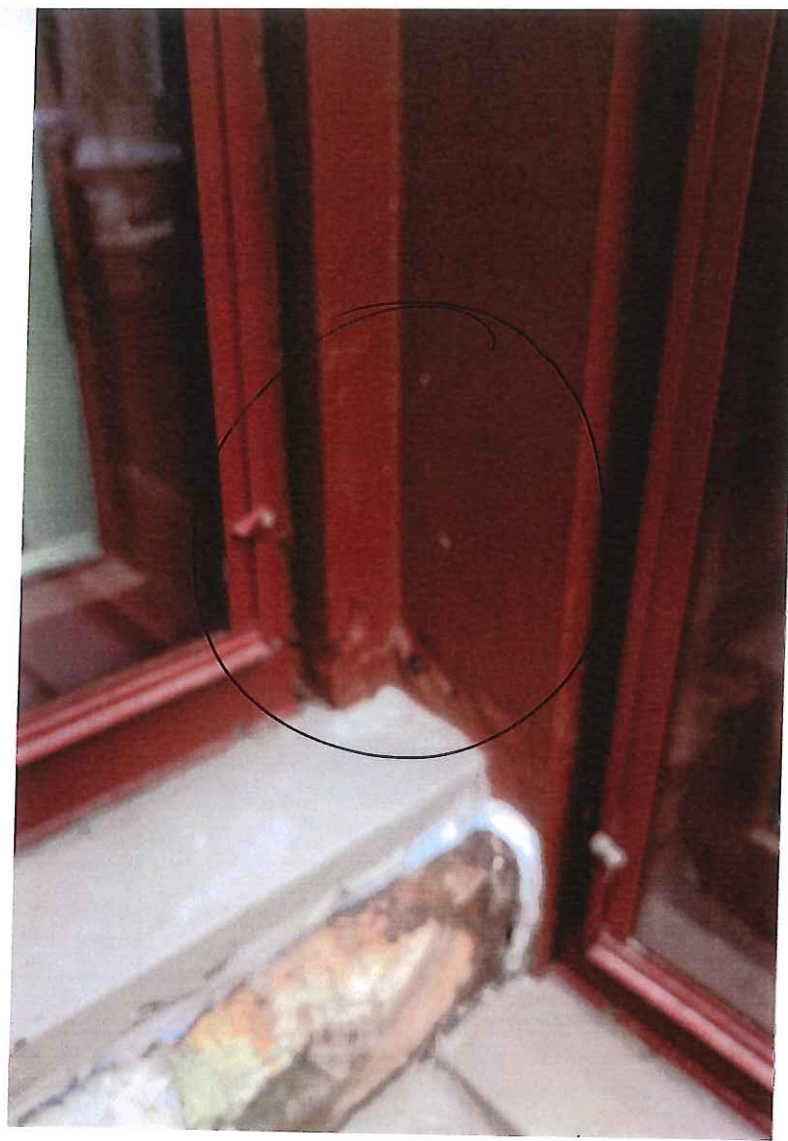
#2

Corried area  
that wood is rotted  
; need repair -

finger can poke  
through

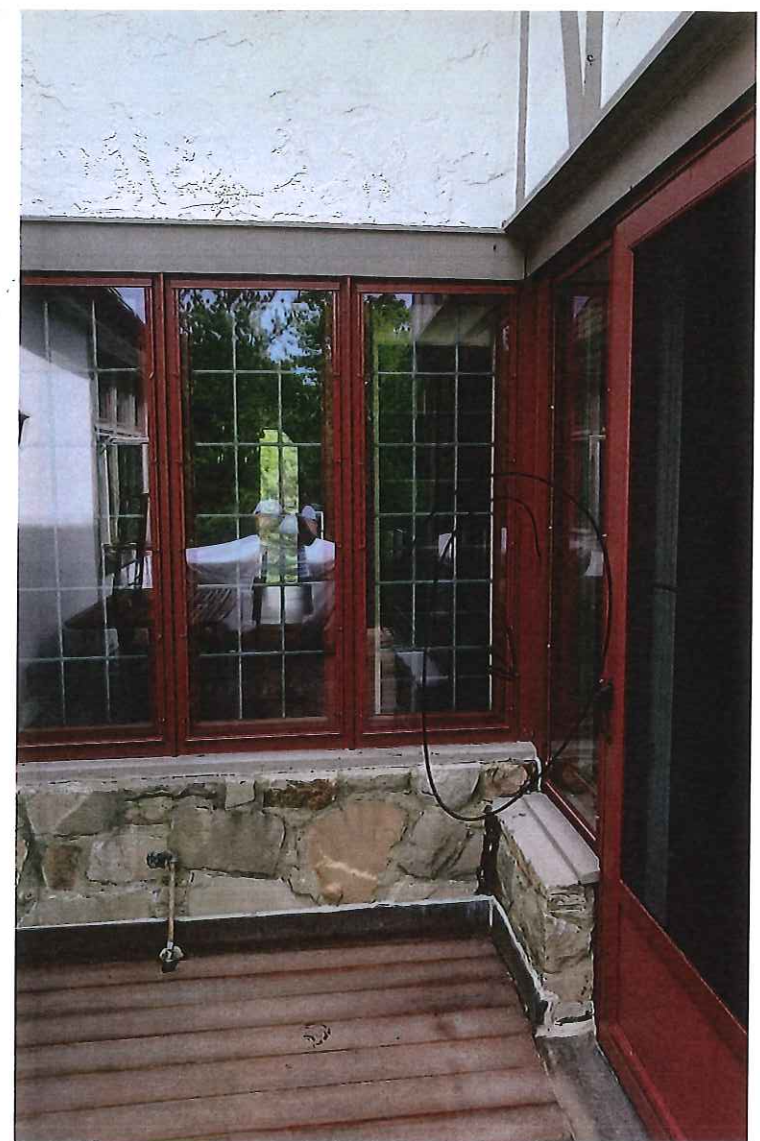
#1

Dining Rm  
Windows that has  
wood frame that  
wood is rotted -  
will be repaired &  
painted with same  
color as shown in  
picture

(this is on Northside /  
back side of house)

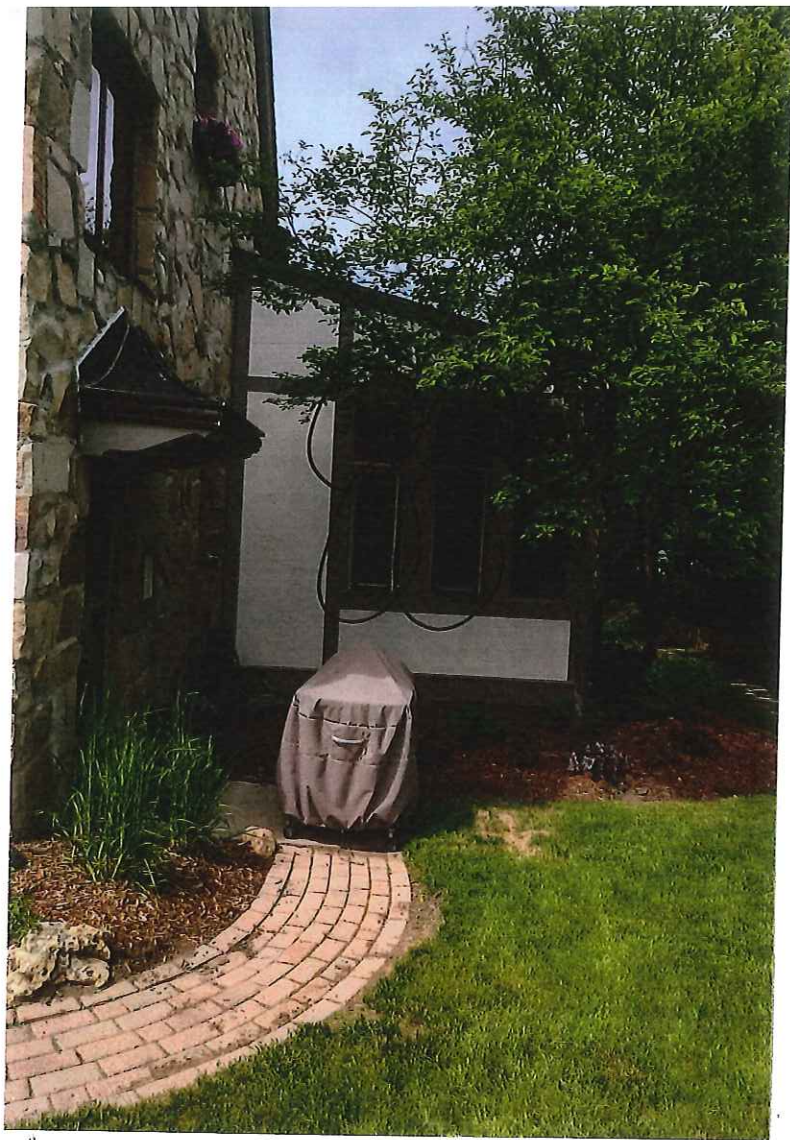
#6

Kitchen Sashes;  
transom require  
re placement

Sashes 2 on the  
left

transoms - the two  
end will be replaced  
not the middle one

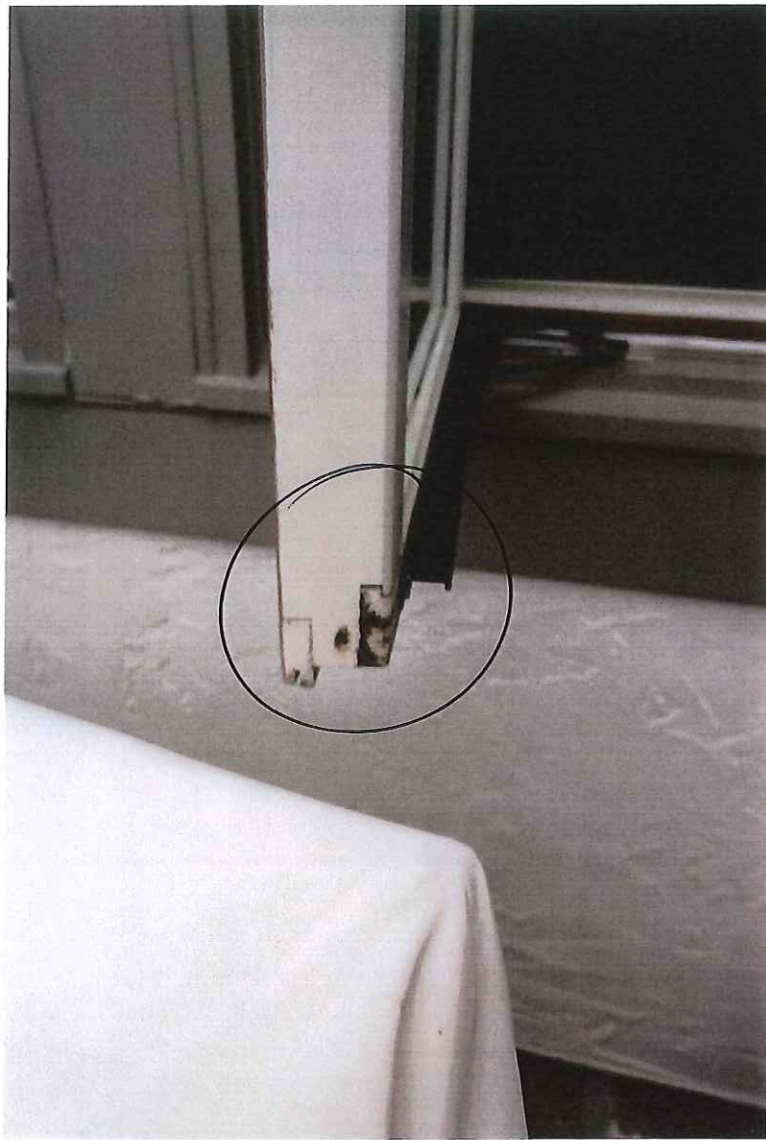
#5

Master bed room  
Sash with wood  
Rot

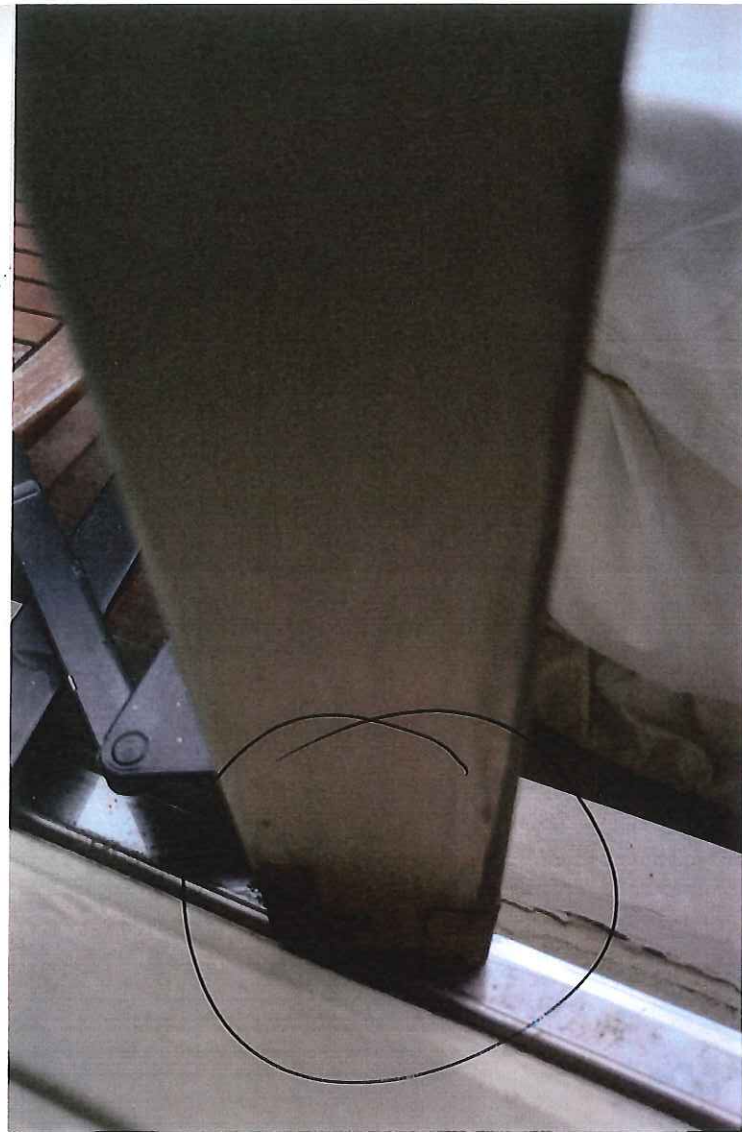
#4

Master bed room  
Sash with  
wood Rot

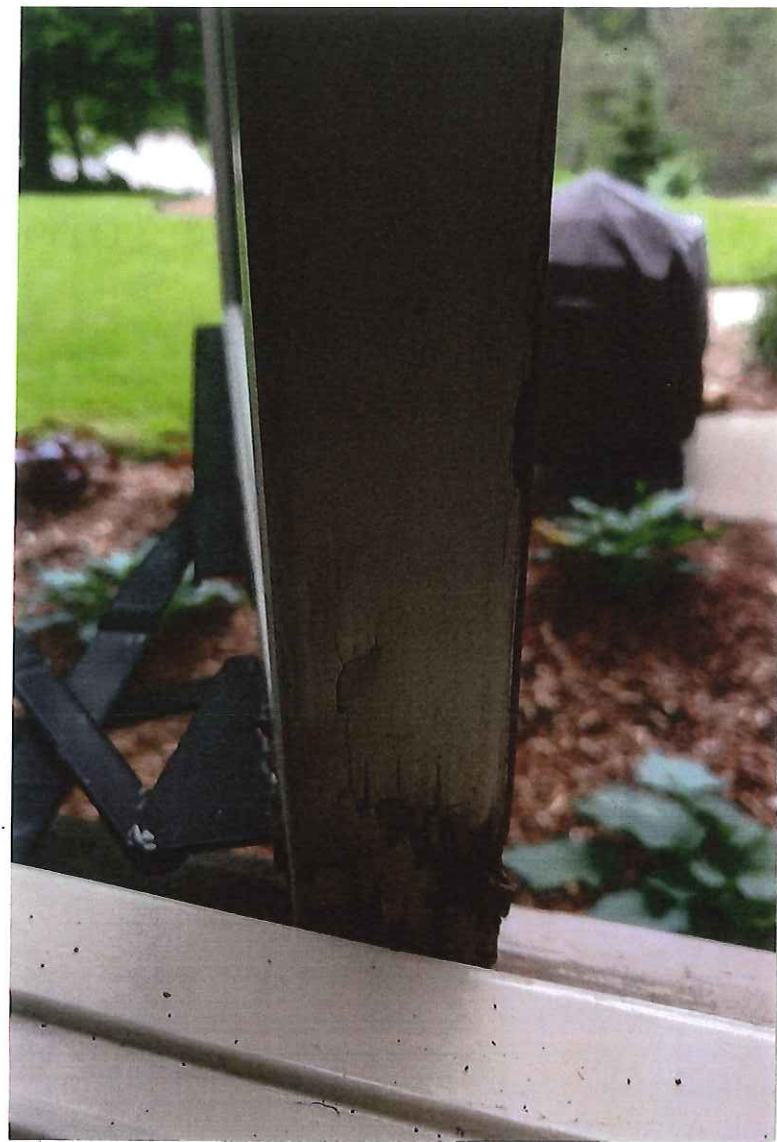
#9

Kitchen encasement  
sash with rot

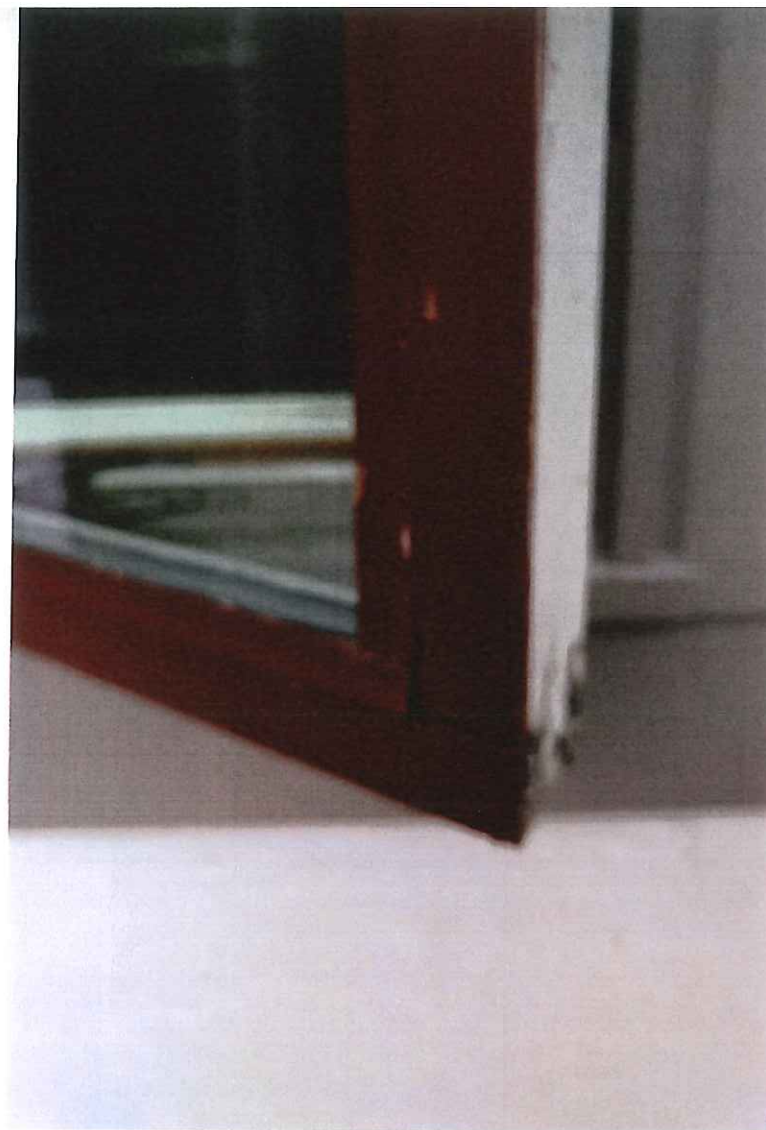
#8

Kitchen encasement  
sash with rot

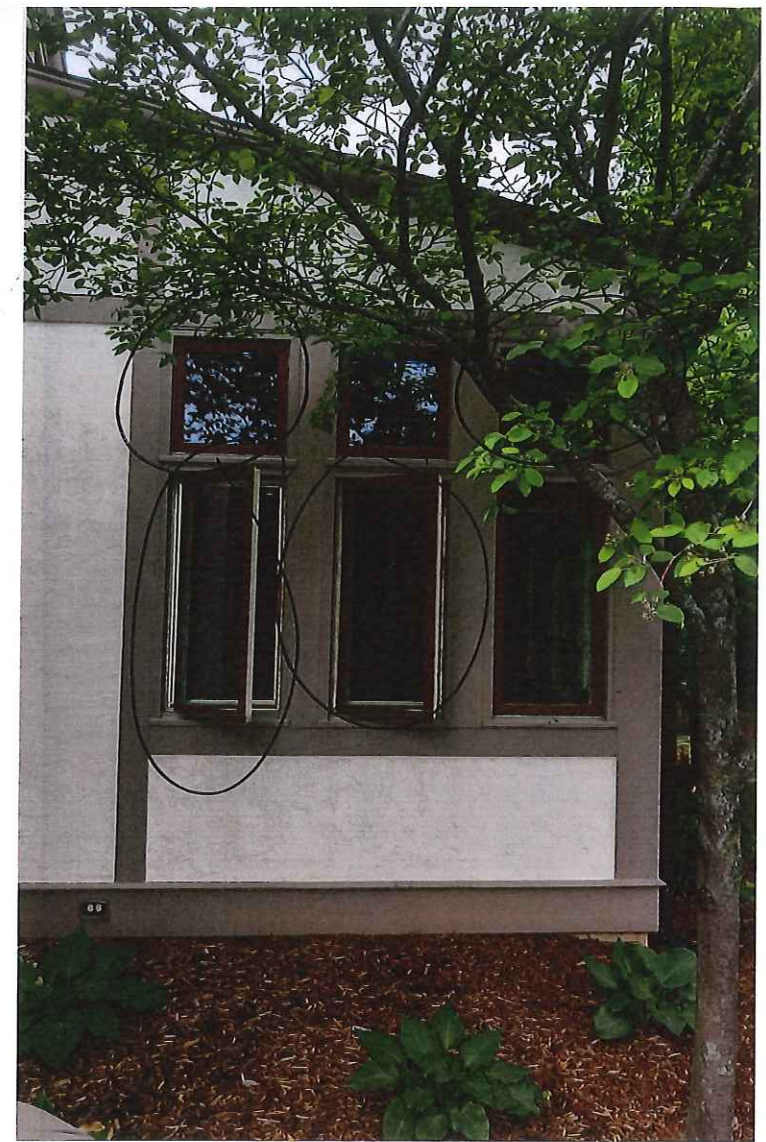
#7 -

Kitchen windows  
closer picture

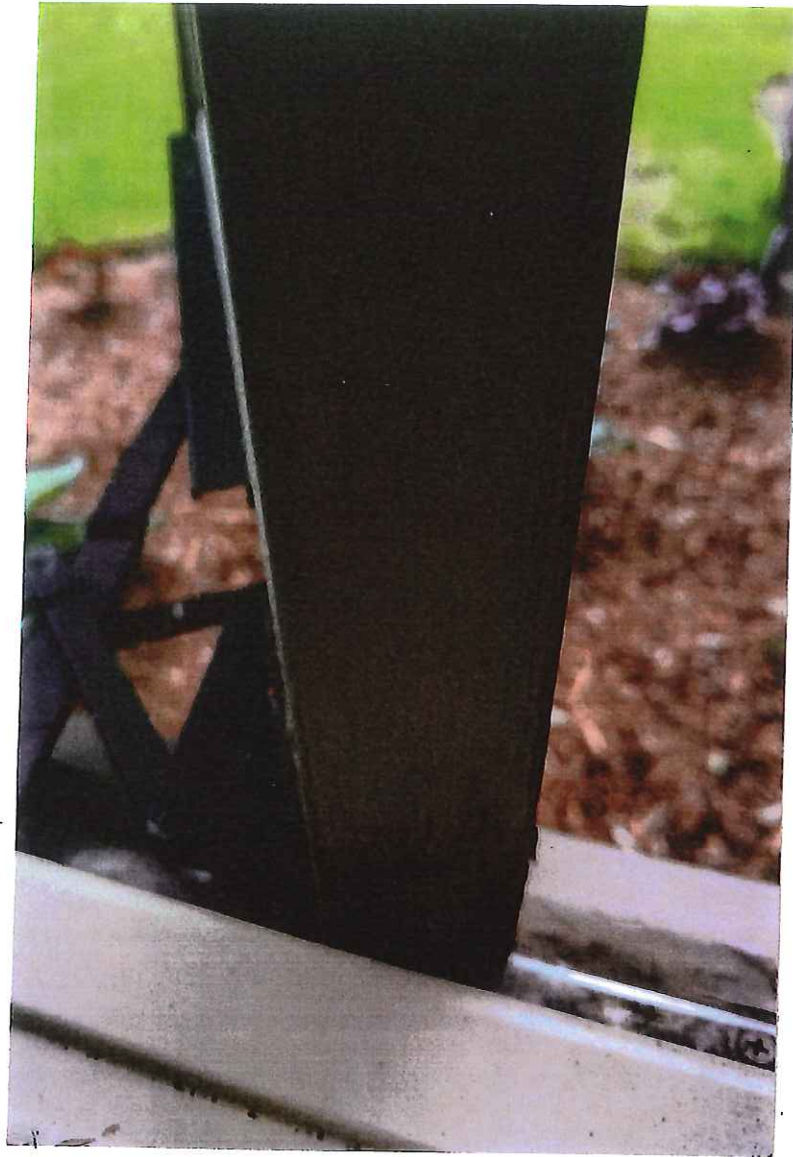
#12

Kitchen encasement  
Sash with rot

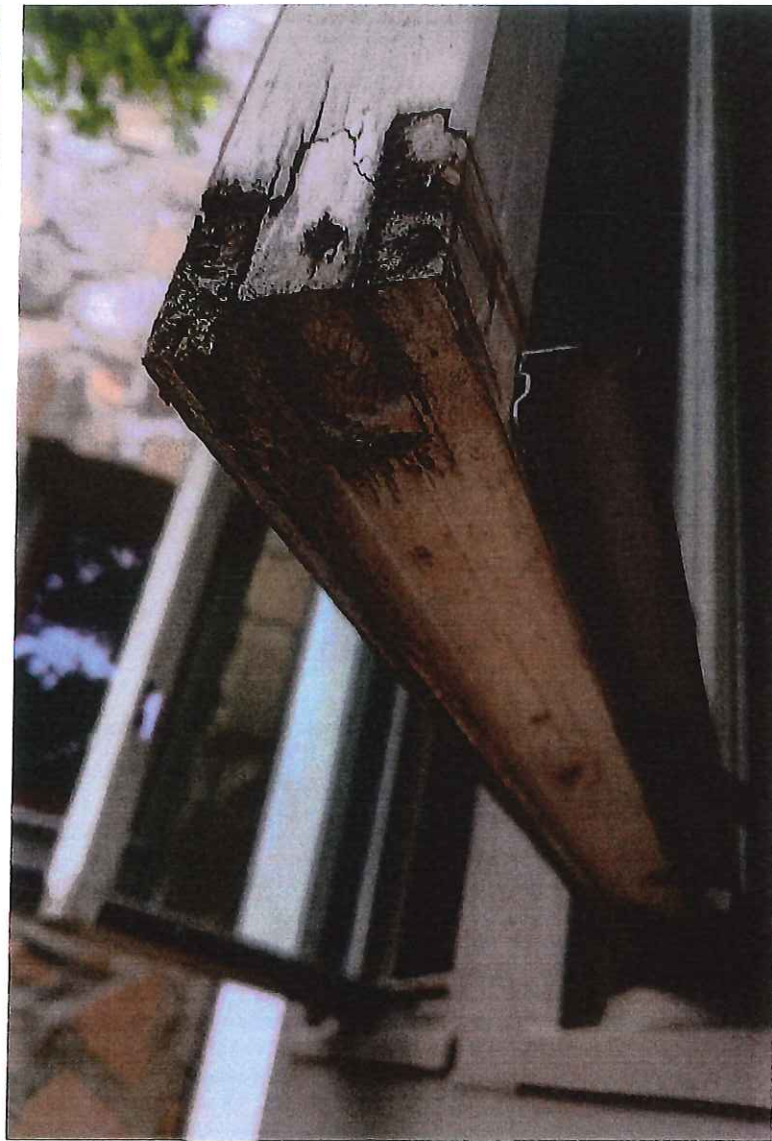
#11

Kitchen encasement  
Sash with rot

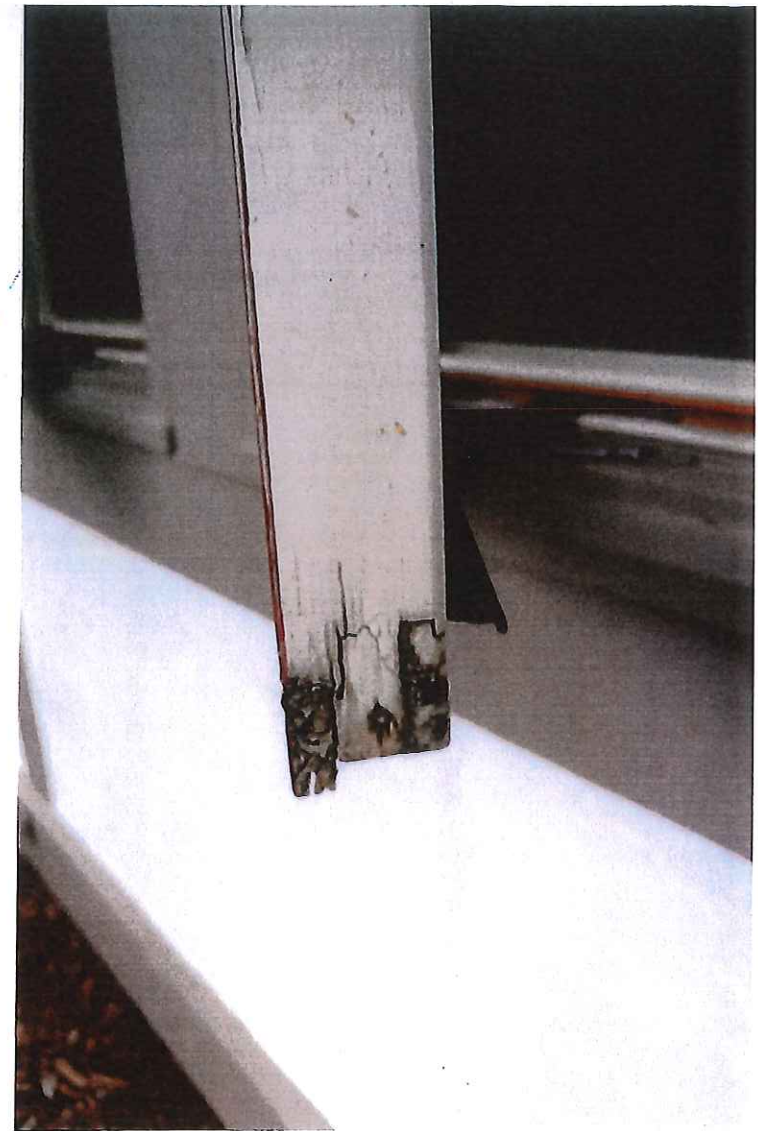
#10

Kitchen encasement  
Sash with rot

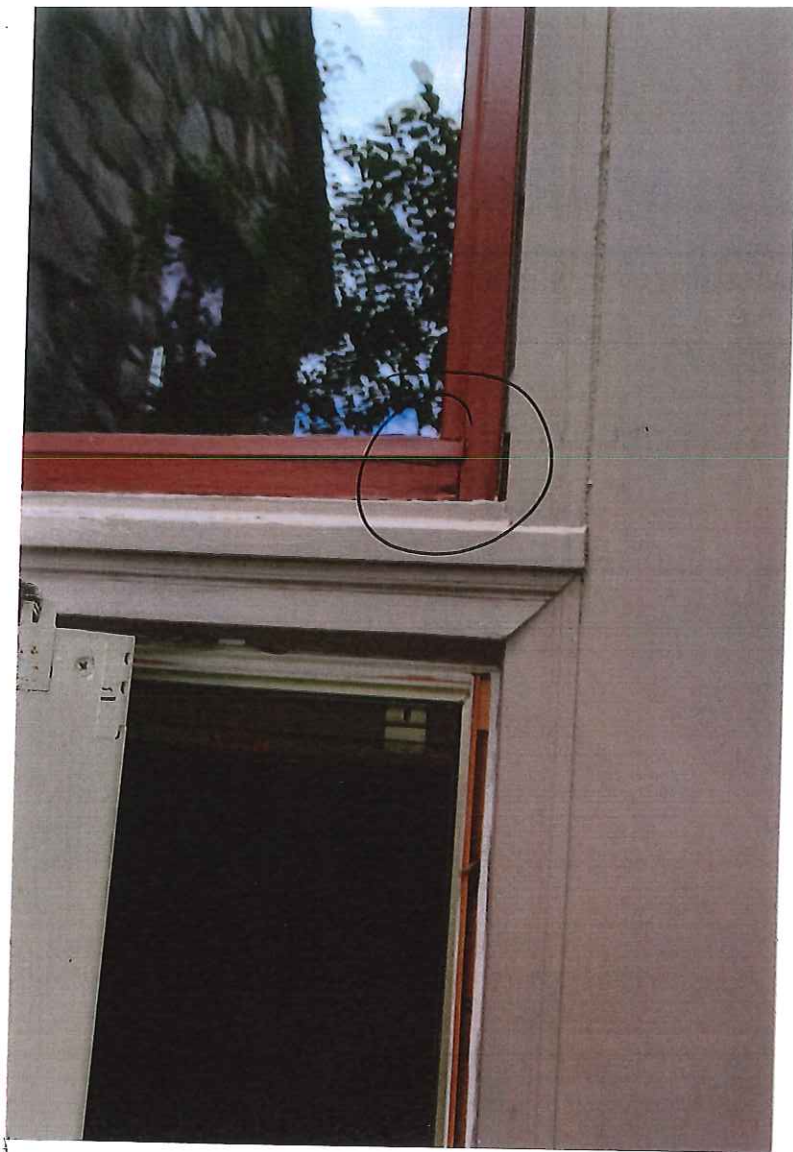
#15

Transom to be  
replaced due to  
rot - finger poked  
through bottom of  
sash

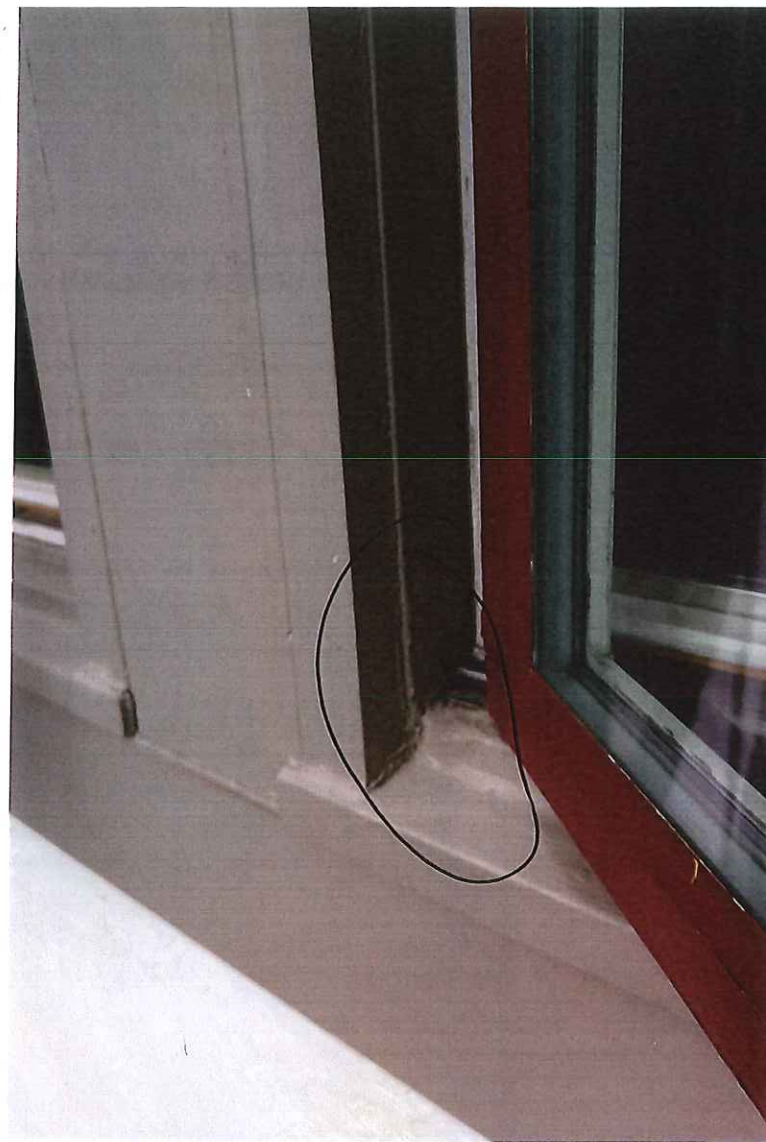
#14

Kitchen window  
frame - wood  
rot to be repaired

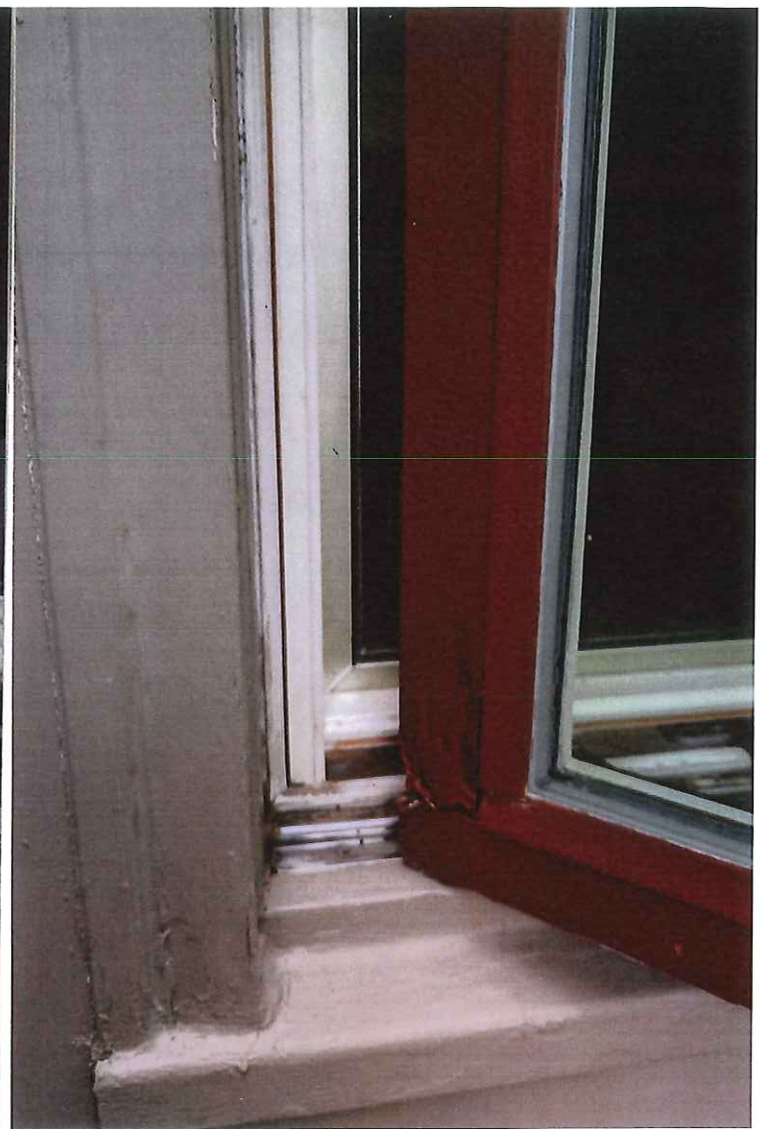
#13

Kitchen encasement  
sash with rot

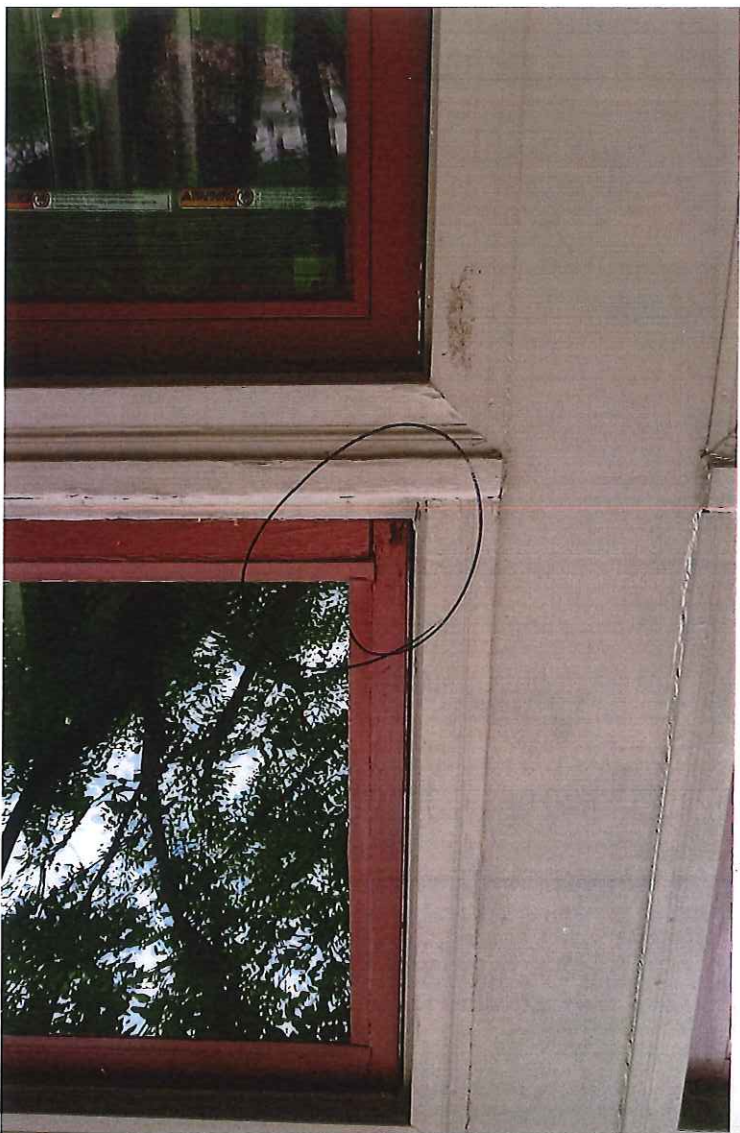
#16 Transom to be  
replace due to rot  
finger joined through  
bottom 7 inch
