## **FC Elliot Porch Restoration**

501 Dunbar Avenue -Porch roof replacement -Soffit & facia repairs -Installation of chimney liner Issued: 12/3/2019

## Photos of Damaged Areas

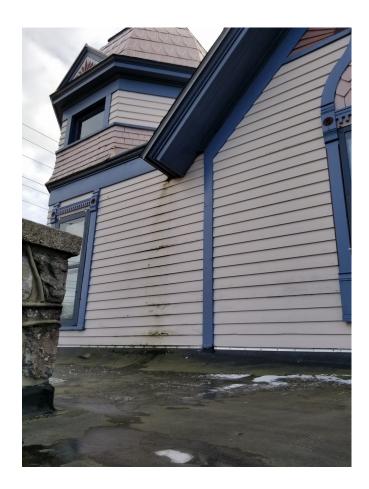
Detail from roof line.

Missing gutter has caused damage to siding, including rot. Entire section from window to blue molding needs to be replaced.

Note "tenting" of rubber roof line below. Leaking apparent from below porch roof.

New gutter and spout will be added to prevent future damage.

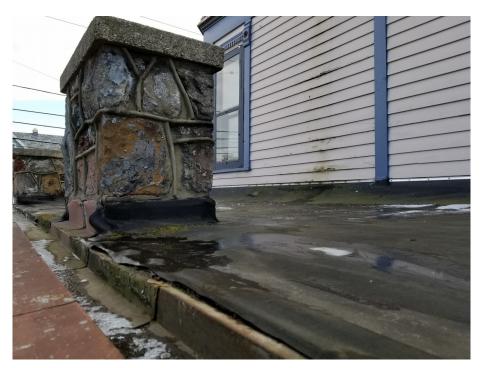
Evidence of porch roof water damage. Note pealing along gutter line, tenting, rolling, bumps.

Peeling of roof from architectural features.

Improper flashing along roof line.

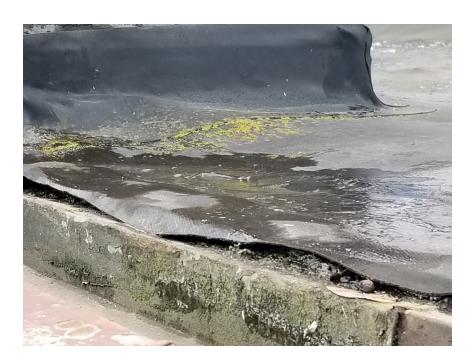
Detail photo. Evidence of underlay rot. Peeling of roof surface.

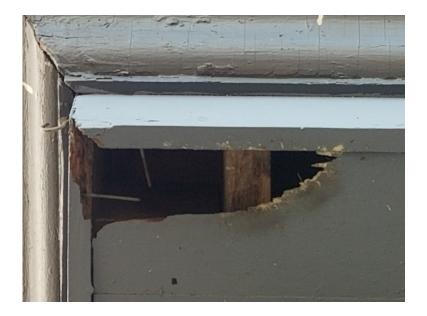
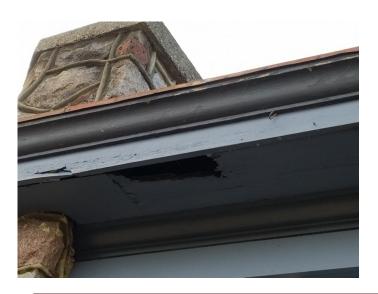
## Various examples of soffit and fascia damage.
