Saratoga Mill Dam Inspection Report

Field File No. 67.23

Key Sequence No. 630

Re: Dam Safety Inspection Report, Saratoga Mill Dam
WDNR Field File No. 67.23, Key Sequence No. 630

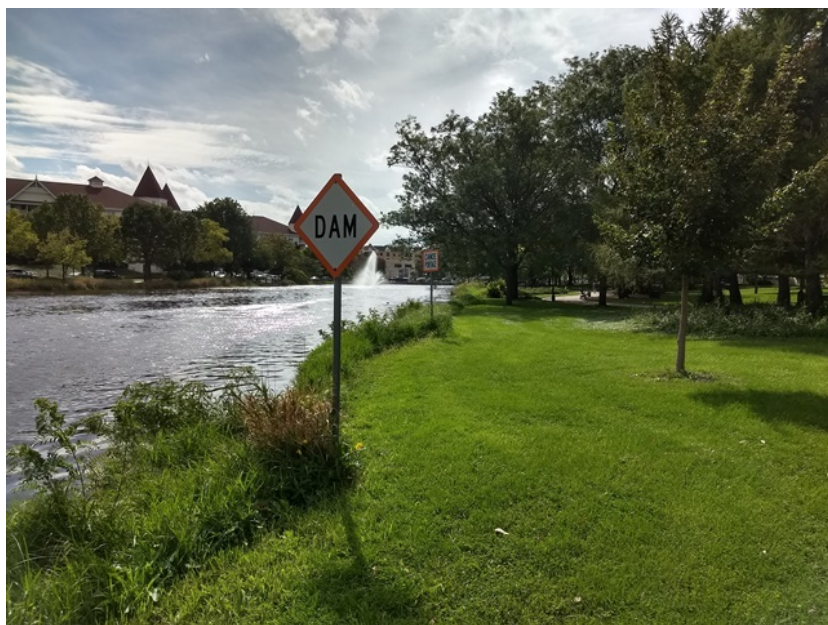
Saratoga Mill Dam
0063010031801.jpg
Dam Warning Sign and Portage Route

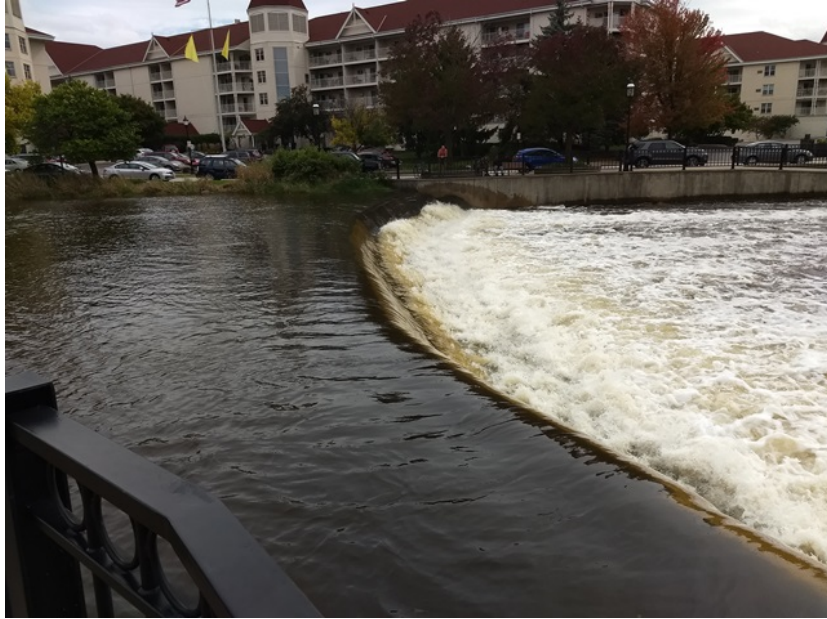
Saratoga Mill Dam
0063010031802.jpg
Overflow Spillway from Right Overlook

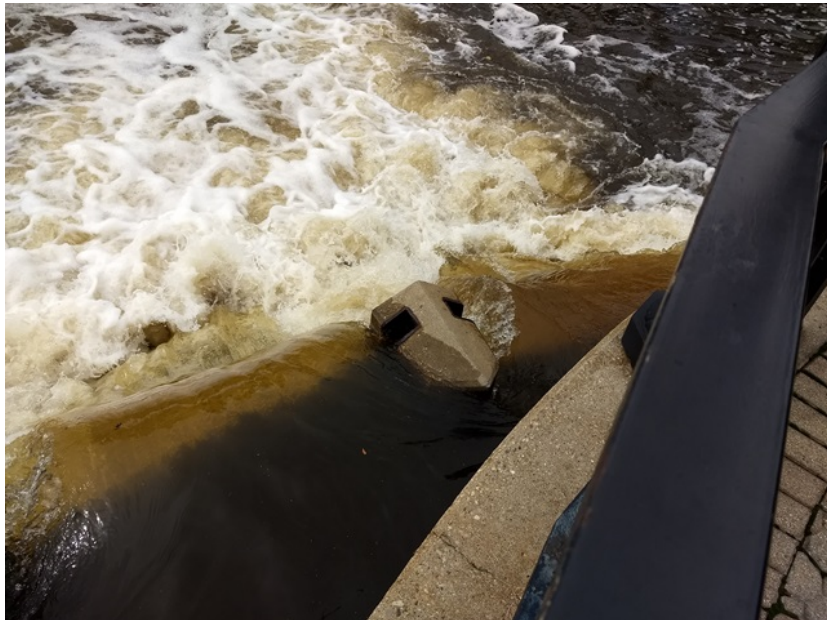
B. Stoplogs Dimensions: Condition:			Stop Logs 5 foot good									
C. Abutments Condition: * Seepage/wetness:			Good									
D. Piers (number, shape) Condition: *			Good

Saratoga Mill Dam
0063010031803.jpg
Stop Logs

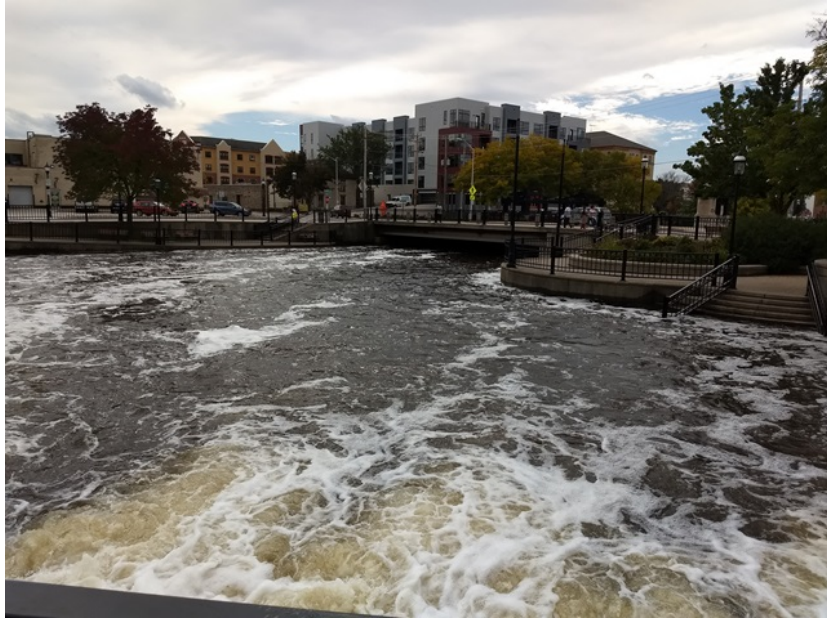
Saratoga Mill Dam
0063010031804.jpg
Downstream Bridge

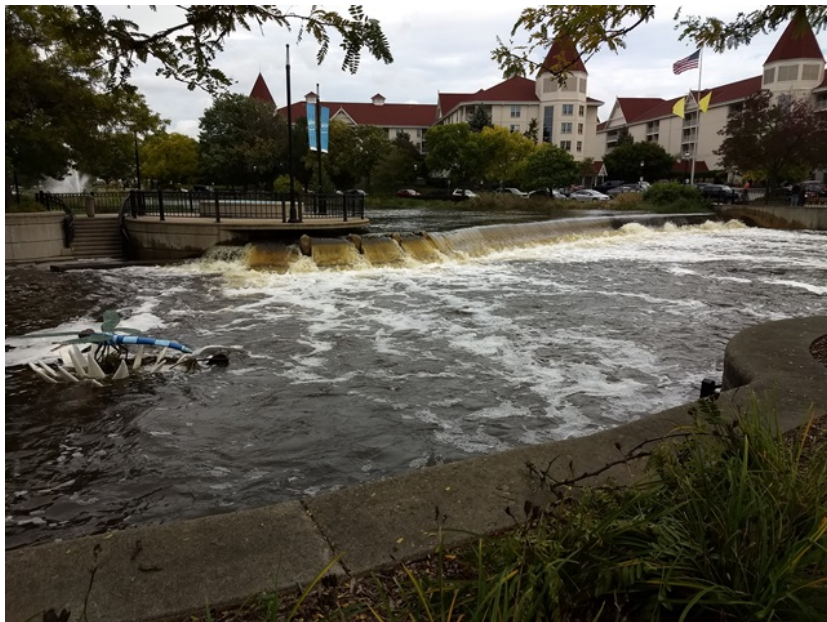
Saratoga Mill Dam
0063010031805.jpg
Upstream View of Dam

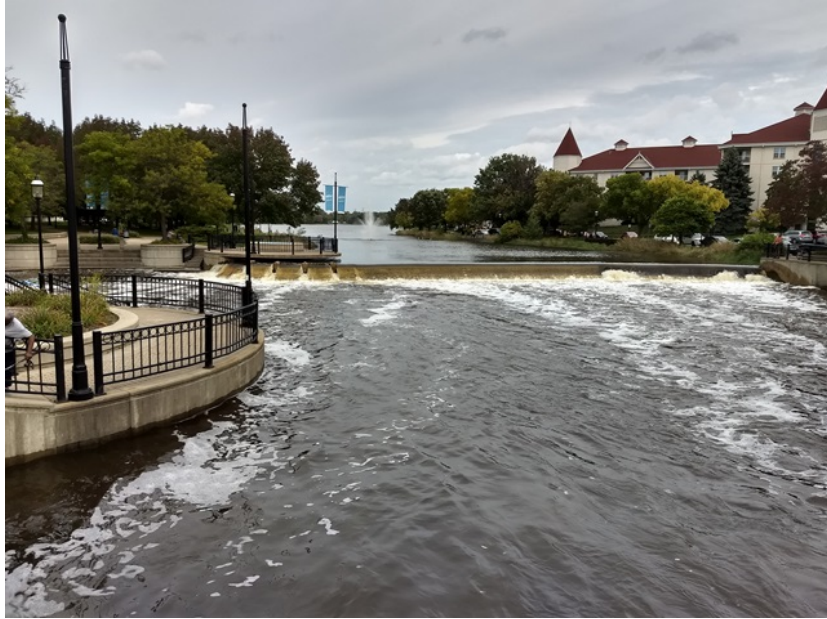
Saratoga Mill Dam
0063010031806.jpg
Upstream View of Dam

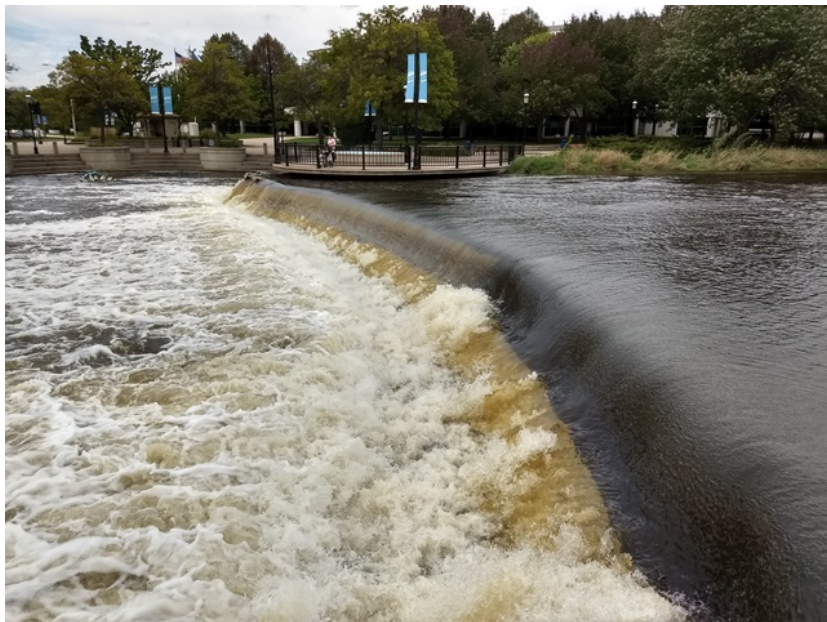
Saratoga Mill Dam
0063010031807.jpg
Overflow Spillway from Left Abutment

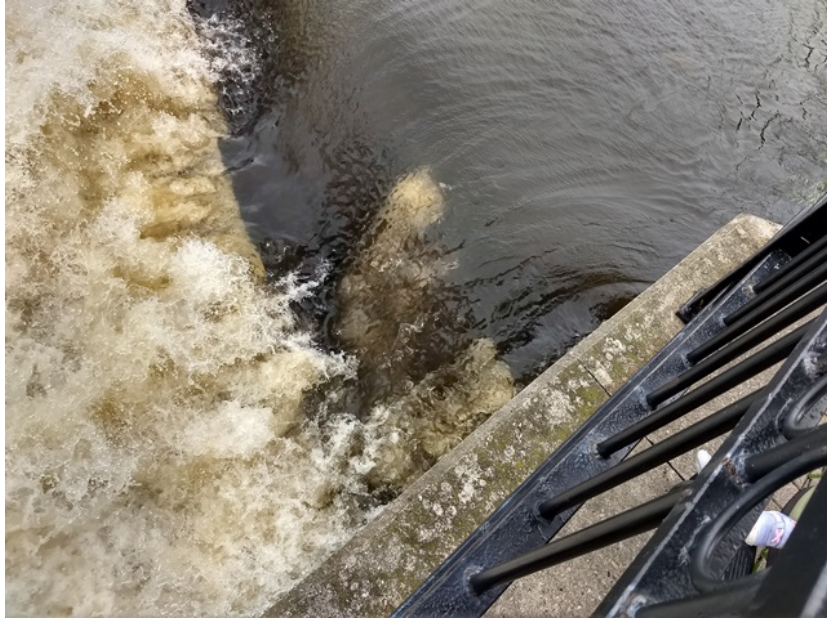
G. Abutments										3			
Condition: *		Good											
Seepage/wetness:		No wetness observed in either site visit											
H. Drains				No problem	x		Not applicable	x		Could not inspect			
Type: Weep holes, Relief drains, Other:													
Flow Rate:

Saratoga Mill Dam
0063010031808.jpg
Left Abutment
