LANDMARKS COMMISSION APPLICATION

NICKELL BUILDING

338-340 West Main Street, Waukesha, WI. 53186

**PLANNED
IMPROVEMENTS**

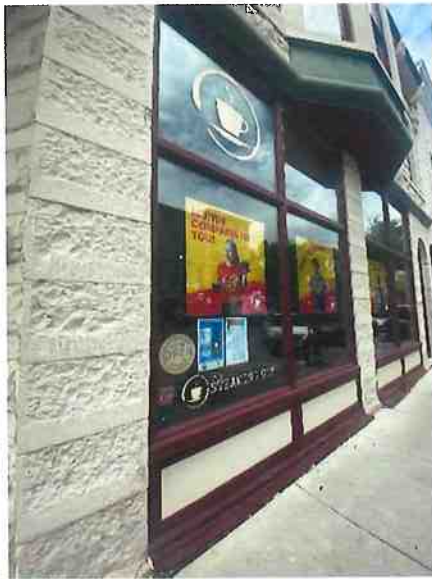
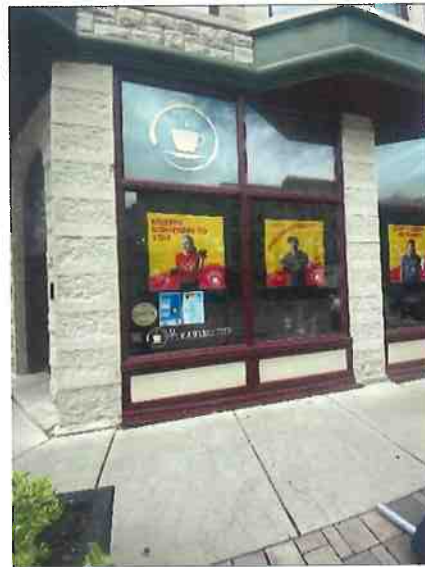
FIRST FLOOR WINDOW PICTURES

2 of the windows require glass replacement on the first floor. The seal of the window is broken, and the glass is foggy. Windows are located on Main Street – South Side of the building.

The glass for the large window (with the 'Open' sign) will be replaced, additionally, the glass above (with the Steaming Cup logo) will be replaced.

The glass will be replaced with clear glass utilizing the same size glass. The wood in the window frame surrounding the glass will remain the same dimensions as it is now.

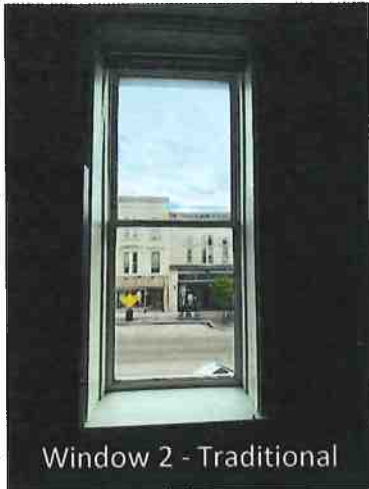
Window 2 - Traditional

12 Traditional Double Hung Windows require repair due to rotted sashes and/or impaired glass. The sashes will be replaced with wood using the existing dimensions. Exterior paint on sashes will match the current colors. The glass within the window will also be the same dimension and replaced with clear glass.

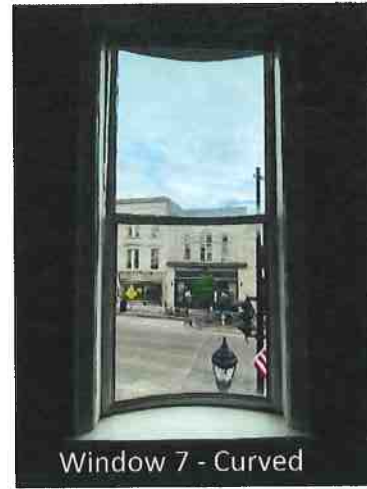
Window 7 - Curved

3 Curved Double Hung Windows require repair due to rotted sashes and/or impaired glass. The windows currently have curved glass and will be replaced with curved glass.

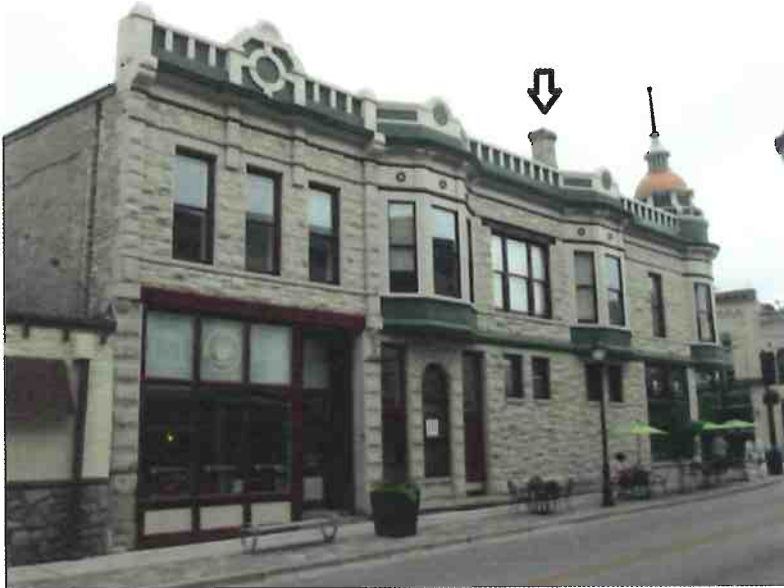
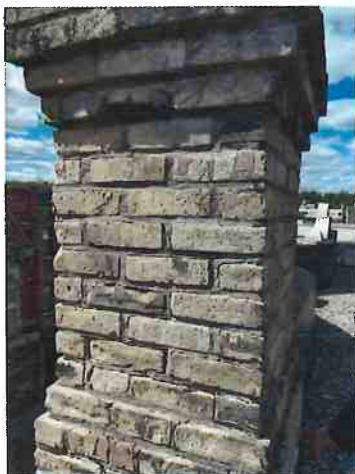
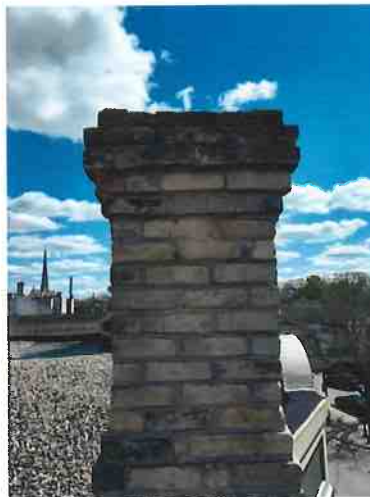
CHIMNEY REPAIR PICTURES

The chimney is not in service; however, the tuckpointing needs repair. The chimney is visible from Clinton Street and is located above a busy sidewalk. The repair work done on the chimney will be done utilizing historically appropriate materials.

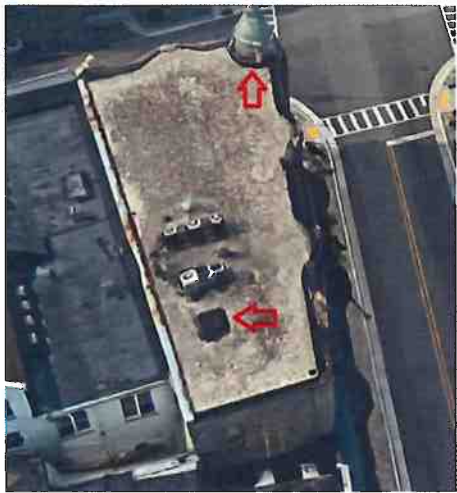
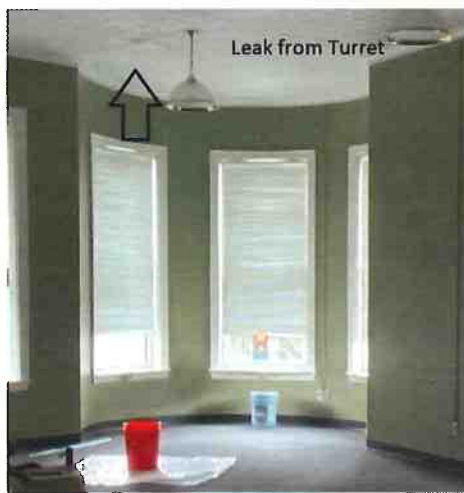
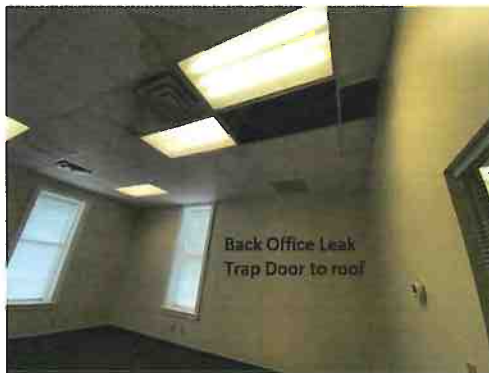
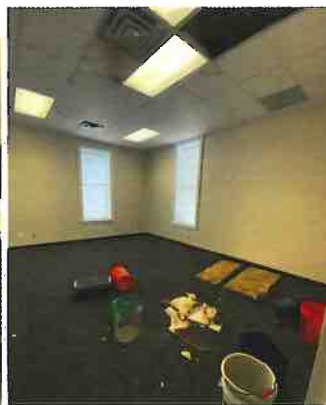
ROOF REPAIR PICTURES

The roof currently leaks under the turret in the front office space and under the trap door in the back-office space. Upon inspection the roof is in good condition and requires minimal work to correct the leaks. The roof cannot be seen from the ground level.

Please note – ariel photo date is unknown. Red arrows indicate where the water leaks.

- Re-caulk any seams as necessary on the decorative round metal corner piece.
- Check all of the rubber flashings at the base of the above metal. Make any repairs as necessary.
- Shovel the existing ballast back approximately 3' from its current location.
- Investigate the newly exposed roofing for any holes or defects in the membrane and make any necessary repairs.
- Re-distribute the ballast correctly.
- Repair the top of the bump-up on the wall to the east of the corner.
- Re-caulk the top of the termination bar at this location.
- Provide metal cap for the existing masonry chimney

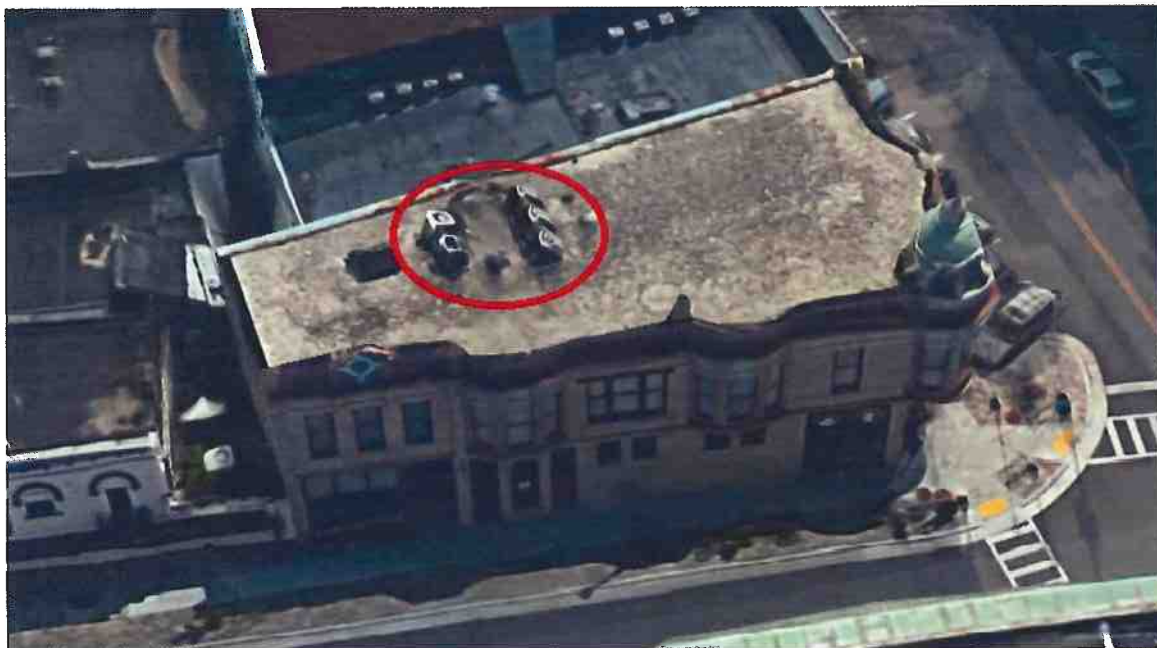
HEATING & COOLING PICTURES

3 of the 5 furnaces and condensers require replacement. They were all installed in the 90s and are not energy efficient. The current condensers are located on the roof, not visible and do not alter the appearance of the building. The units being replaced will be placed in same location they are now and will not be visible from the street.

- Remove existing three (3) furnaces and condensers.
- Furnish and install three (3) new High Efficiency Goodman furnaces at existing locations.
- Furnish and install three (3) new Goodman air conditioner condensers on roof at existing locations.
- Venting to existing PVC locations.
- Reuse and flush refrigeration lines.
- Low voltage to existing thermostats.
- Electrical connections.
- Crane rental and street permit.

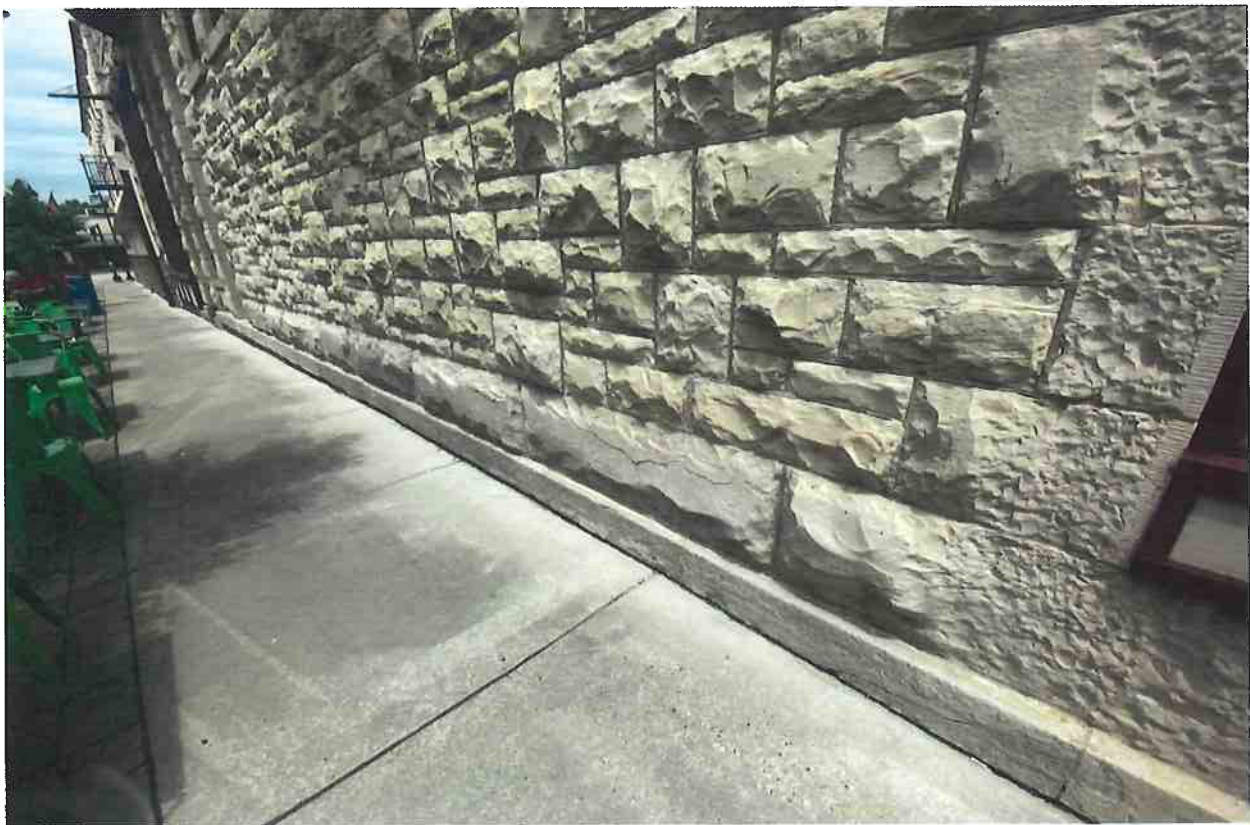
WEST ELEVATION STONE/TUCKPOINT PICTURES

The large stones (approximately 8" high and 58" wide) on the West side of the building are deteriorating and require attention. We are researching the best way to preserve this stone as we are aware power washing and sealing the stone is not recommended. You will see an amount on the Fred Stier bid to correct this – we do not intend to address this issue until we can find an appropriate method to address the matter. Any advice is welcome.

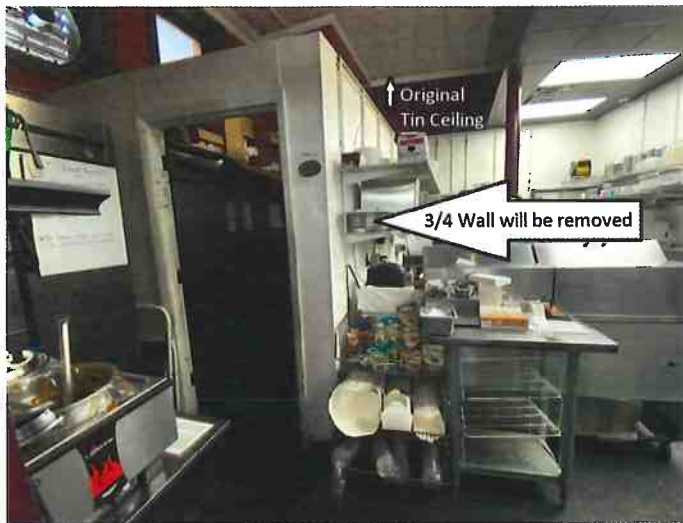
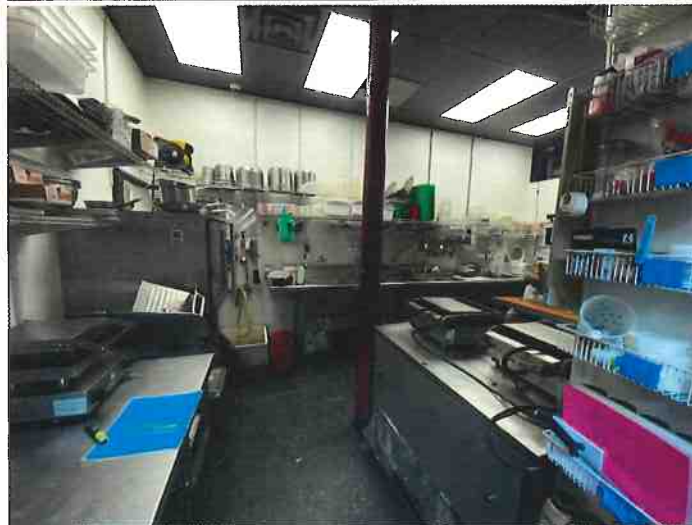
KITCHEN PICTURES

The existing floor in the kitchen requires repair. The kitchen space holds little historical significance due to the number of times the interior has been altered for various business. The floor will be repaired and the $\frac{3}{4}$ wall will be removed to create a larger space for the café kitchen to operate. A portion of the original tin ceiling is over the kitchen space, the tin ceiling will not be altered.

- Remove existing electrical outlets and switch from $\frac{3}{4}$ wall
- Remove existing $\frac{3}{4}$ wall from kitchen
- Furnish and install $\frac{1}{2}$ " plywood screwed down to joists
- Furnish and install Mannington Realities vinyl flooring glued direct with heat welded seams
- Furnish and install 6" vinyl base
- Furnish and install reducers at doorways as needed
- Refeed electrical through floor for new equipment layout
- Provide an allowance of \$3,000.00 disconnect and reconnection of sinks
- Equipment removal by owner

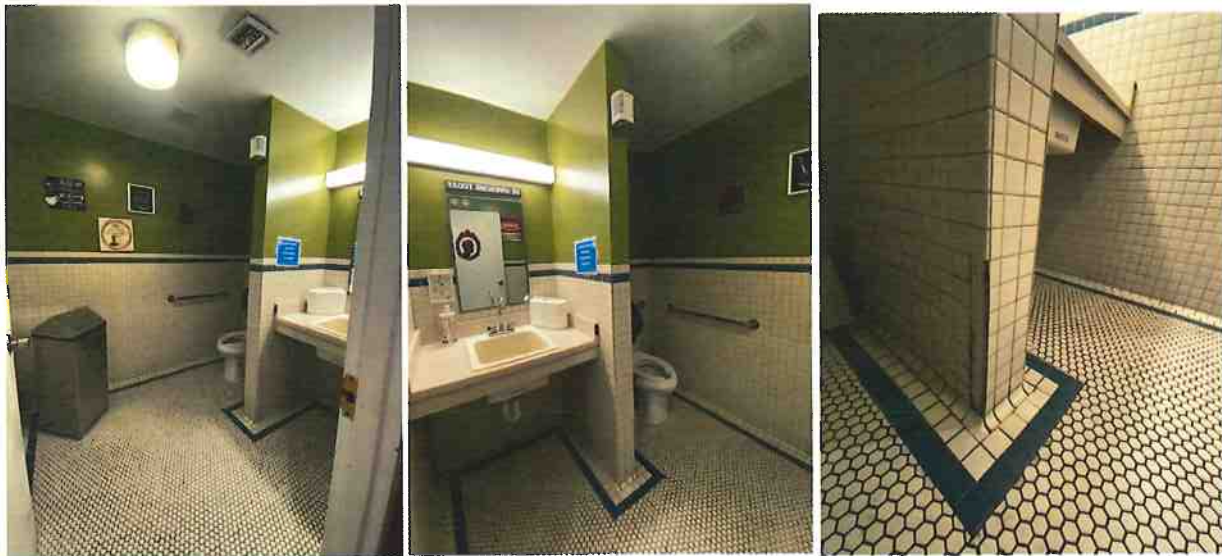
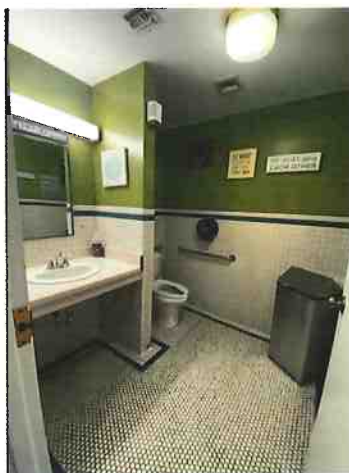
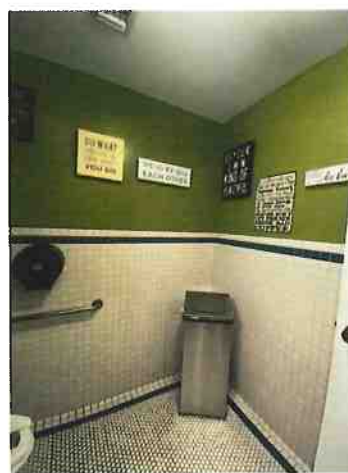
FIRST FLOOR RESTROOM PICTURES

The first-floor restrooms hold no historical significance due to the number of times the interior has been altered for various businesses. The restrooms were updated during the 90's and need minor updates.

Cosmetic updates: updated lighting, replace the sinks & faucets, new vanity tops

Repair work: Repair Ceramic tile corners

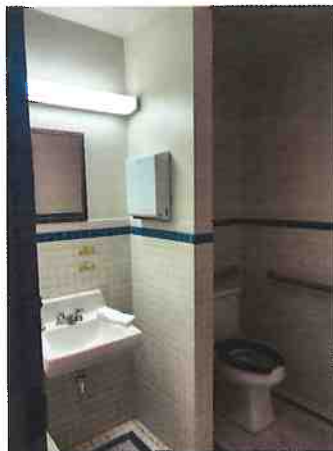
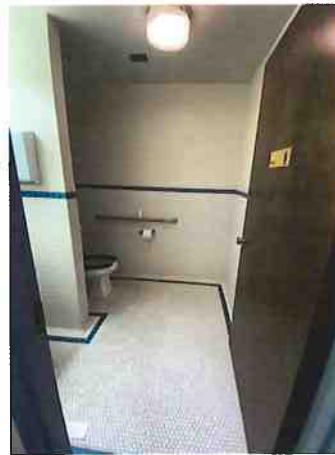
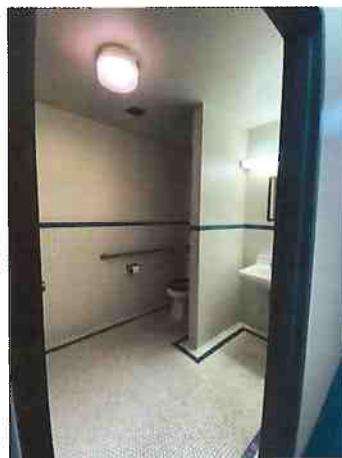
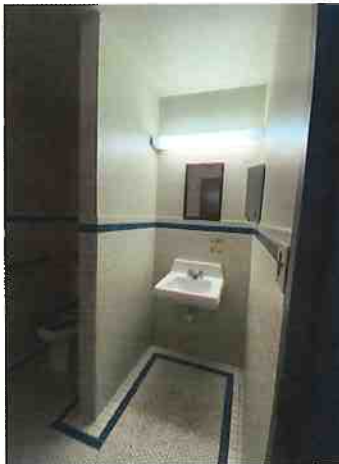
SECOND FLOOR RESTROOM PICTURES

The second-floor restrooms hold no historical significance due to the number of times the interior has been altered for various businesses. The restrooms were updated during the 90's and need minor updates.

Cosmetic updates: updated lighting, replace the sinks & faucets, new vanity tops

Replace: Replace existing toilets with new ADA toilets

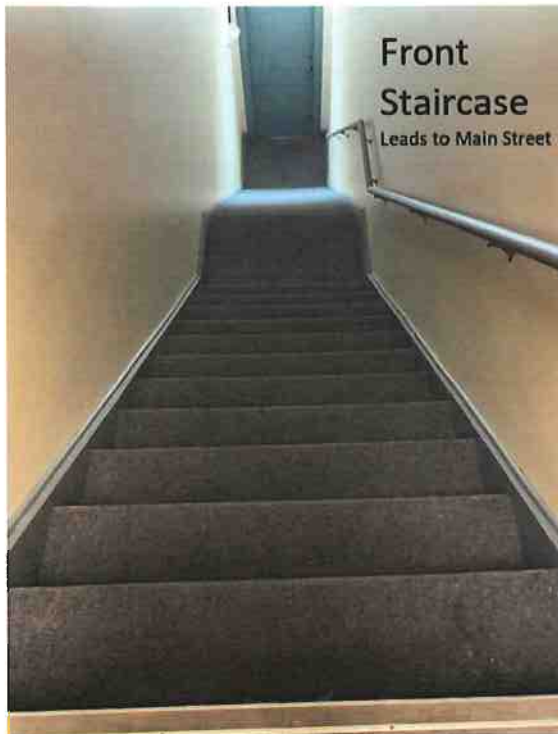
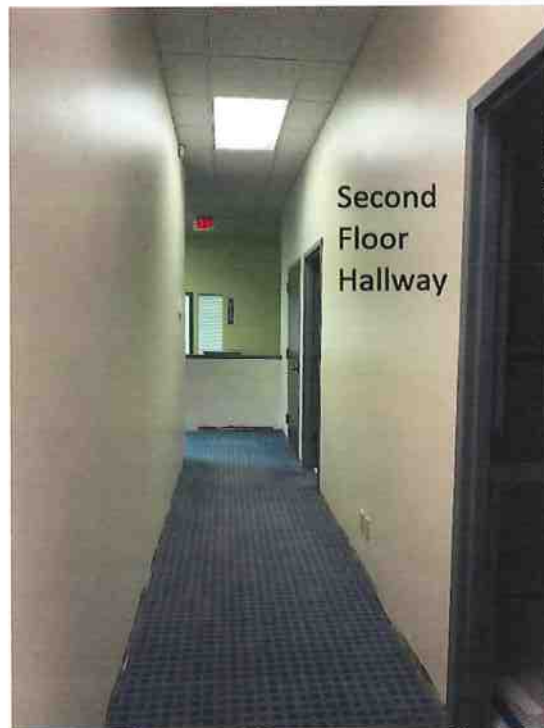
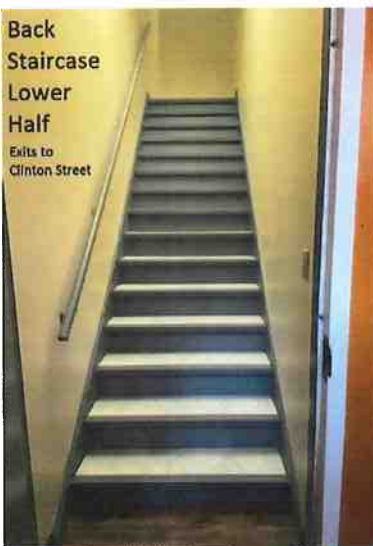
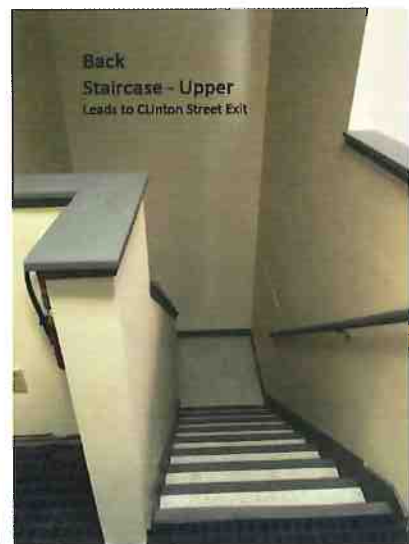
SECOND FLOOR HALLWAY/STAIRCASES PICTURES

R1211, LLC plans to remove the existing flooring in both staircases and hallway and replace with classic LVP flooring. Neither the second-floor hallway nor the staircases hold historical significance due to the number of times the interior has been altered for various businesses. This area was updated during the 90's and needs cosmetic updates. The flooring is outdated and has no historic value.
