John Atlee President Water Doctors

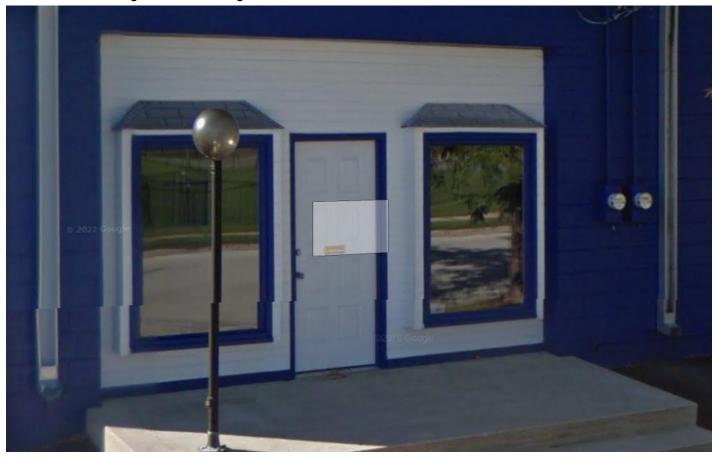
A few weeks ago (now over a Month) we had a large rain storm that made the siding on the North side leak water into the building creating a water issue. When we searched to find the issue we found the old siding had deteriorated to mush and rotted the inside 2"x6"s and the wall needed to be replaced quickly. During the investigation on the south side we checked the north side since it had the same siding. The siding was also rotten and it was making it so the garage door wouldn't open correctly. A decision was made quickly to get a contractor out for repairs right away.

Here is what the original North facing wall looked like

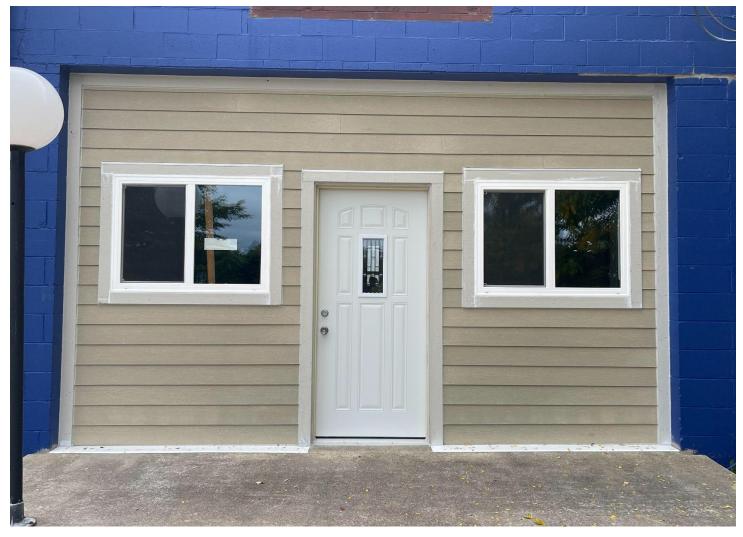
Here is what the new wall looks like

On the north facing side we replaced the walls with the same 2"x6" walls, a 36" white exterior door (the same size as before) and two new windows. The old windows were custom windows that we were told will take currently 4 months or more to get. So slightly smaller windows were chosen, keeping the same/similar look and feel to the building. We did have new concrete board siding installed as it would last longer! Since we did not want this to happen again. Currently the inside walls are not finished as the inspector has not been onsite yet.

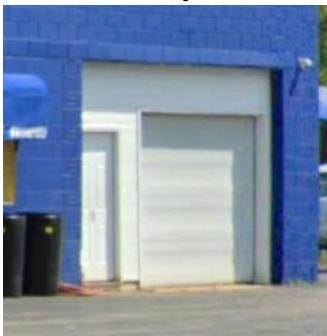
Here is what the south facing wall looked like

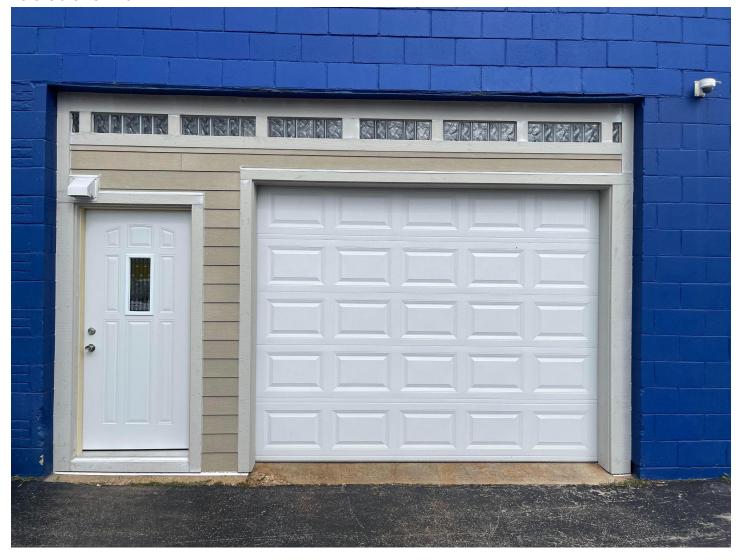
Here is the new wall

The south facing walls with the garage door and 36" white exterior door was replace with the same 2"x6" walls, a 36" white exterior door as the other side had. The garage door was replace at the same time. We did add some glass block windows above the garage door for a small amount of natural light to get in the shop room. We did have new concrete board siding installed as it would last longer! Since we did not want this to happen again. Currently the inside walls are not finished as the inspector has not been onsite yet.
