TECHNICAL MEMORANDUM

RE: SOIL & GROUNDWATER MANAGEMENT PLAN CITGO/EXPO SERVICE// PROPOSED KWIK TRIP 527 1700 PEWAUKEE ROAD, WAUKESHA, WI

Date September 22, 2016

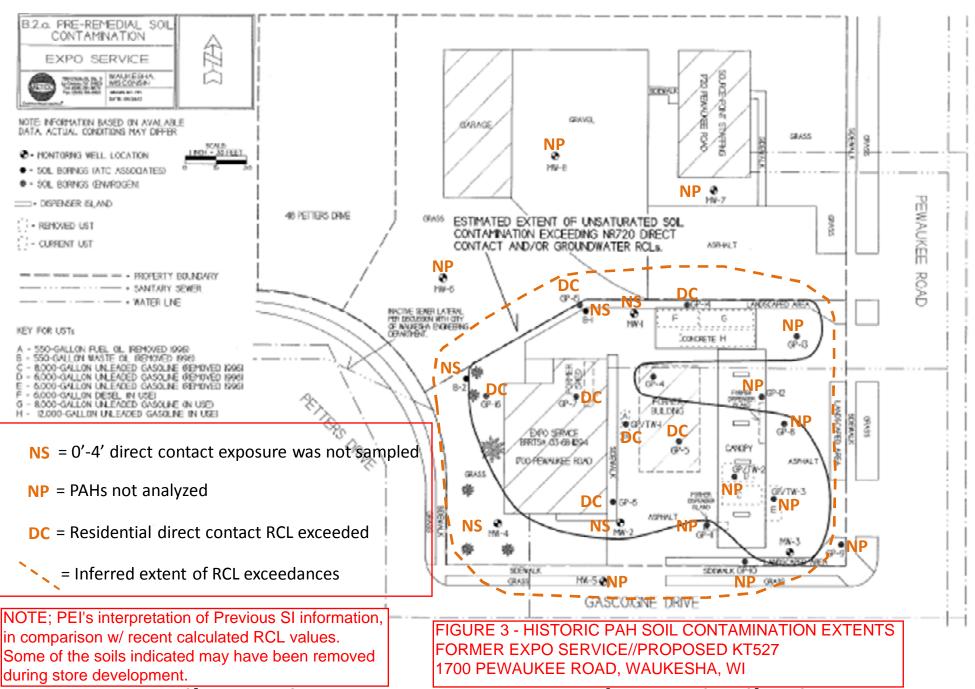
Soil PAH Direct Contact RCL Exceedance Distribution

The previous investigation (1996-2014) & Phase II ESA results identified petroleum soil contamination in numerous locations around the site. The Phase II results indicate this is most likely residual petroleum contamination from the previous release/investigation. Petroleum contaminated soil still remains on the site. Figure 5 & 7 shows the possible extent of petroleum contaminated soil based on the ESA results.

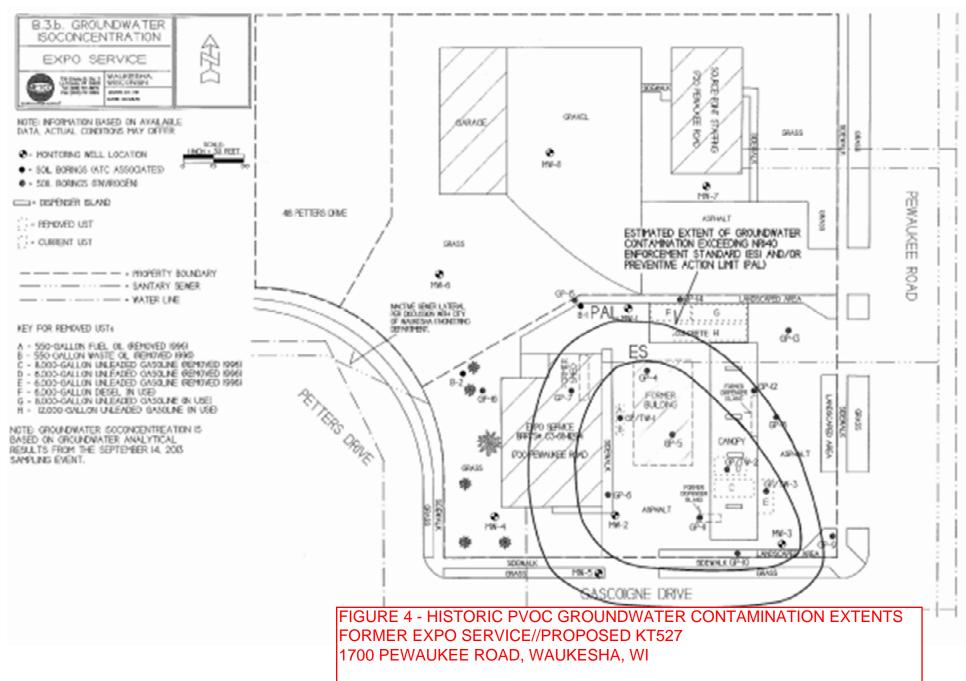
PVOC Groundwater Quality Standard Exceedance Distribution

Groundwater was encountered in several of the borings, and it was determined that groundwater is likely present at 15 feet bls, Perched water in aggregate fill material is possible, and was observed in the UST basin sump at 10 ft bg. During the Phase II ESA, petroleum contaminated groundwater was confirmed to still be present on the site (Figure 6 & 7).

PEI does not anticipate a large volume of groundwater to be encountered based on depths of typical footings and since the lean clay material in not very porous, thus minimal influx of groundwater. However, any perched water encountered in excavations should be handled as potentially petroleum contaminated. <u>PEI will coordinate vacuum truck service (Covanta Services)</u> to remove a portion of this water to facilitate satisfactory removal and appropriate installation of structure backfill material.
