MEMO

SUBJECT: 220 S Prairie Avenue, Waukesha, WI – Wetland Screening

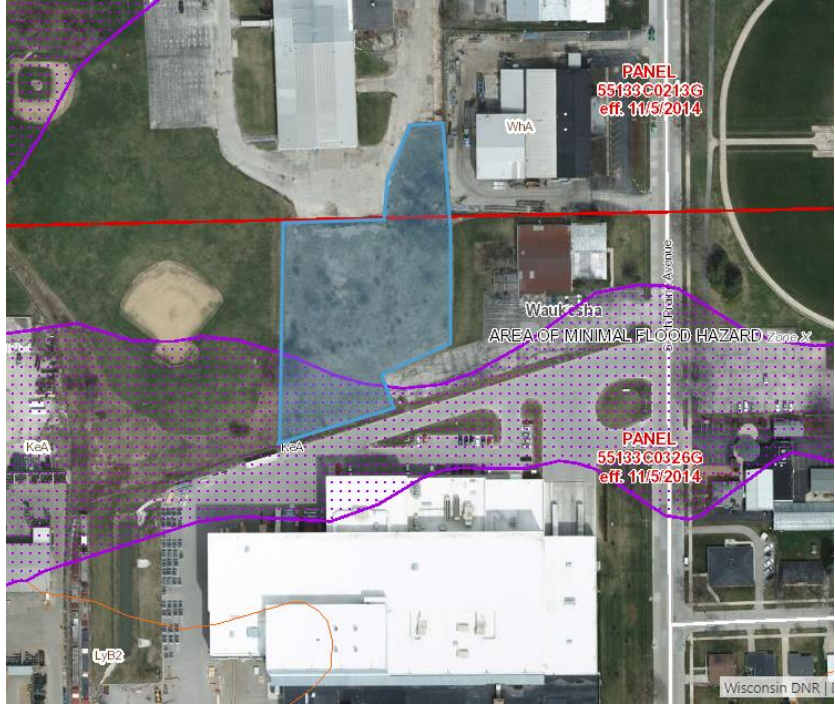
WDNR Surface Water Data Viewer

No mapped waterways, wetlands or floodplain were identified within the Project Area. No topographic depressions, swales or ditches are present. The on-site investigation did not result in the observation of any areas that would be considered problematic or in need of further study or delineation. Vegetation is a mix of upland and mesic herbaceous plants, shrubs and trees. Common vegetation included buckthorn, box elder, teasel, Canada goldenrod, Virginia stickseed and quackgrass.

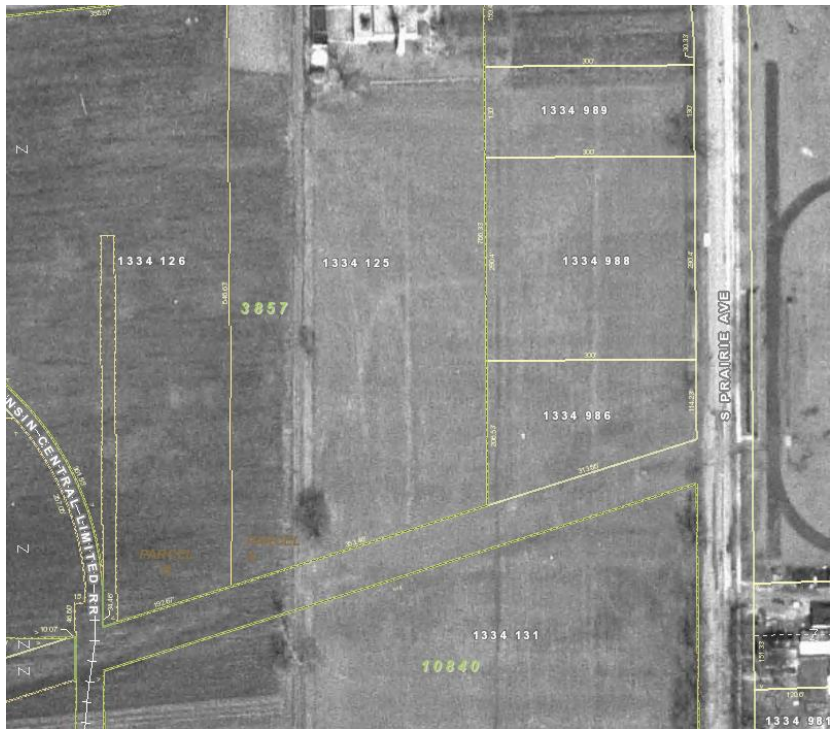
Waukesha County GIS – 1963 Aerial Photo

The undeveloped area is situated between a city park, and several commercial/industrial buildings and parking lots west of South Prairie Avenue. Based on aerial photo review, the Project Area was once a developed part of the adjacent park and included a baseball field. The field was abandoned between 1990 and 1995. Remnants of the field, including chain-link fencing, are still present in the vegetation that has overgrown the field. The field is still visible in aerial photos as late as 2010. There is no evidence of wetland signatures in any aerial photo reviewed.
