**WETLAND & PRIMARY ENVIRONMENTAL CORRIDOR
DELINEATION REPORT**

SALEM UNITED METHODIST CHURCH PROPERTY

**NW One-quarter, Section 12, T6N, R19E
CITY OF WAUKESHA
WAUKESHA COUNTY
WISCONSIN**

Report completed: March 18, 2016

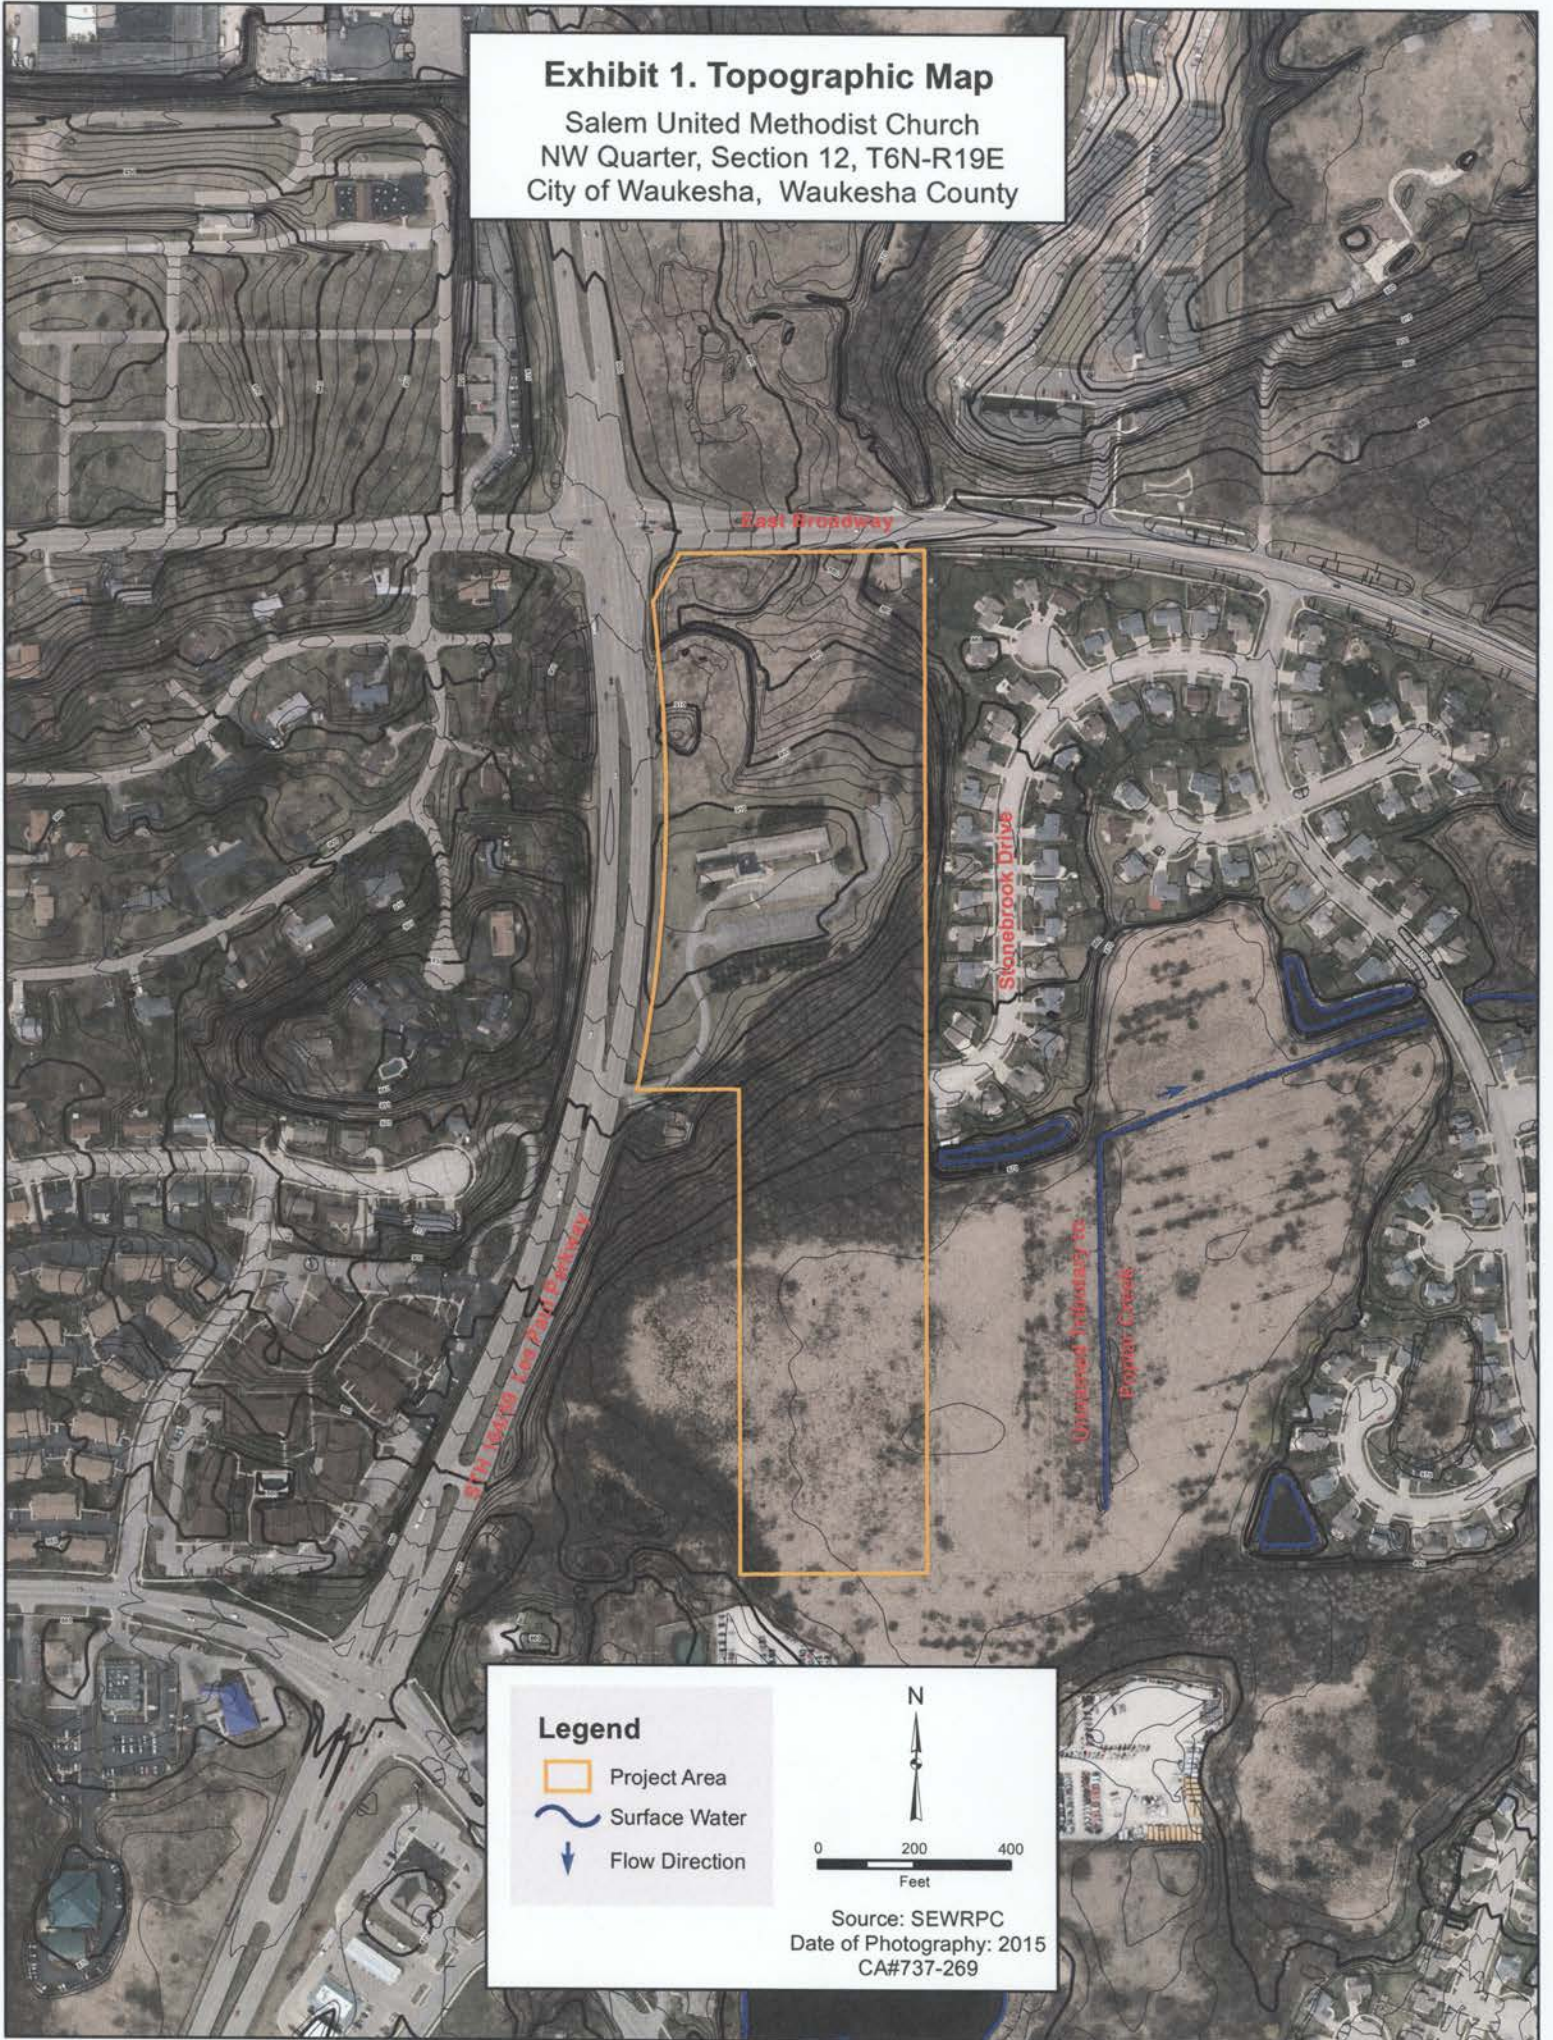
Exhibit 1. Topographic Map

The topographic map (Exhibit 1) depicts a project area within significant topographic relief. Elevations range from a high of 918 feet above National Geodetic Vertical Datum, 1929 adjustment (NGVD 29), on the northwest part of the property to a low elevation of 864 feet above NGVD 29 on the southern portion of the property. While no waterways or waterbodies are contained within the project area, an unnamed tributary to Poplar Creek just east of the project area drains a large wetland complex, a portion of which is contained on the subject property.

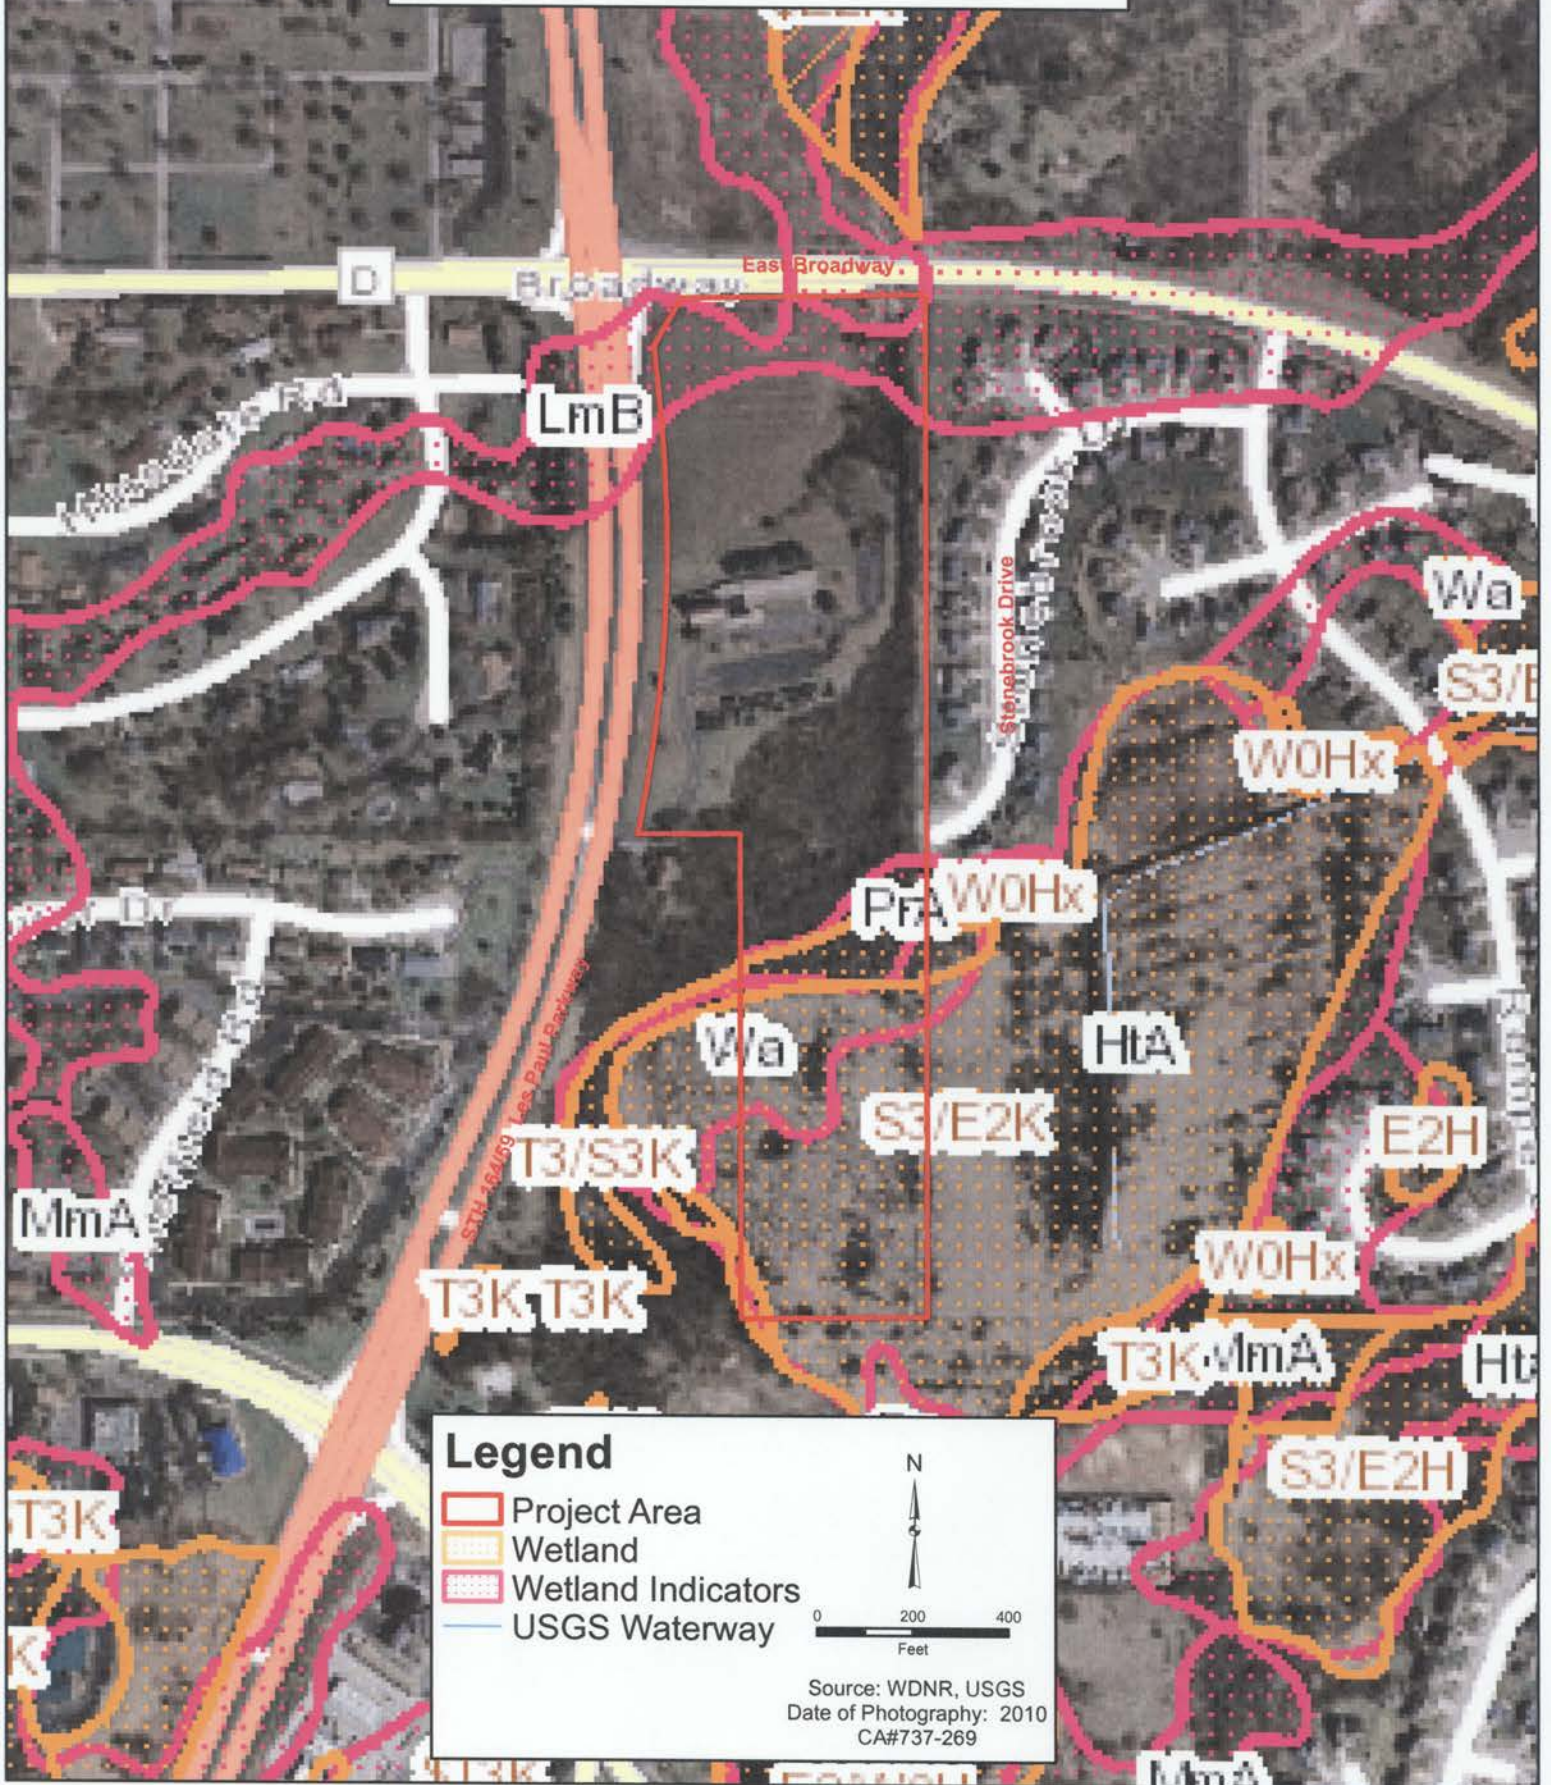
Exhibit 2. WDNR Surface Water Data Viewer Wisconsin Wetland Inventory Map

The WDNR Surface Water Data Viewer (WWI) map (Exhibit 2) indicates one large wetland complex in the south part of the project area consisting of S3/E2K (Scrub/shrub – Emergent/wet meadow) and T3/S3K (Forested – Scrub/shrub) wetland types. The unnamed tributary to Poplar Creek mentioned above is identified as a USGS waterway on this exhibit. WDNR identifies this waterway as a first order stream. Natural community and general condition information is not available from WDNR.

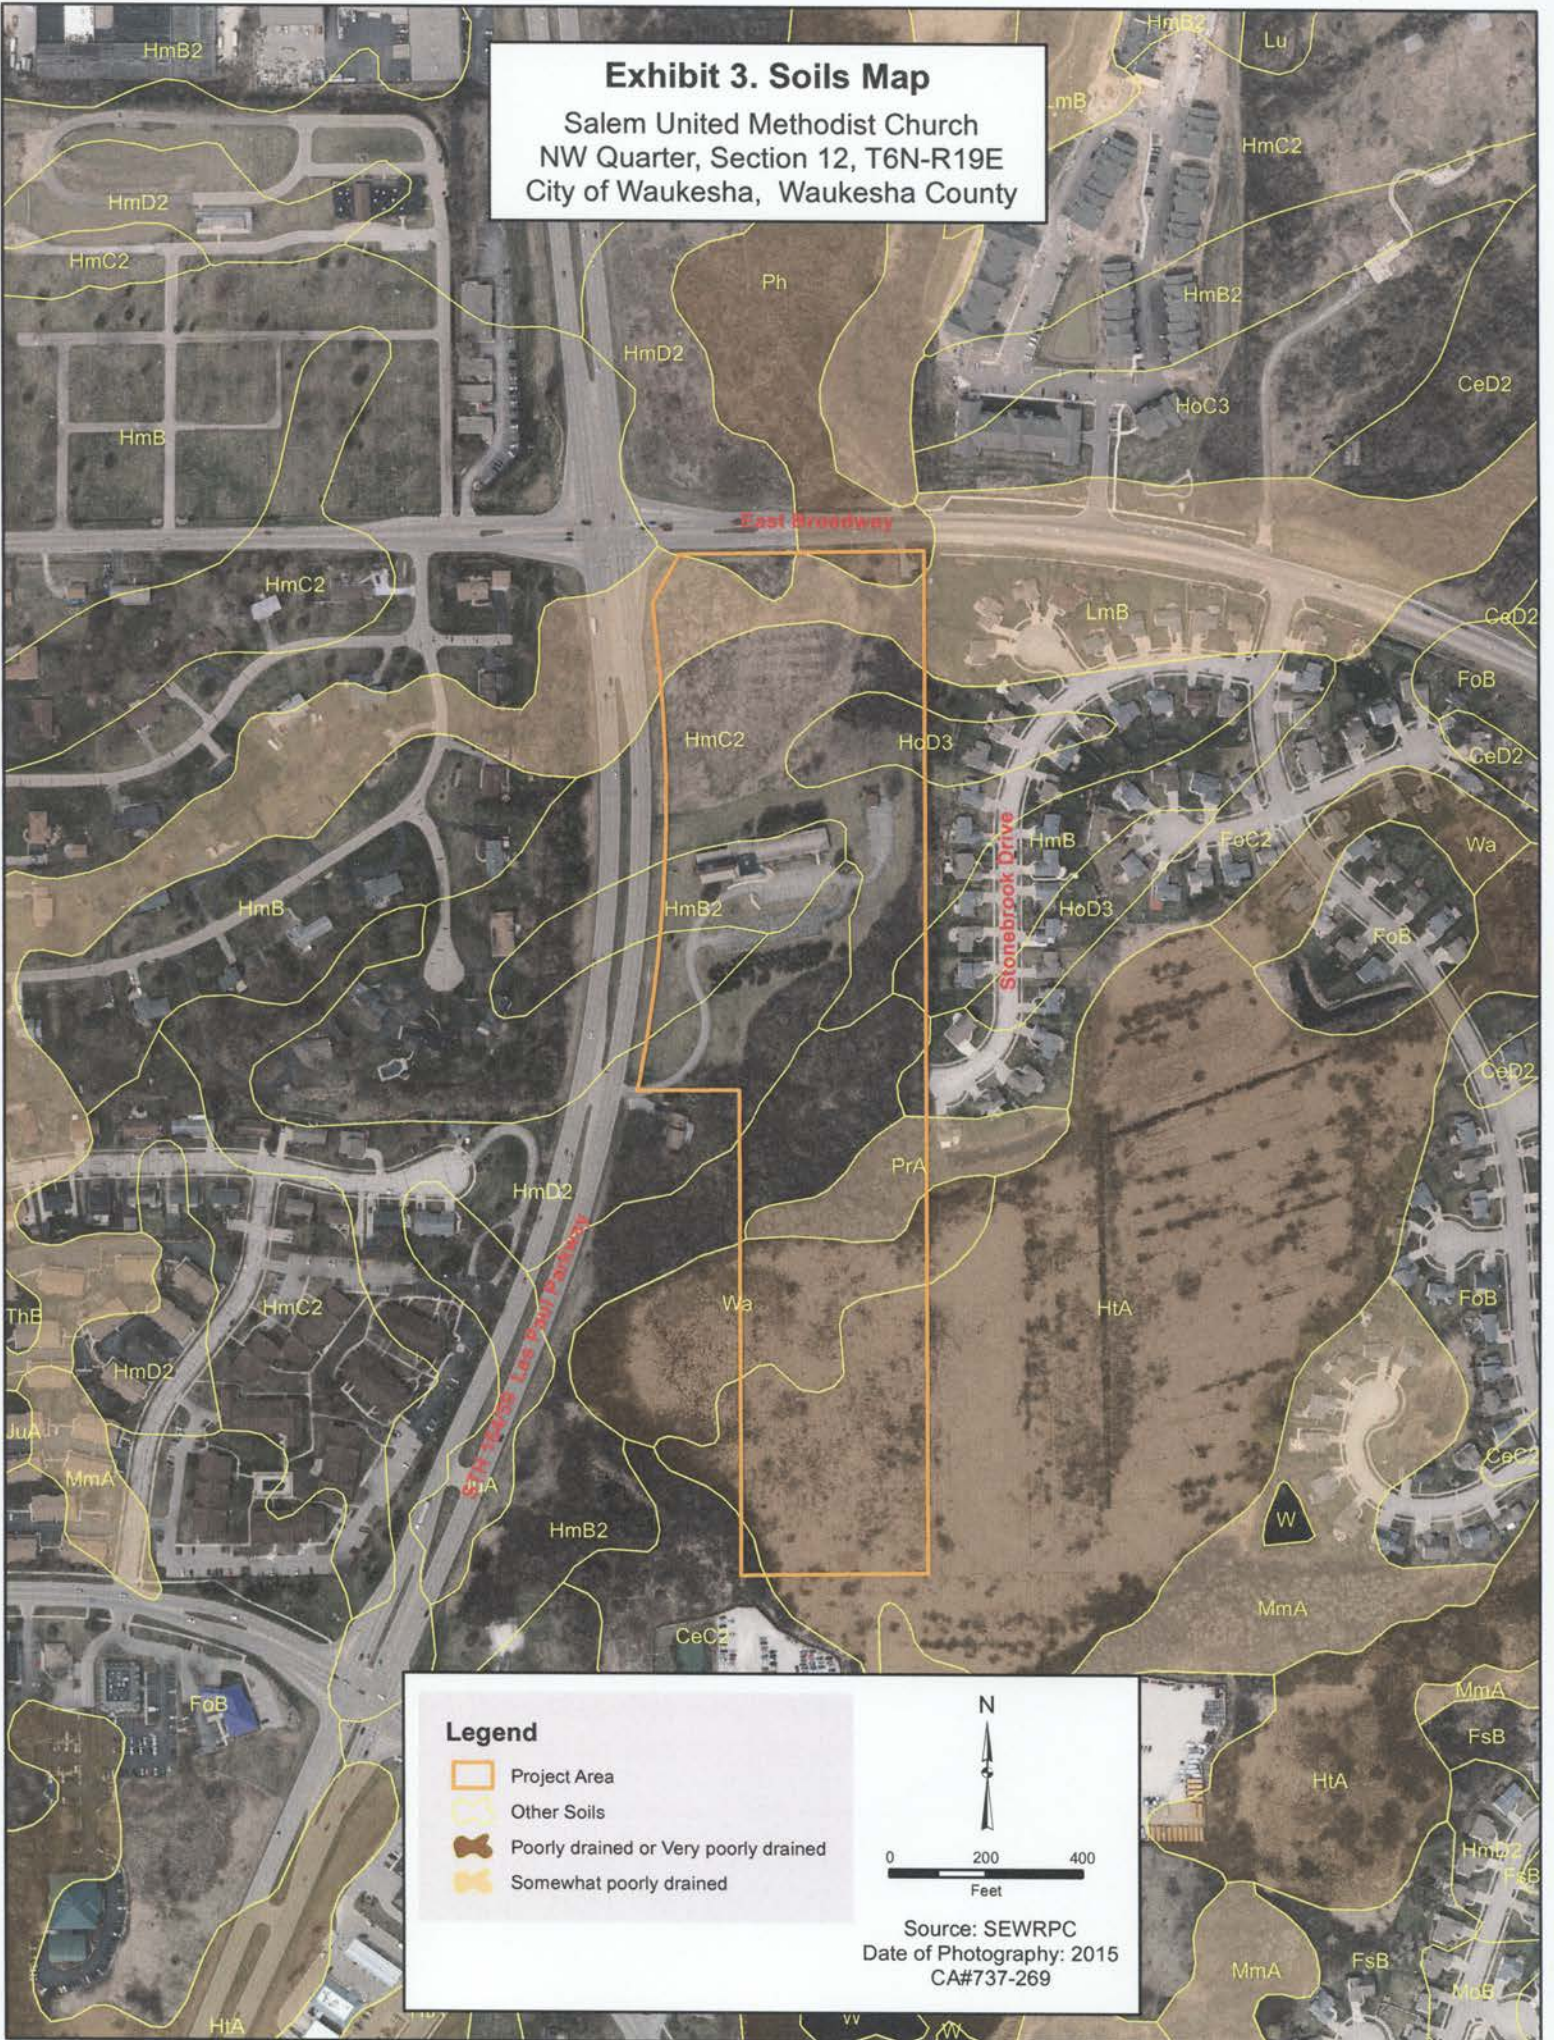
Exhibit 3. Soils Map

The NRCS Soil Survey map (Exhibit 3) shows the following soils in the project area:

Soil Name	Slope %	Hydric Rating	% Soil Coverage in Project Area	Sample Site(s)
Casco loam (CeC2)	6-12%, eroded	Non-hydric	0.3%	
Fox loam (FoC2)	6-12%, eroded	Non-hydric	0.6%	
Hochheim loam (HmB)	2-6%	Non-hydric	0.7%	
Hochheim loam (HmB2)	2-6%, eroded	Non-hydric	16.1%	
Hochheim loam (HmC2)	6-12%, eroded	Non-hydric	26.0%	
Hochheim loam (HmD2)	12-20%, eroded	Non-hydric	11.6%	
Hochheim soils (HoD3)	12-20%, severely eroded	Non-hydric	4.0%	
Houghton muck (HtA)	0-2%	Hydric	18.4%	
Lamartine silt loam (LmB)	1-4%	Predominantly Non-hydric	7.4%	
Pella silt loam (Ph)	0-2%	Predominantly hydric	1.2%	1
Pistakee silt loam (PrA)	1-3%	Predominantly Non-hydric	5.0%	2 and 3
Wallkill silt loam (Wa)	0-3%	Hydric	8.4%	4

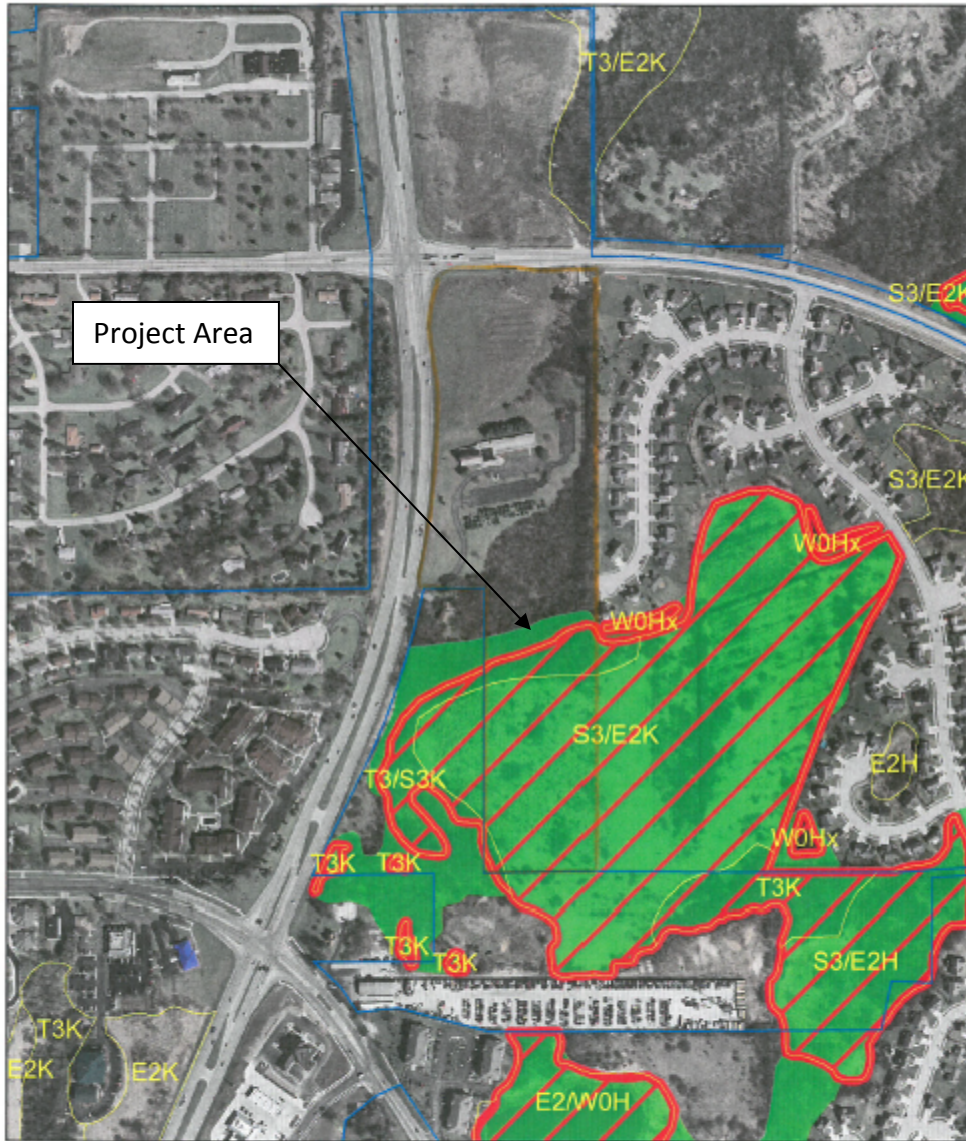
EXHIBIT 7. ADID Wetland Map

The ADID wetland map (Exhibit 7) indicates that wetlands located in the south part of the project area are located in a designated Primary Environmental Corridor (PEC) and, as such, have been designated as ADID wetlands under the Section 404(b)(1) Guidelines of the Clean Water Act.

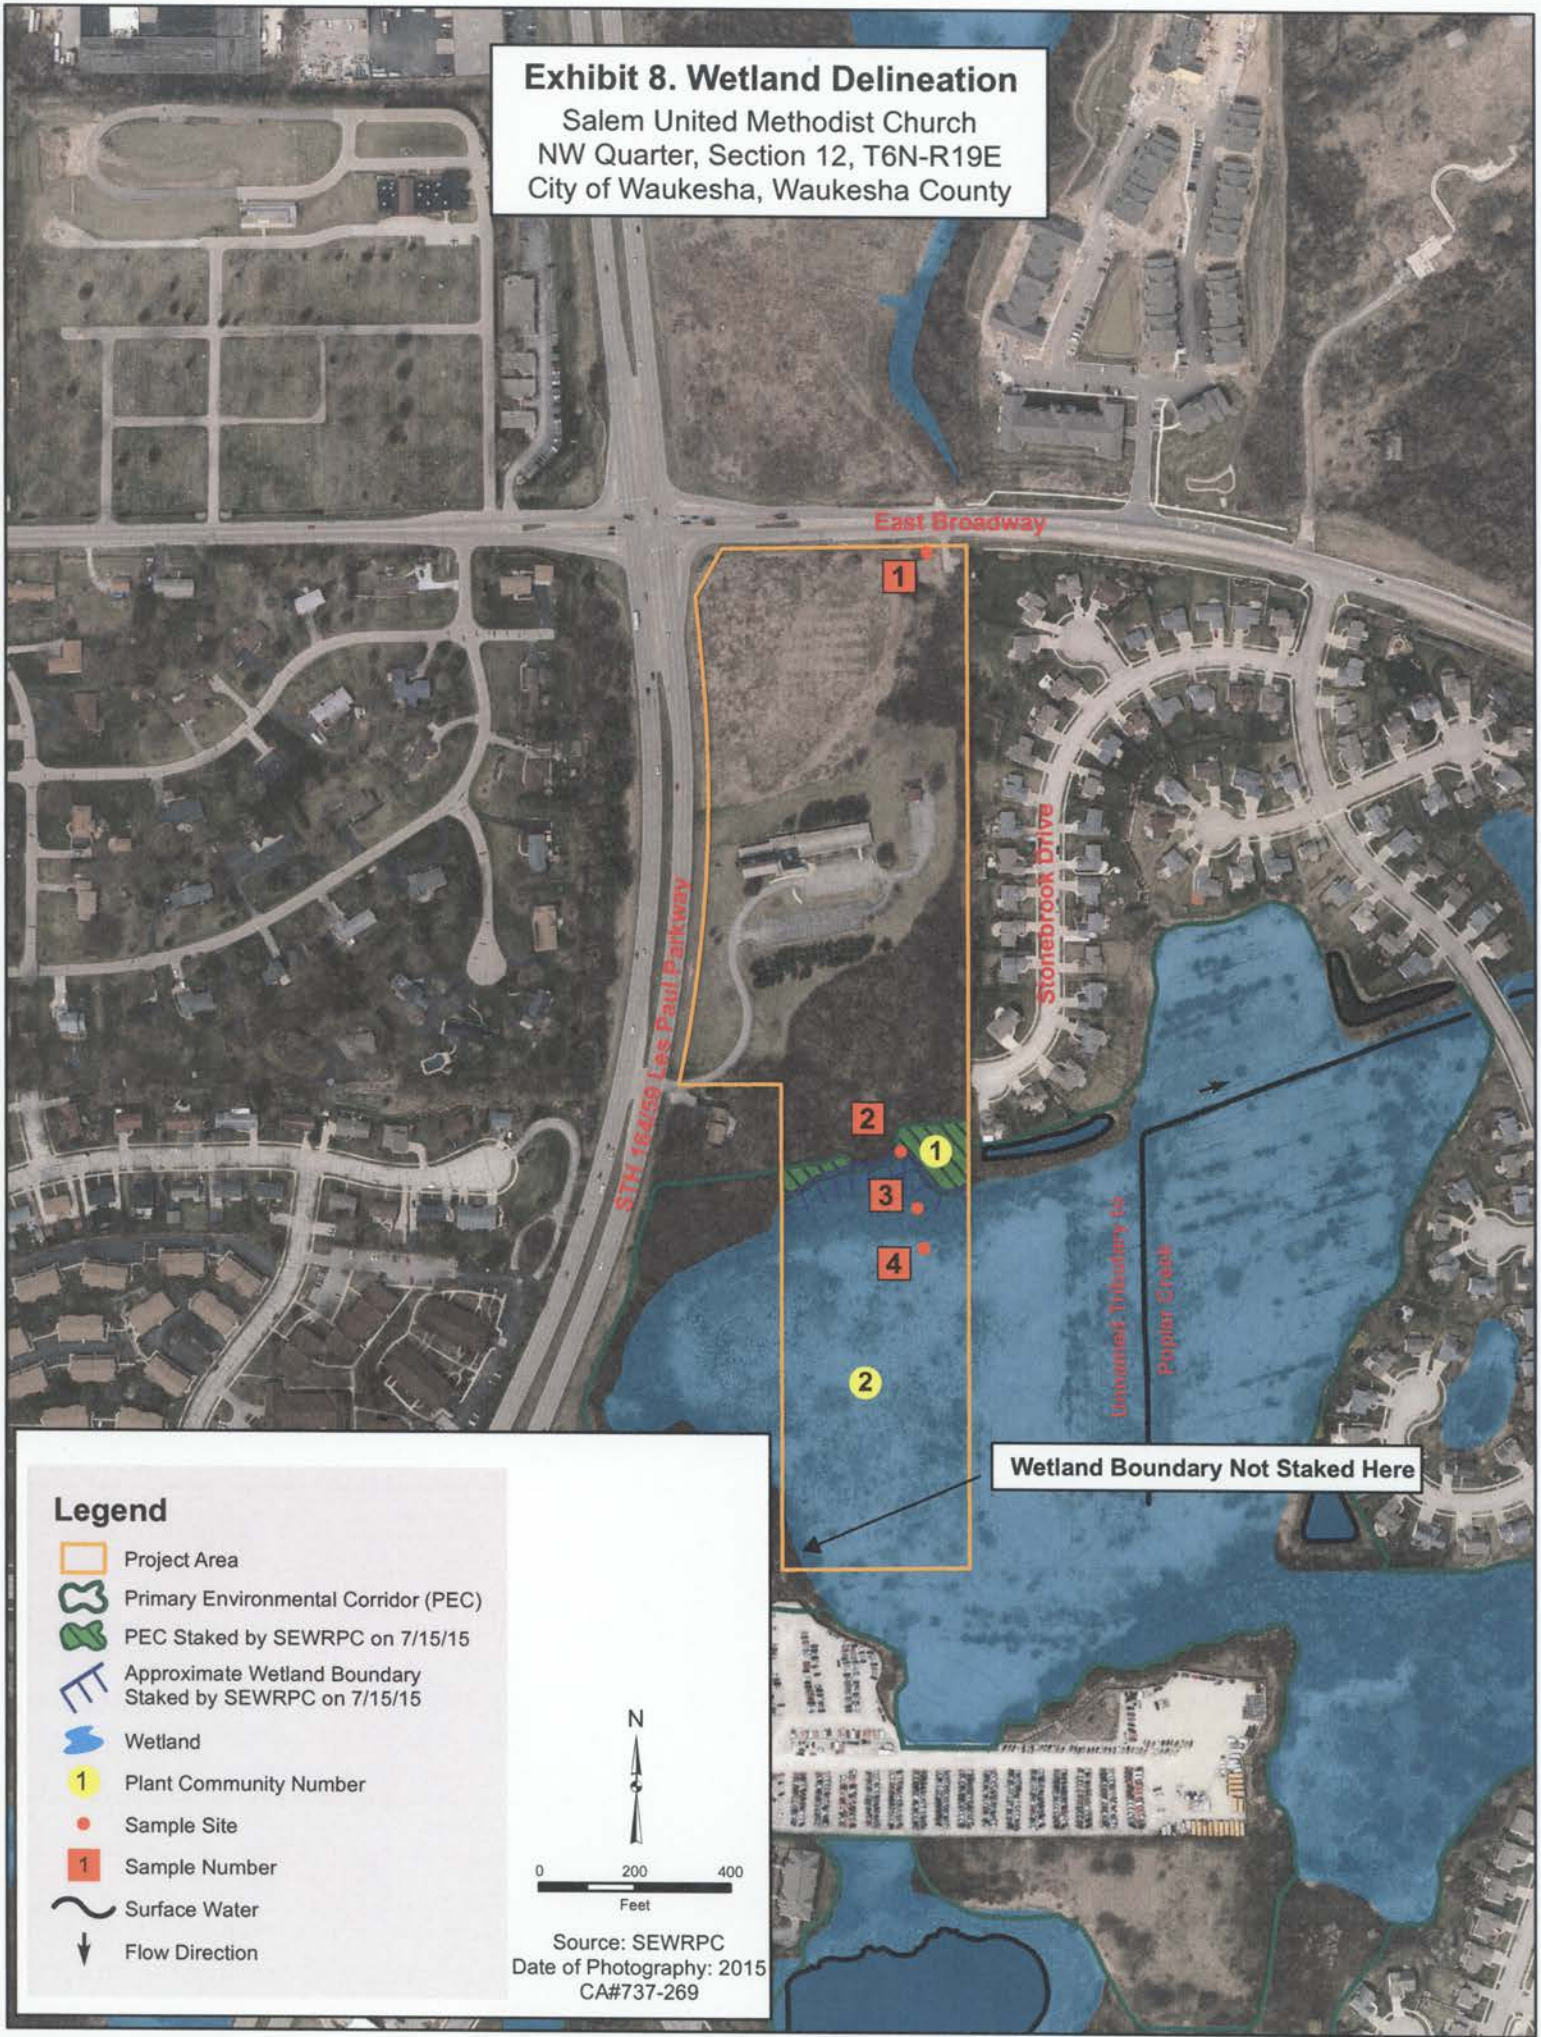
Exhibit 8. Wetland Delineation

The results of the wetland and PEC delineation field inspection for this project area are shown on Exhibit 8, which includes approximate wetland and PEC boundaries, sample site numbers and locations, and plant community area numbers and locations.

The wetlands located within the recorded Primary Environmental Corridor (PEC) as shown on Exhibit 8, have been designated as Advanced Delineation and Identification (ADID) wetlands under the Section 404(b)(1) Guidelines of the Clean Water Act and are deemed generally unsuitable for the discharge of dredge and fill material. In addition, the nonagricultural performance standards set forth in Section NR 151.125 of the *Wisconsin Statutes*, require establishment of a 75-foot impervious surface protective area to protect this “highly susceptible” wetland. This designated protective area boundary is measured horizontally from the delineated wetland boundary to the closest impervious surface. The protective area requirements should be taken into consideration for any planned development of the subject property and it is suggested that a church official or their representative contact WDNR regarding approaches to meet the requirements. Finally, please be advised that no Federal or State regulatory jurisdiction determinations relative to any wetland permits or certifications are made under this report.

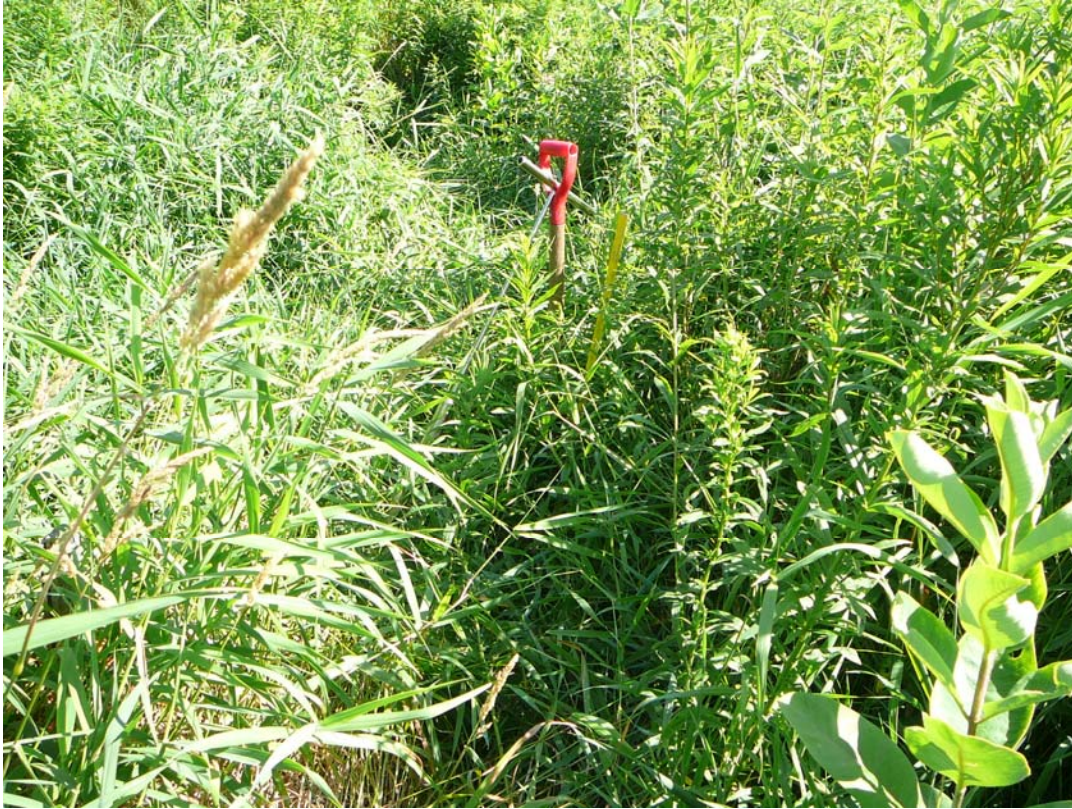
Photo 1. Upland sample site 1.
Old field with scattered buckthorns.

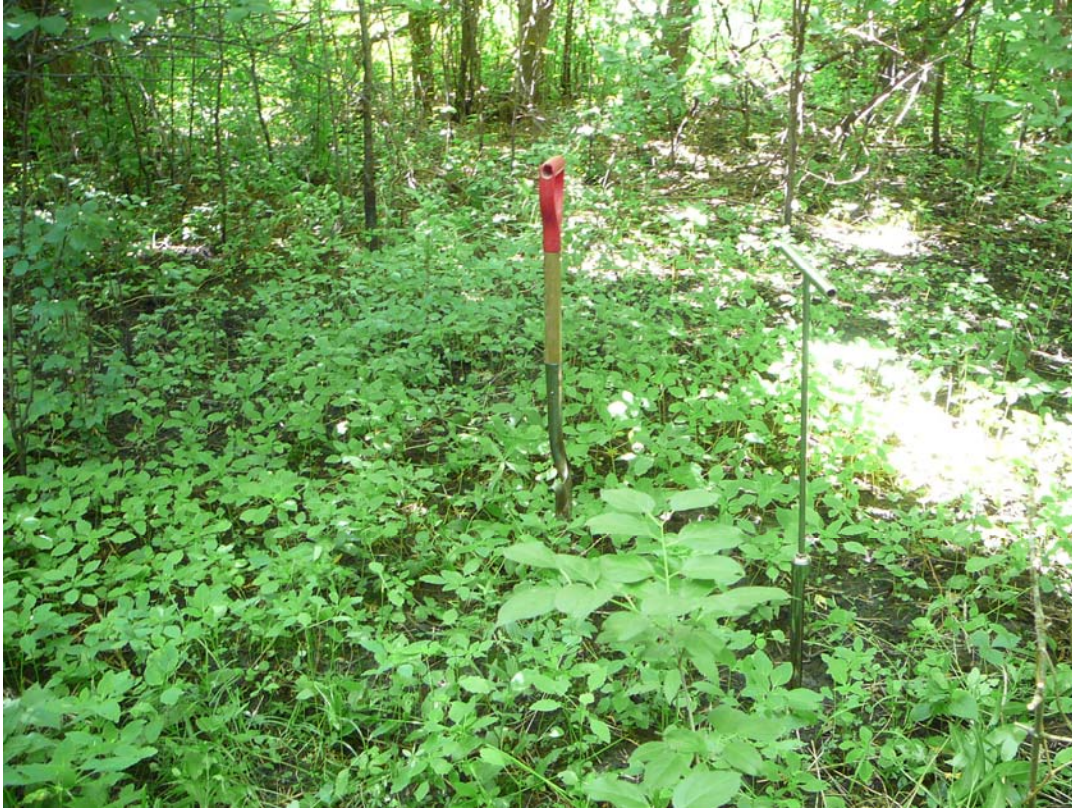
Photo 3. Wetland sample site 3.
Buckthorn thicket and lowland hardwoods.

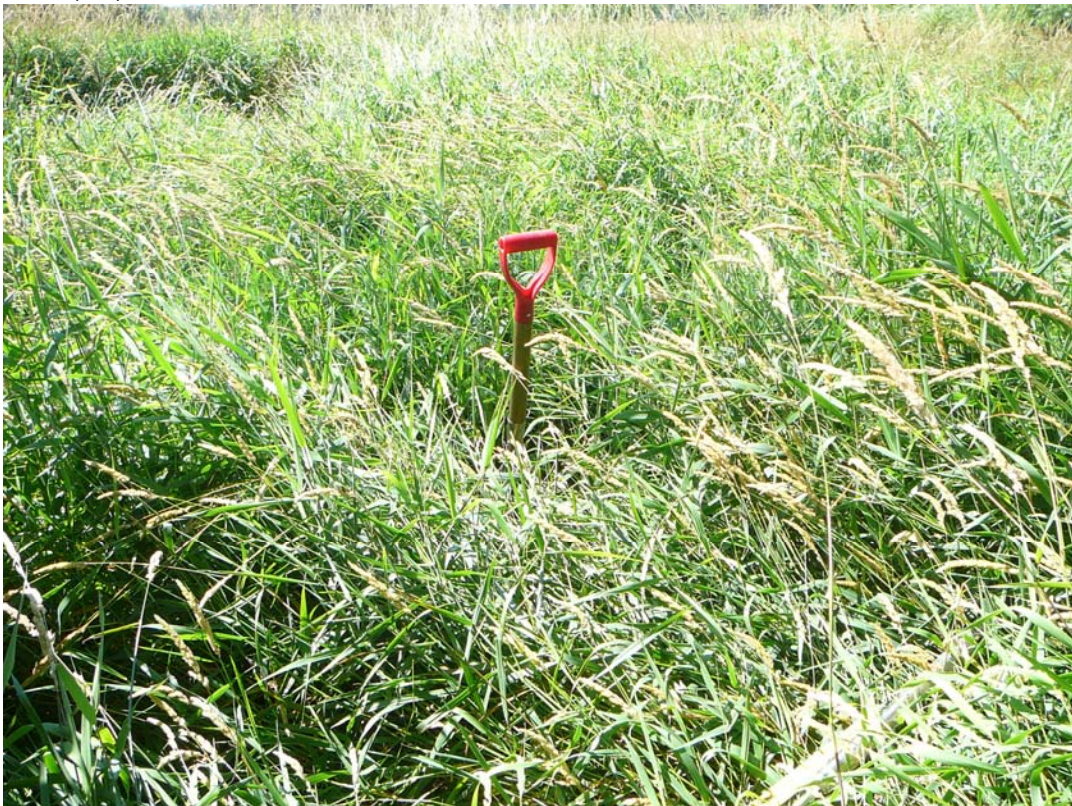
Photo 4. Wetland sample site 4.
Fresh (wet) meadow.
