LANDMARKS COMMISSION APPLICATION

PROPERTY RECORD 507 N GRAND AVE Architecture and History Inventory

507 N. Grand Ave, Waukesha, WI 53186

Inspection Date: 04/05/17 & 04/06/17

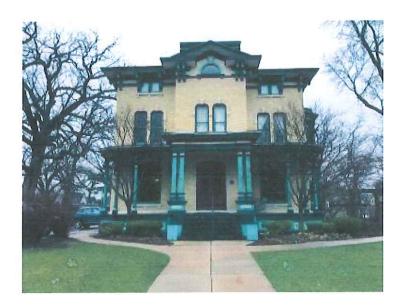
Figure 4: The downspout on the south side of the home has been discharging by the foundation. The grading needs to be improved on the south and east sides of the home.

- Fresh seepage was visible in the basement at the southeast corner by the crawl space dividing wall. The exterior grade is low and the downspout is not properly extended on the exterior. Fresh stains are visible on the east and north foundation walls in areas as well. The concrete on the exterior should be properly sealed where it meets the home and pitched away from the house in these areas. Recommend repair as necessary.

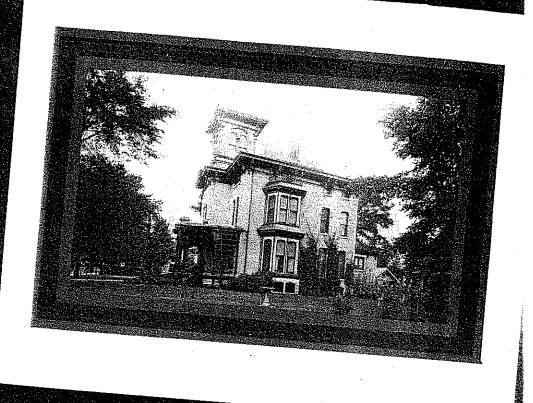
The Frame House - 507 North Grand Avenue, Waukesha, built of cream brick in 1880 for Andrew Frame, was designed by Milwaukee architect Edward Townsend Mix in 1980 s. Andrew Frame, long-time president of Waukesha National Bank (which became the community, including Frame Field to Carroll College and Frame Park to the City.
