# WDNR PROFESSIONALLY ASSURED WETLAND DELINEATION REPORT

**Project Name:** River Road Lot 2

Project Location: City of Waukesha, Waukesha County, WAKC1375125, T6N/R19E/SEC20.

raSmith Project Number: 2255319

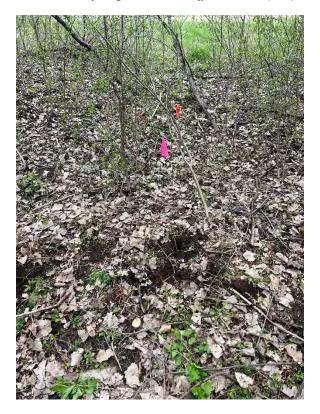
Wetland boundary flag (pink) facing DP1-WET (orange flag)

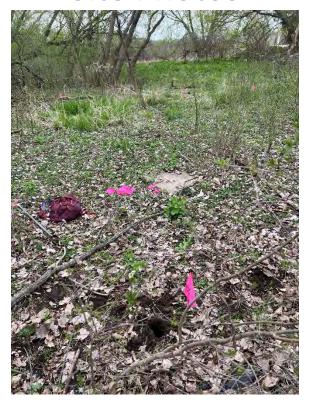
Photo 2:DP2-UPL

Hydric Soil Present? Yes No	within a Wetland? Yes No			
Wetland Hydrology Present?	If yes, optional Wetland Site ID:			
Remarks: (Explain alternative procedures here or in a separate report.)				
DP is located in an upland shrub community.				
HYDROLOGY				
Wetland Hydrology Indicators:	Secondary Indicators (minimum of two required)			
Primary Indicators (minimum of one is required; check all that apply)	Surface Soil Cracks (B6)			
Surface Water (A1) Water-Stained Leaves (	<u> </u>			
High Water Table (A2) Aquatic Fauna (B13)	Moss Trim Lines (B16)			
Saturation (A3)Marl Deposits (B15)	Dry-Season Water Table (C2)			
Water Marks (B1) Hydrogen Sulfide Odor				
Sediment Deposits (B2)  Oxidized Rhizospheres				
Drift Deposits (B3) Presence of Reduced In	· · · · · · · · · · · · · · · · · · ·			
Algal Mat or Crust (B4)Recent Iron Reduction in				
Iron Deposits (B5) Thin Muck Surface (C7)				
Inundation Visible on Aerial Imagery (B7) Other (Explain in Remai

Sparsely Vegetated Concave Surface (B8)	FAC-Neutral Test (D5)			
Field Observations:				
Surface Water Present? Yes No Depth (inches):  Water Table Present? Yes No Depth (inches):				
Water Table Present? Yes No Depth (inches):				
Saturation Present? Yes No Depth (inches):	: Wetland Hydrology Present? Yes No			
(includes capillary fringe)	and the second s			
Describe Recorded Data (stream gauge, monitoring well, aerial photos, pro	evious inspections), ii available.			
Remarks:				
No westlend budgeless were about a				
No wetland hydrology was observed.

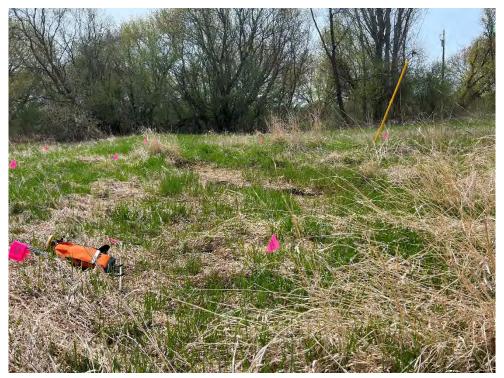
Photo 4:DP4-WET

Hydric Soil Present? Yes V	within a Wetland? Yes V No				
Wetland Hydrology Present? Yes ✓ No	If yes, optional Wetland Site ID: W-1				
Remarks: (Explain alternative procedures here or in a separate report.)					
Everysted swale					
Excavated swale					
HYDROLOGY					
Wetland Hydrology Indicators:	Secondary Indicators (minimum of two required)				
Primary Indicators (minimum of one is required; check all that apply)	Surface Soil Cracks (B6)				
Surface Water (A1) Water-Stained Leaves (	· · ·				
✓ High Water Table (A2)  Aquatic Fauna (B13)	Moss Trim Lines (B16)				
Saturation (A3) Marl Deposits (B15)	Dry-Season Water Table (C2)				
Water Marks (B1) Hydrogen Sulfide Odor	Crayfish Burrows (C8)				
Sediment Deposits (B2) Oxidized Rhizospheres	on Living Roots (C3) Saturation Visible on Aerial Imagery (C9)				
Drift Deposits (B3) Presence of Reduced Ir					
Algal Mat or Crust (B4)Recent Iron Reduction i

-	A 144A, 145, 149B)		Depleted Dark							
-	ucky Mineral (S1)		Redox Depres		8)					
	eyed Matrix (S4)		Marl (F10) ( <b>LR</b>				<sup>3</sup> Indicato	ors of hydrophytic vegetation and		
——Sandy Re			Red Parent Ma	aterial (F	21) <b>(ML</b> F	RA 145)	wetland hydrology must be present,			
Stripped	Matrix (S6)							ess disturbed or problematic.		
	ayer (if observed):									
Type:										
Depth (in	ches):						Hydric Soil Pres	ent? Yes V No No		
Remarks:										
Soils me	et F6-Redox	Dark	Surface.

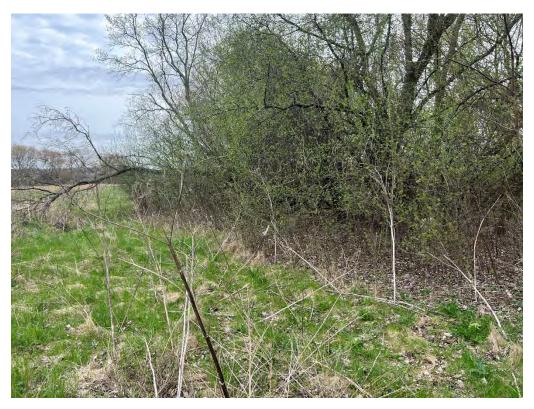
Photo 5: Shrub line on south side

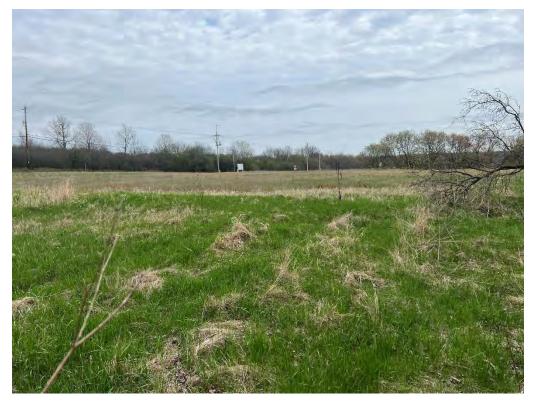
Photo 6: W-1

- **Type:** Emergent Meadow (PEM) wetland, dominated by invasive herbaceous vegetation (rcg), consistent with a seasonally saturated low quality wet meadow community.
- Size: Approximately 2,350 square feet.
- Position (Landscape Context & Connectivity):

Located within a shallow swale that appears to have artificial origins from previous disturbance/stormwater management. Surrounding land use includes old fields and residential development.

- Dominant Vegetation (By Stratum):
  - Herbaceous Layer: Phalaris arundinacea FACW & Poa pratensis FACU
  - > Shrub Layer: *Apocynum cannabinum* FAC
  - > Tree Layer: Not present
- Hydric Soil Indicators: F6 Redox Dark Surface

Soils exhibited a dark matrix color (10YR 3/2) & N 2.5/ with 5% redox concentrations as soft masses within the upper 12 inches.

- **Hydrology Indicators:** A2 High Water Table, A3 Saturation & D2 Geomorphic Position.
  - Evidence of wetland hydrology was supported by a high-water table and saturation with 12 inches as well as concave depressional landform. No standing water was observed at the time of the visit, though saturated conditions were present at the soil surface.
- Data Points: DP 3-UPL & DP 4-WET

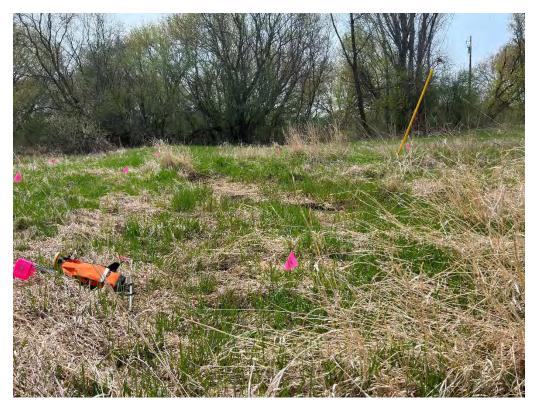
Photo 7:W-2 DP6-WET

- **Type:** Emergent Meadow (PEM) wetland, dominated by invasive herbaceous vegetation (rcg), consistent with a seasonally saturated low quality wet meadow community.
- **Size:** Approximately 3,366 square feet.
- Position (Landscape Context & Connectivity):

- **Hydrology Indicators:** A2 High Water Table, A3 Saturation, D2 Geomorphic Position & D5 FAC-Neutral Test.
  - Evidence of wetland hydrology was supported by a high-water table and saturation at the surface within a concave depressional landform. Standing water was observed a few feet away from the data point at the time of the visit.
- Data Points: DP 5-UPL & DP 6-WET

Wetland Hydrology Present? Yes V No	If yes, optional Wetland Site ID: W-2
Remarks: (Explain alternative procedures here or in a separate re	port.)
Data point is located in an excavated dep	ression (potentially for stormwater purposes)
dominated by rcg. Standing water was ob	served adjacent to the data point.
HADBOLOGA	
HYDROLOGY	
Wetland Hydrology Indicators:	Secondary Indicators (minimum of two required)
Primary Indicators (minimum of one is required; check all that app	
Surface Water (A1)  Water-Stained L	
✓ High Water Table (A2)  Aquatic Fauna (  Anal Deposits (1)	
✓ Saturation (A3) — Marl Deposits (I	·
Water Marks (B1)  — Hydrogen Sulfic	
<del></del>	spheres on Living Roots (C3) Saturation Visible on Aerial Imagery (C9)
Drift Deposits (B3) Presence of Re	
<del></del>	duction in Tilled Soils (C6)  — Geomorphic Position (D2)  Shallow Aguitard (D3)
Iron Deposits (B5) Thin Muck Surfa	<del>_</del>
Inundation Visible on Aerial Imagery (B7) Other (Explain i	<del>_</del>

•	A 144A, 145, 149B)		Depleted Dark							
-	ucky Mineral (S1)		Redox Depres		8)					
	eyed Matrix (S4)		Marl (F10) ( <b>LF</b>				<sup>3</sup> Indicato	ors of hydrophytic vegetation and		
——Sandy Re	edox (S5)		Red Parent M	aterial (F	21) <b>(ML</b> F	RA 145)	wetland hydrology must be present,			
Stripped	Matrix (S6)						unless disturbed or problematic.			
	ayer (if observed):									
Type:										
Depth (in	ches):						Hydric Soil Pres	ent? Yes V No No		
Remarks:										
Soils me	et hydric ind	icator	F6-Redox D	ark S	Surfac	e.

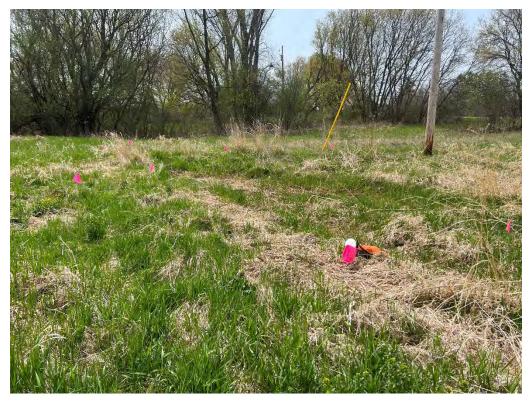
Wetland Hydrology Present?	Yes No / If yes, o	optional Wetland Site ID:				
Remarks: (Explain alternative procedures he	ere or in a separate report.)					
DP 5-UPL is located in between	een 2 artificial wetland so	crapes/detention areas.	Upland berm.			
HYDROLOGY						
Wetland Hydrology Indicators:		Secondary Indicators (mi	nimum of two required)			
Primary Indicators (minimum of one is require	ed; check all that apply)	Surface Soil Cracks	Surface Soil Cracks (B6)			
Surface Water (A1)	Water-Stained Leaves (B9)	Drainage Patterns (B10)				
High Water Table (A2)	Aquatic Fauna (B13)		Moss Trim Lines (B16)			
Saturation (A3)	Marl Deposits (B15)		Dry-Season Water Table (C2)			
Water Marks (B1)	Hydrogen Sulfide Odor (C1)		Crayfish Burrows (C8)			
Sediment Deposits (B2)	Oxidized Rhizospheres on Living R	<u> </u>				
Drift Deposits (B3)	Presence of Reduced Iron (C4)					
Algal Mat or Crust (B4) Iron Deposits (B5)	Recent Iron Reduction in Tilled So Thin Muck Surface (C7)

Photo 8:Bem between W-2 and W-2 facing south

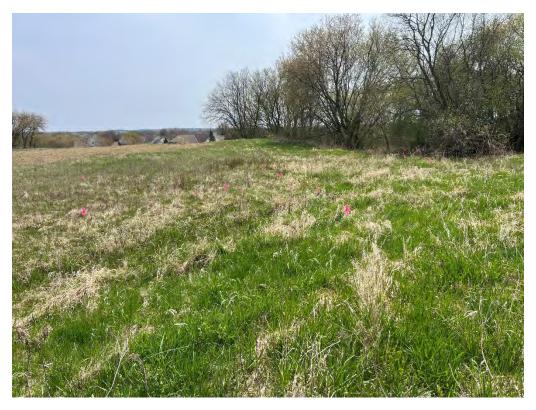
Photo 9:W-3 on far south edge

- **Type:** Both Forested (Palustrine) and Emergent (Palustrine) wetland characteristics were observed by the dominance of both herbaceous and woody vegetation, consistent with these communities.
- **Size:** Approximately 0.28 acres 12,200 square feet-wetland extends outside of study area.
- Position (Landscape Context & Connectivity):

Hydrology Indicators: B9 – Water-Stained Leaves & D2 – Geomorphic Position
 Evidence of wetland hydrology was supported by water-stained leaves and position

within a concave landform receiving overland flow. No standing water was observed at the time of the visit, though saturated conditions were observed at 12 inches in the soil pit.

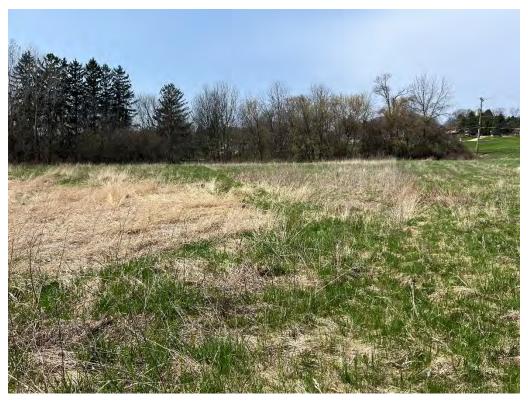
Photo 10:Fallow area of site facing west from access road

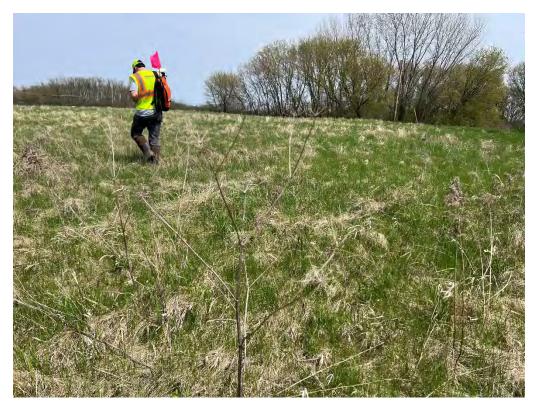
Photo 11: Upland facing east

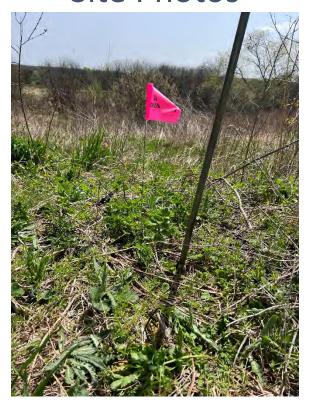
Photo 12: DP7-UPL

Wetland Hydrology Present? Yes No	If yes, optional Wetland Site ID:
Remarks: (Explain alternative procedures here or in a separate	report.)
Postrictive layer at 6" rock and grayel fil	1
Restrictive layer at 6" rock and gravel fil	ı
HYDROLOGY	
Wetland Hydrology Indicators:	Secondary Indicators (minimum of two required)
Primary Indicators (minimum of one is required; check all that as	
Surface Water (A1) Water-Stained	d Leaves (B9) Drainage Patterns (B10)
High Water Table (A2)  Aquatic Fauna	a (B13) Moss Trim Lines (B16)
Saturation (A3) Marl Deposits	Dry-Season Water Table (C2)
	lfide Odor (C1) Crayfish Burrows (C8)
Sediment Deposits (B2) Oxidized Rhiz	zospheres on Living Roots (C3) Saturation Visible on Aerial Imagery (C9)
Drift Deposits (B3) Presence of F	Reduced Iron (C4) Stunted or Stressed Plants (D1)
	Reduction in Tilled Soils (C6) Geomorphic Position (D2)
Iron Deposits (B5) Thin Muck Su	urface (C7) Shallow Aquitard (D3)

Mesic Spodic (A17)			Redox Dark Su	rface (F	(F6)Other (Explain in Remarks)			
(MLRA 144A, 145, 149B)			Depleted Dark Surface (F7)					
Sandy M	ucky Mineral (S1)	•	Redox Depress	ions (F	8)			
Sandy Gleyed Matrix (S4)			Marl (F10) ( <b>LRR K, L</b> )				<sup>3</sup> Indicators of hydrophytic vegetation and	
—— Sandy Redox (S5)			Red Parent Material (F21) (MLRA 145)					
Stripped Matrix (S6)			Ted Falent Material (F21) (MEICA 143)				wetland hydrology must be present,	
							unless distur	bed or problematic.
	ayer (if observed):							
_	Rock and gravel							,
Depth (in	ches): <u>6</u>						Hydric Soil Present?	Yes No
Remarks:								
Soils are fill and do not meet any hydric indicators.

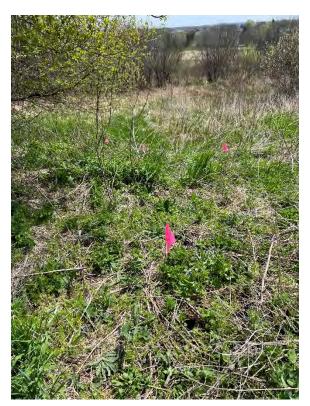
Photo 13:DP7-UPL facing south

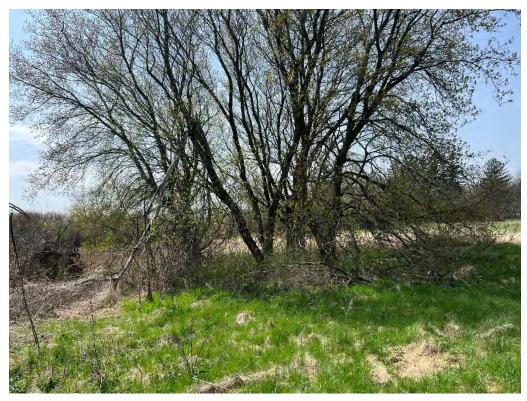
Photo 14:W-3 facing south
