# Storm Water Management Plan for

## STOR-IT Right - Waukesha City of Waukesha, WI

**Project No. 3250218**

**June 23, 2026**

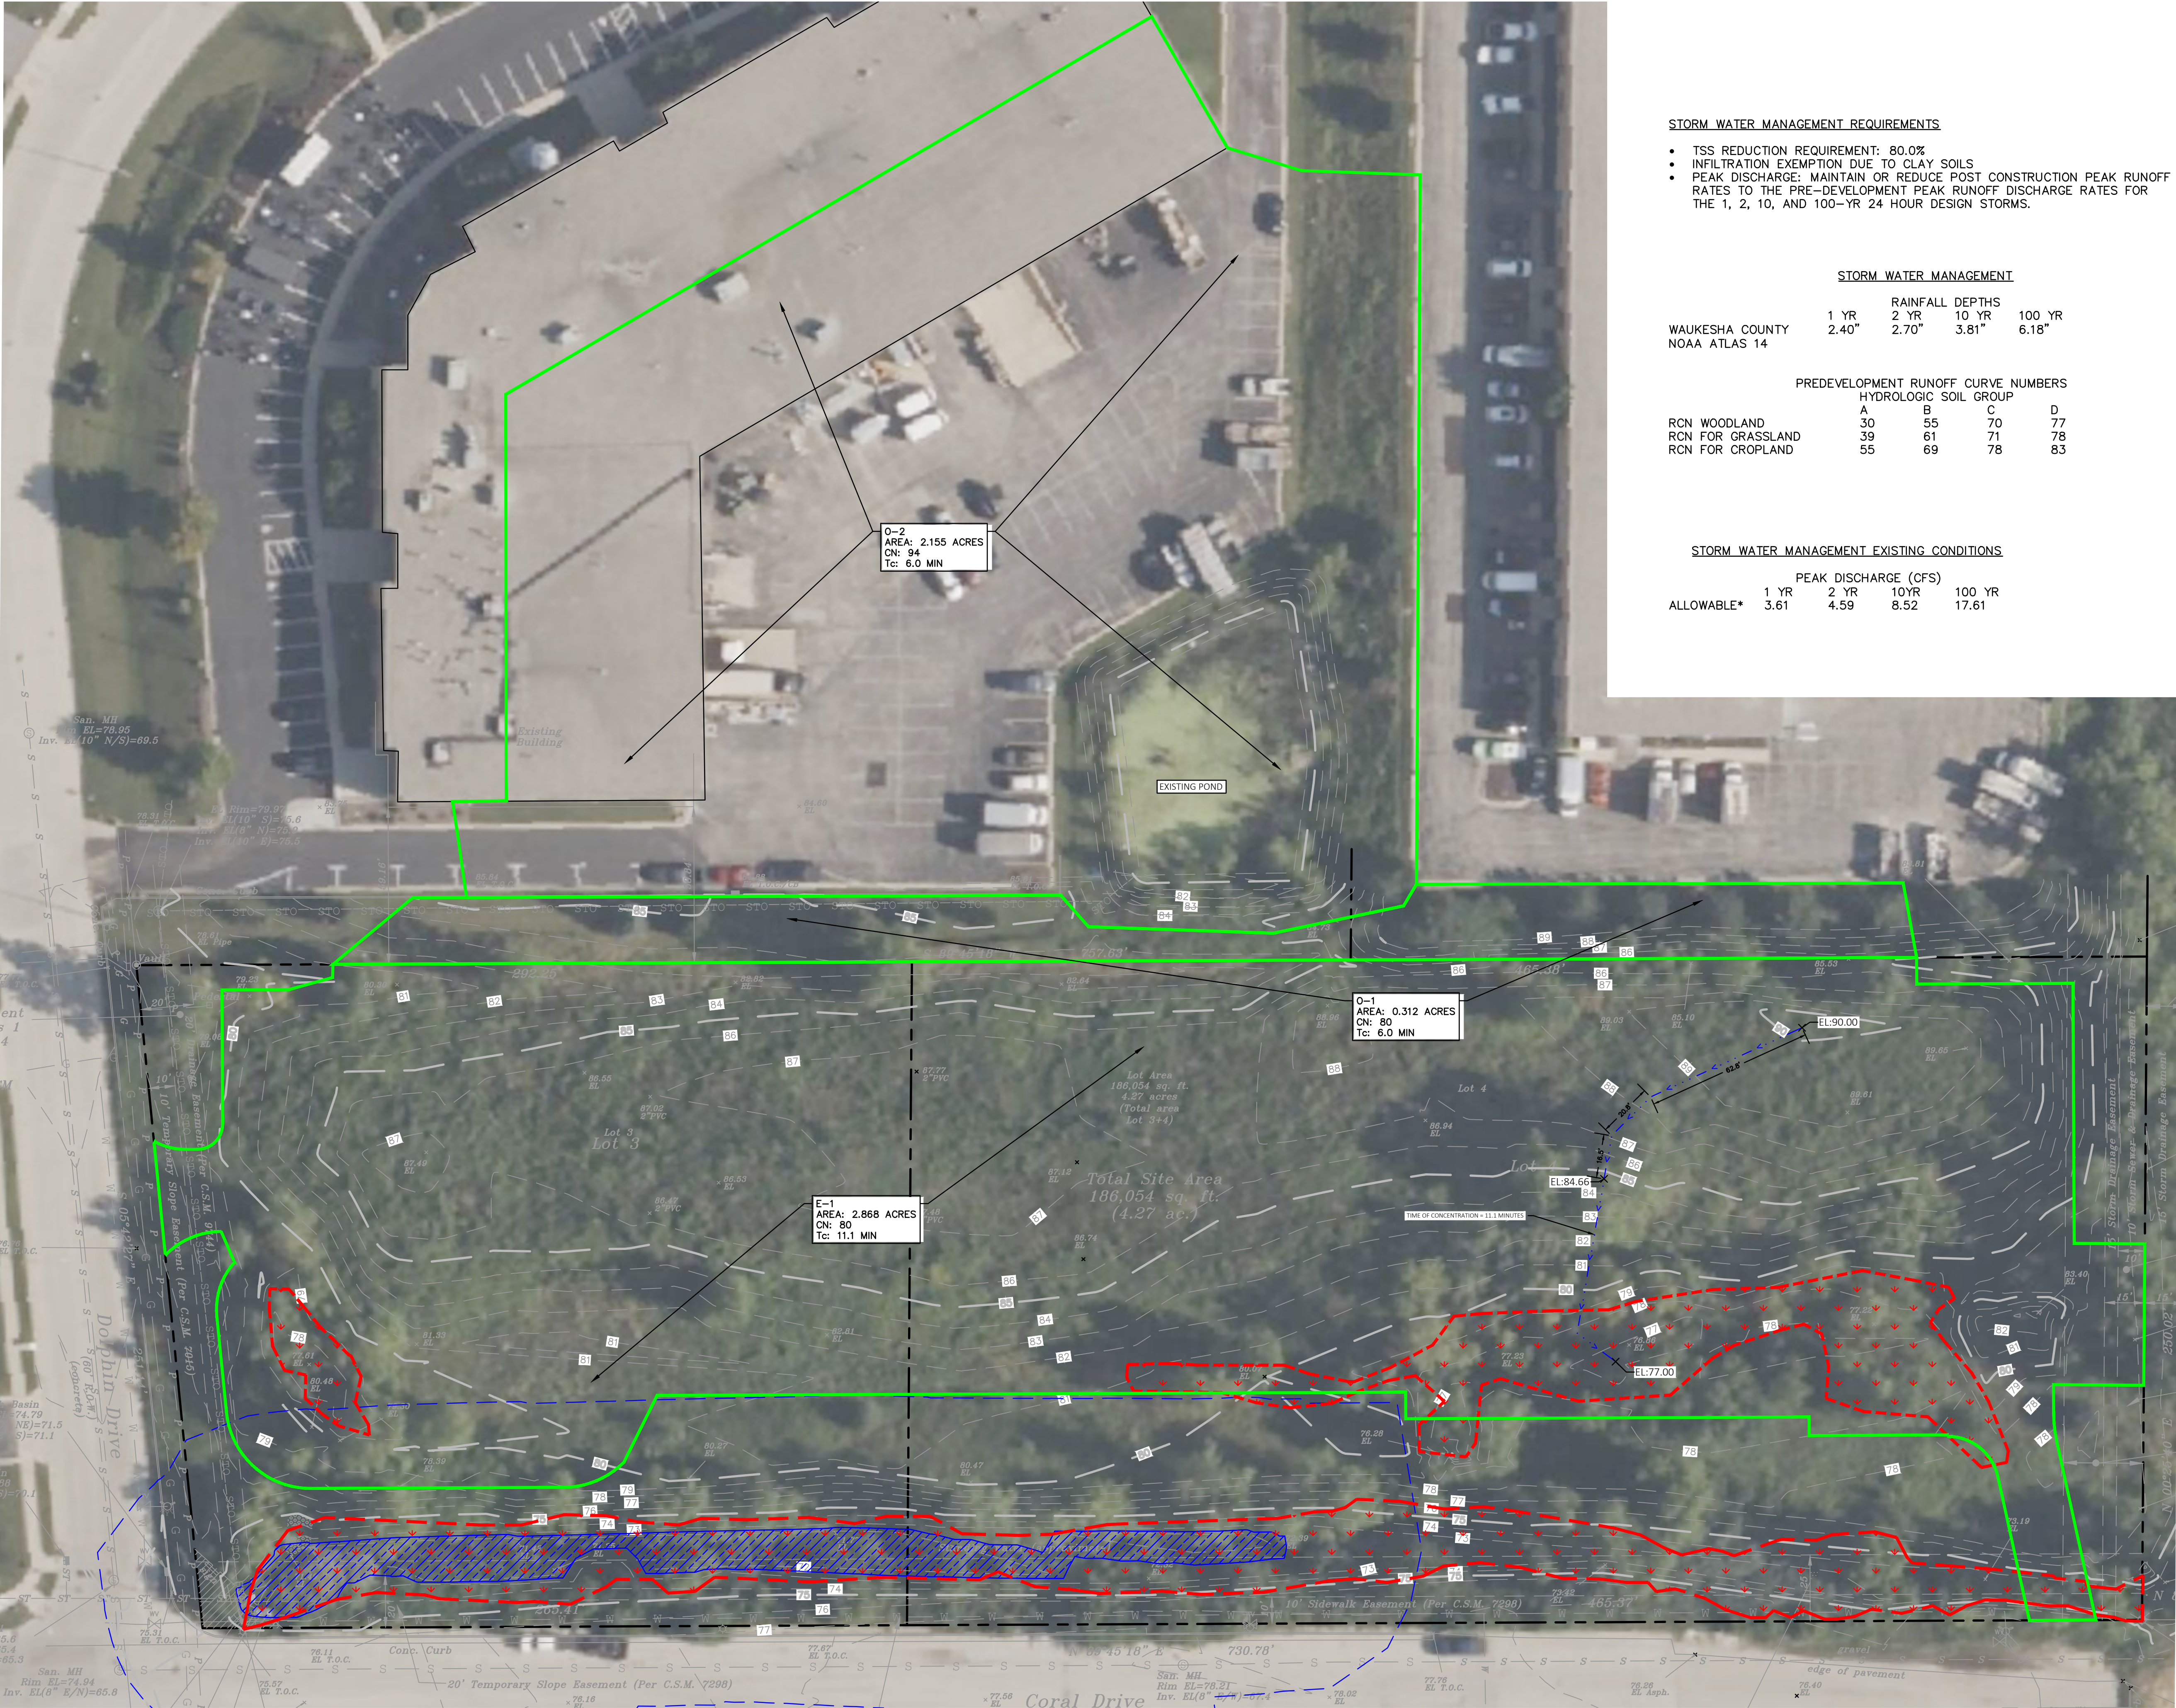
## Water Quantity Design

- STORM WATER MANAGEMENT REQUIREMENTS**
- TSS REDUCTION REQUIREMENT: 80.0%
  - INFILTRATION EXEMPTION DUE TO CLAY SOILS
  - PEAK DISCHARGE: MAINTAIN OR REDUCE POST CONSTRUCTION PEAK RUNOFF RATES TO THE PRE-DEVELOPMENT PEAK RUNOFF DISCHARGE RATES FOR THE 1, 2, 10, AND 100-YR 24 HOUR DESIGN STORMS.

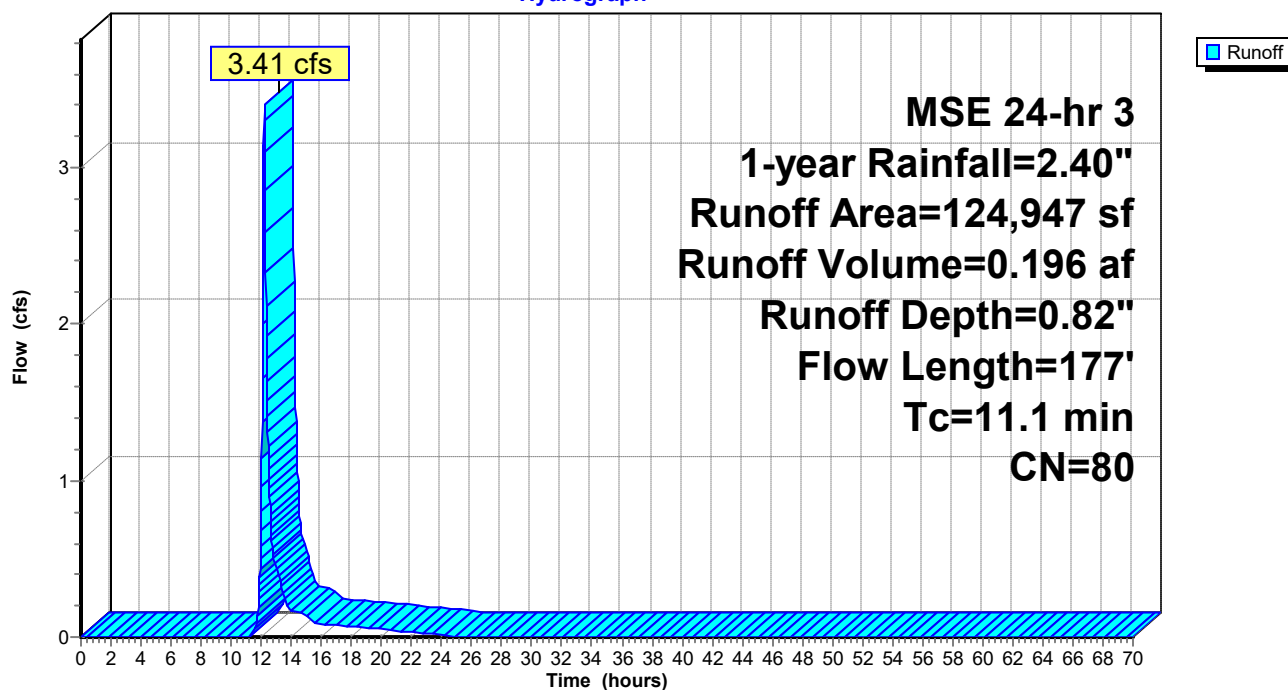
**Subcatchment 1S: E-1**

Hydrograph

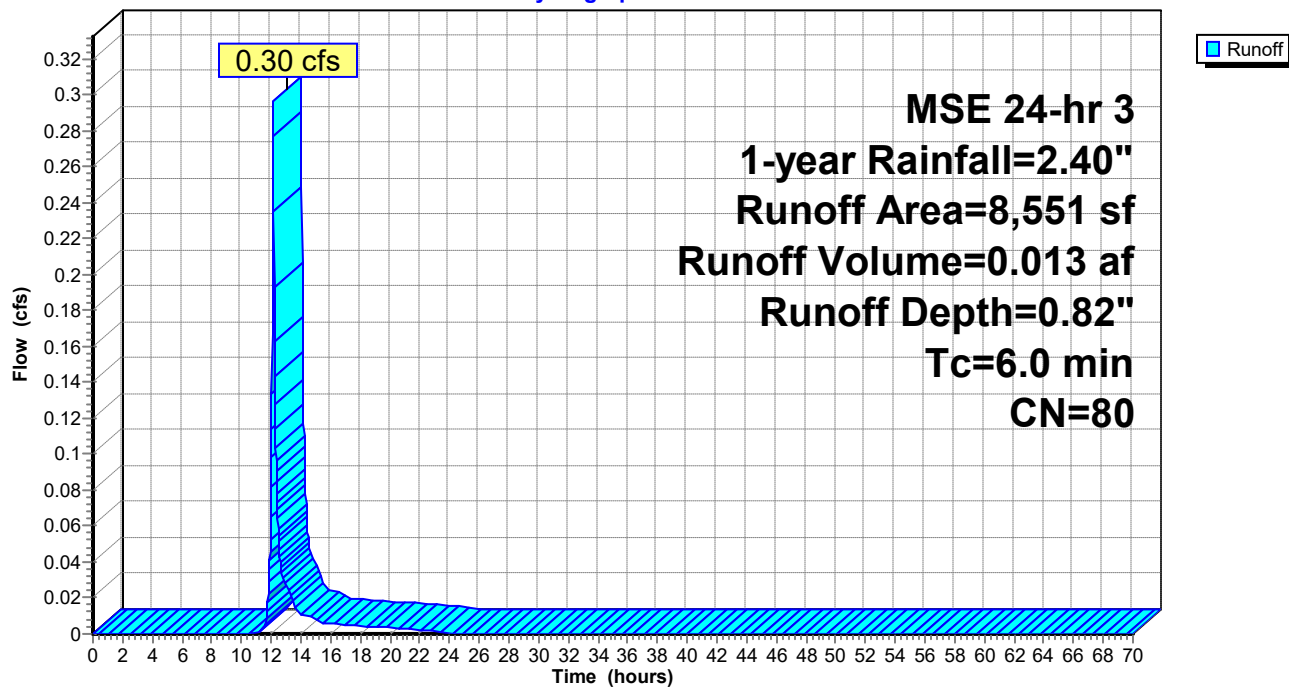
**Subcatchment 11S: O-1**

Runoff = 0.30 cfs @ 12.14 hrs, Volume= 0.013 af, Depth= 0.82"  
 Routed to Reach 2R : Existing Outfall

Hydrograph

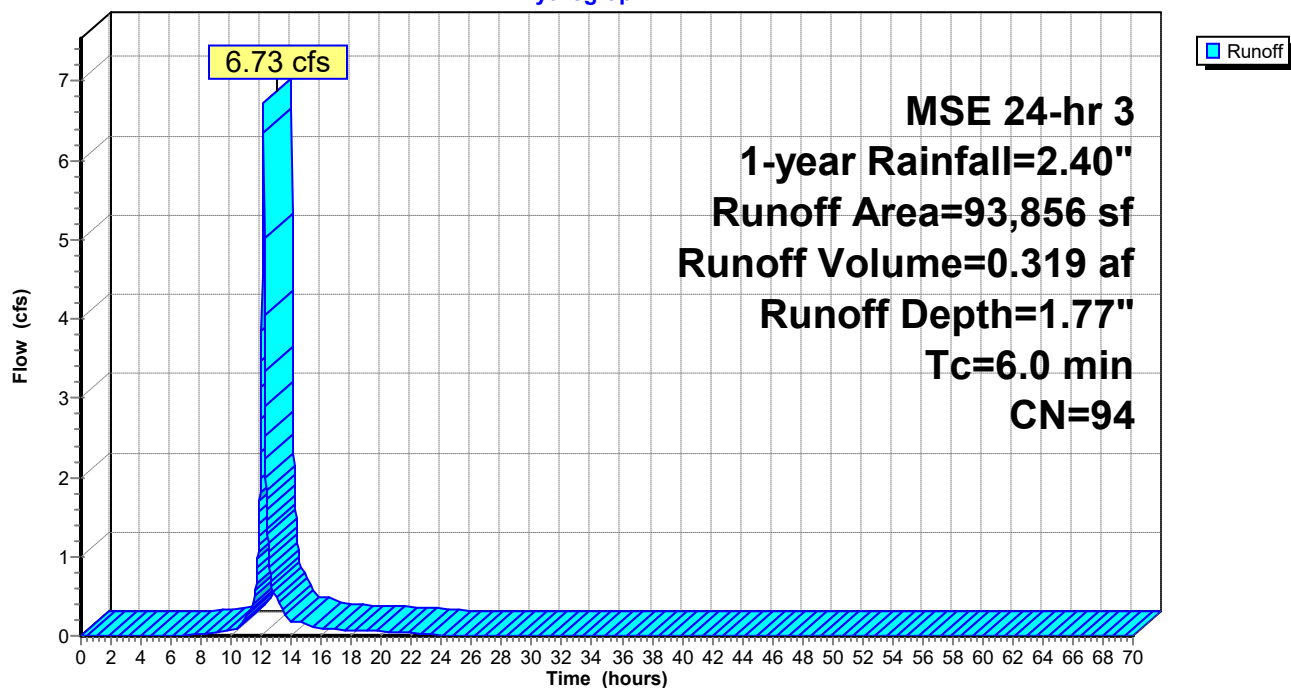
**Subcatchment 21S: O-2**

Runoff = 6.73 cfs @ 12.13 hrs, Volume= 0.319 af, Depth= 1.77"  
 Routed to Pond 23P : Existing North Pond

Hydrograph

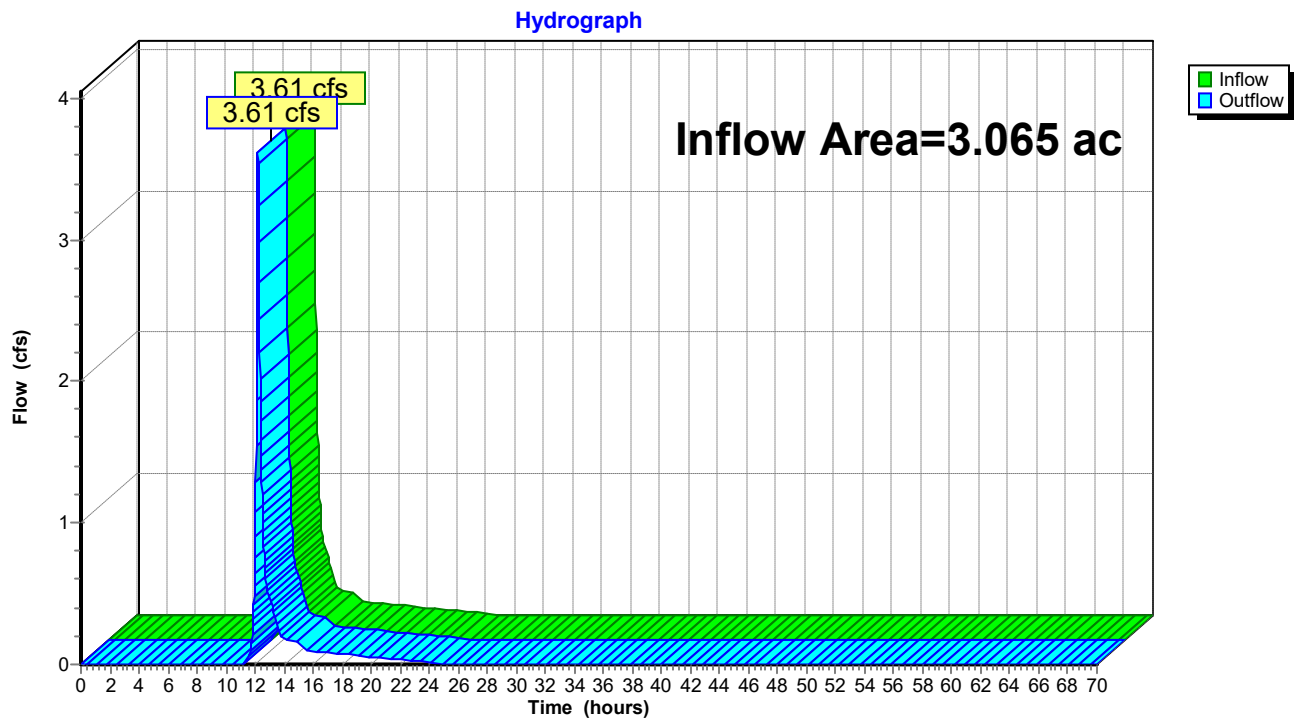
**Reach 2R: Existing Outfall**

Inflow Area = 3.065 ac, 0.00% Impervious, Inflow Depth = 0.82" for 1-year event  
Inflow = 3.61 cfs @ 12.19 hrs, Volume= 0.210 af  
Outflow = 3.61 cfs @ 12.19 hrs, Volume= 0.210 af, Atten= 0%, Lag= 0.0 min

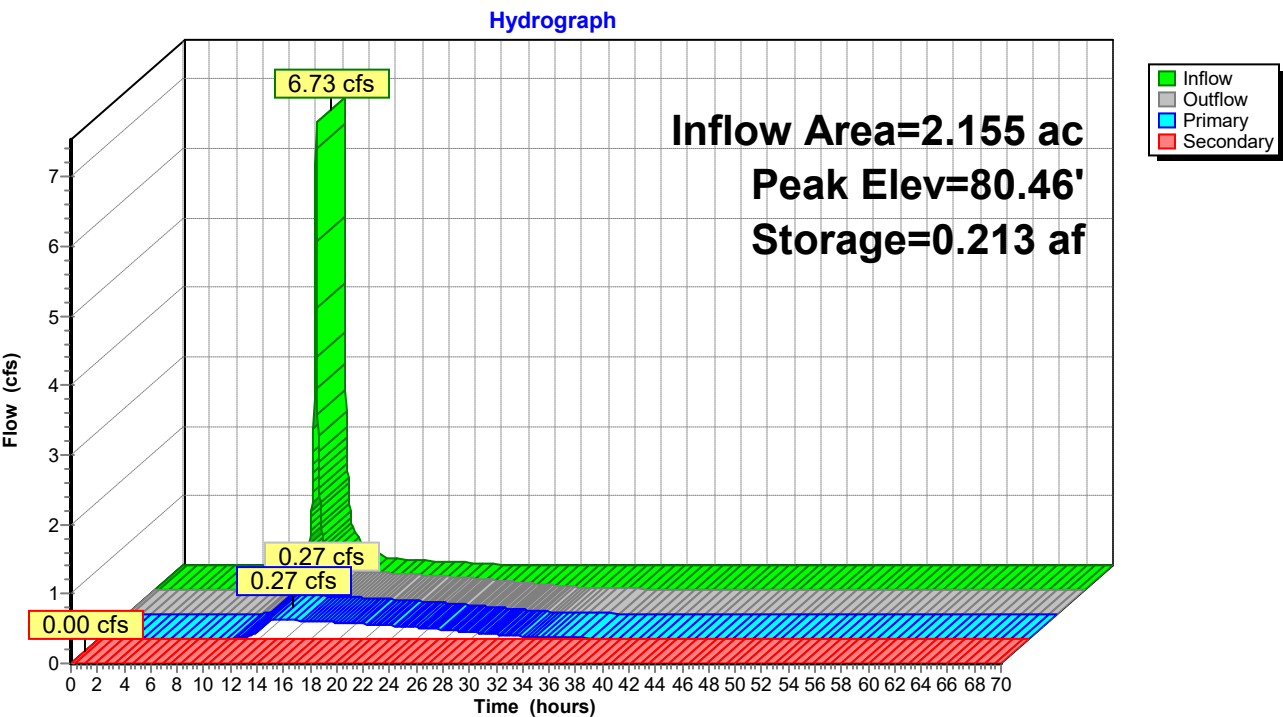
Pond 23P: Existing North Pond

Inflow Area = 2.155 ac, 79.45% Impervious, Inflow Depth = 1.77" for 1-year event  
 Inflow = 6.73 cfs @ 12.13 hrs, Volume= 0.319 af  
 Outflow = 0.27 cfs @ 13.55 hrs, Volume= 0.318 af, Atten= 96%, Lag= 85.0 min  
 Primary = 0.27 cfs @ 13.55 hrs, Volume= 0.318 af  
     Routed to Reach 22R : Existing Storm Sewer  
 Secondary = 0.00 cfs @ 0.00 hrs, Volume= 0.000 af  
     Routed to Reach 2R : Existing Outfall

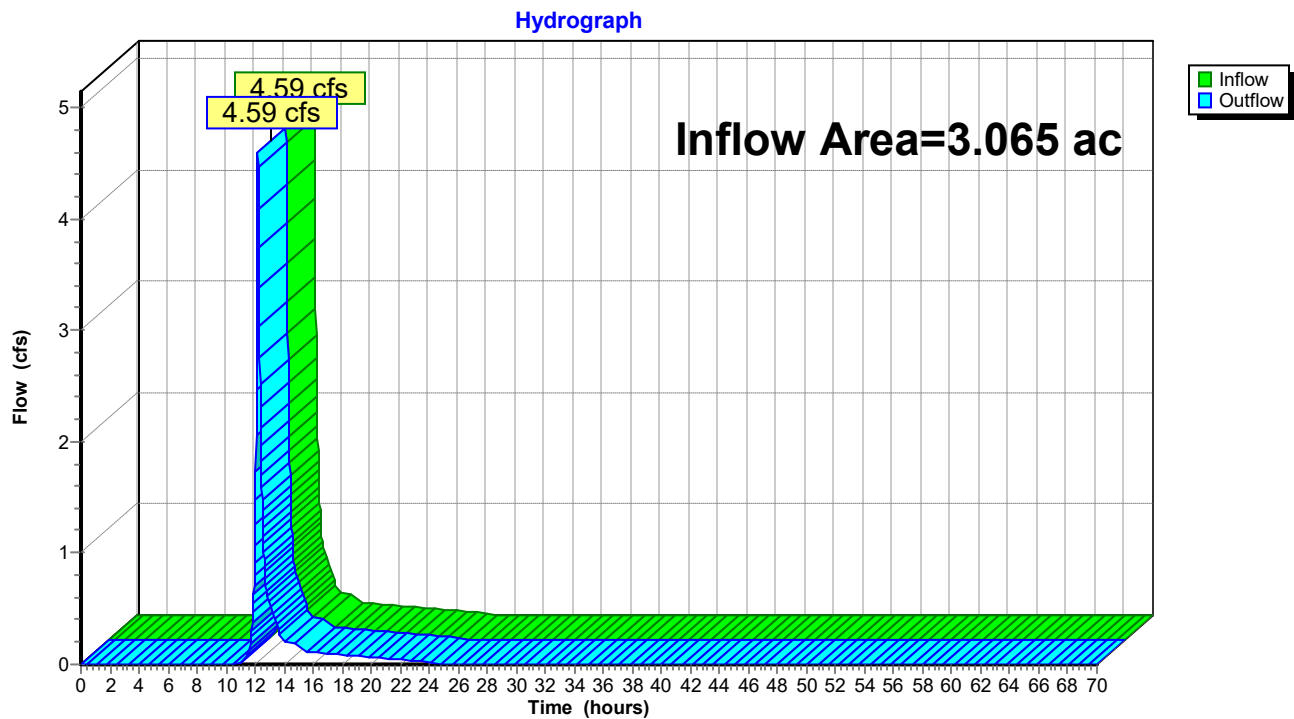
**Reach 2R: Existing Outfall**

Inflow Area = 3.065 ac, 0.00% Impervious, Inflow Depth = 1.03" for 2-year event  
Inflow = 4.59 cfs @ 12.19 hrs, Volume= 0.263 af  
Outflow = 4.59 cfs @ 12.19 hrs, Volume= 0.263 af, Atten= 0%, Lag= 0.0 min

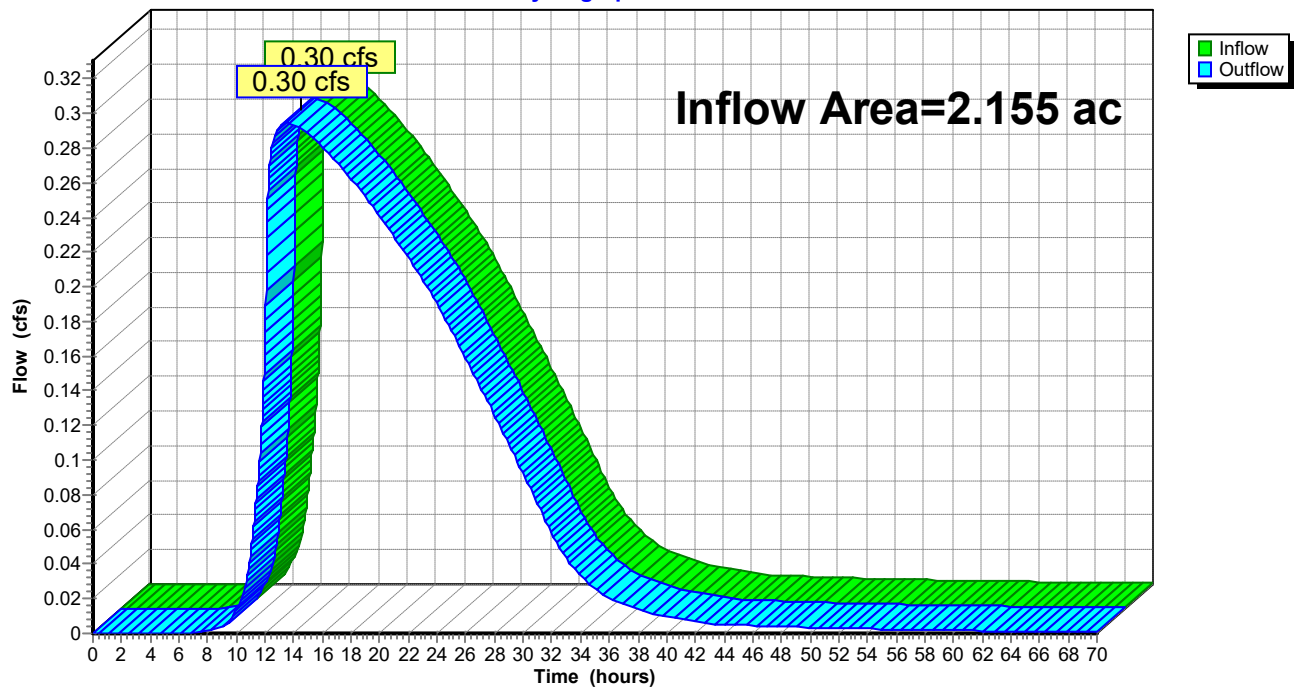
**Reach 22R: Existing Storm Sewer**

Inflow Area = 2.155 ac, 79.45% Impervious, Inflow Depth > 2.05" for 2-year event  
Inflow = 0.30 cfs @ 13.56 hrs, Volume= 0.369 af  
Outflow = 0.30 cfs @ 13.56 hrs, Volume= 0.369 af, Atten= 0%, Lag= 0.0 min

Hydrograph

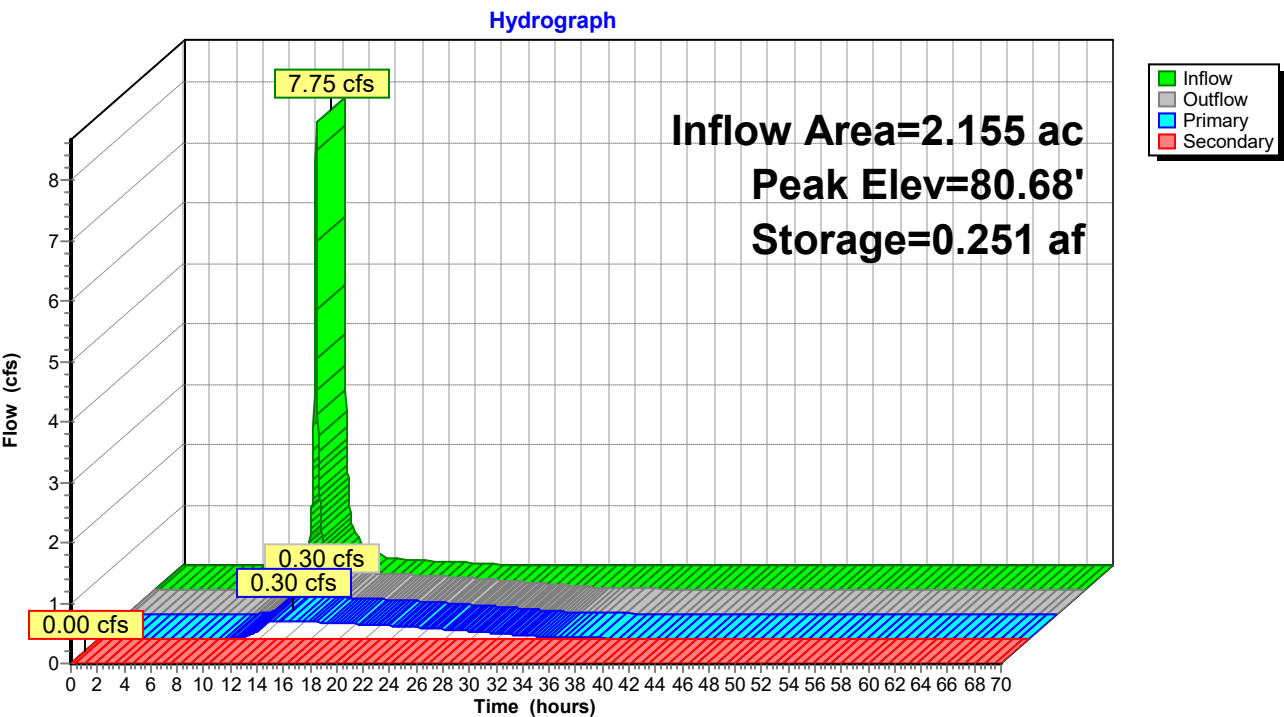
Pond 23P: Existing North Pond

Inflow Area = 2.155 ac, 79.45% Impervious, Inflow Depth = 2.06" for 2-year event  
 Inflow = 7.75 cfs @ 12.13 hrs, Volume= 0.370 af  
 Outflow = 0.30 cfs @ 13.56 hrs, Volume= 0.369 af, Atten= 96%, Lag= 86.0 min  
 Primary = 0.30 cfs @ 13.56 hrs, Volume= 0.369 af  
     Routed to Reach 22R : Existing Storm Sewer  
 Secondary = 0.00 cfs @ 0.00 hrs, Volume= 0.000 af  
     Routed to Reach 2R : Existing Outfall

↑ **3=Broad-Crested Rectangular Weir** ( Controls 0.00 cfs)

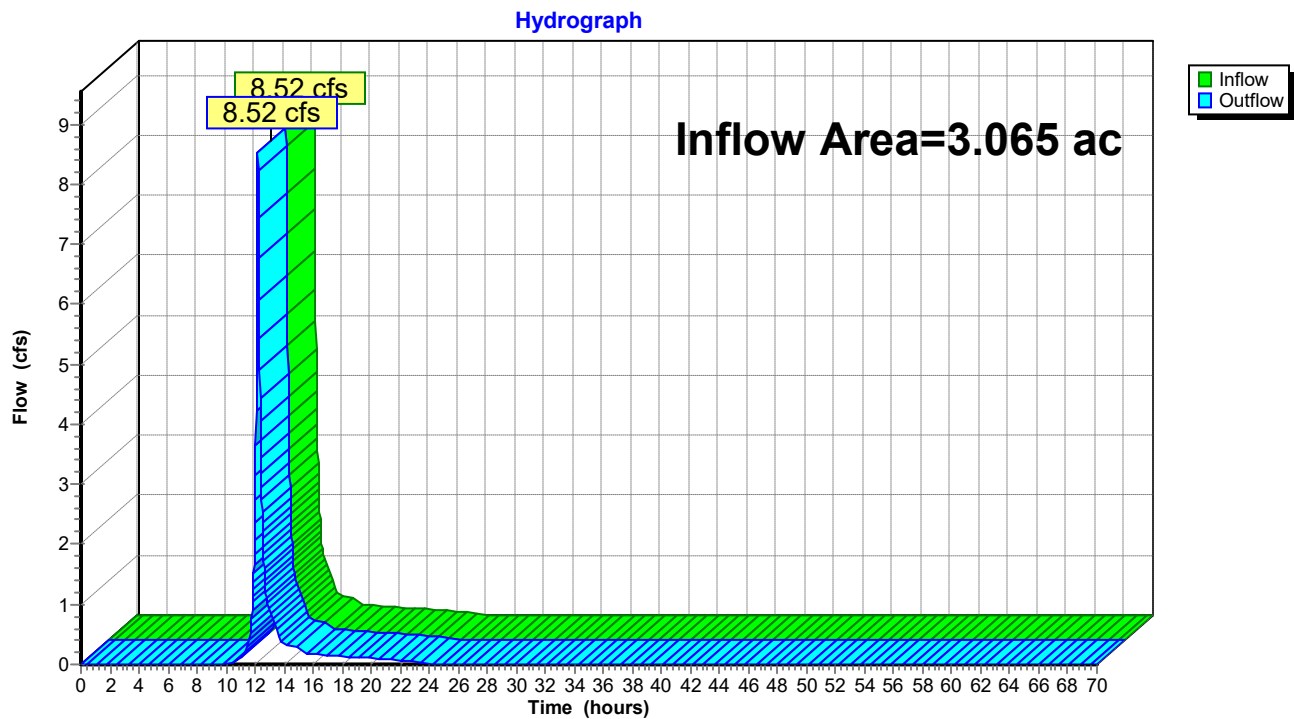
**Reach 2R: Existing Outfall**

Inflow Area = 3.065 ac, 0.00% Impervious, Inflow Depth = 1.89" for 10-year event  
Inflow = 8.52 cfs @ 12.19 hrs, Volume= 0.482 af  
Outflow = 8.52 cfs @ 12.19 hrs, Volume= 0.482 af, Atten= 0%, Lag= 0.0 min

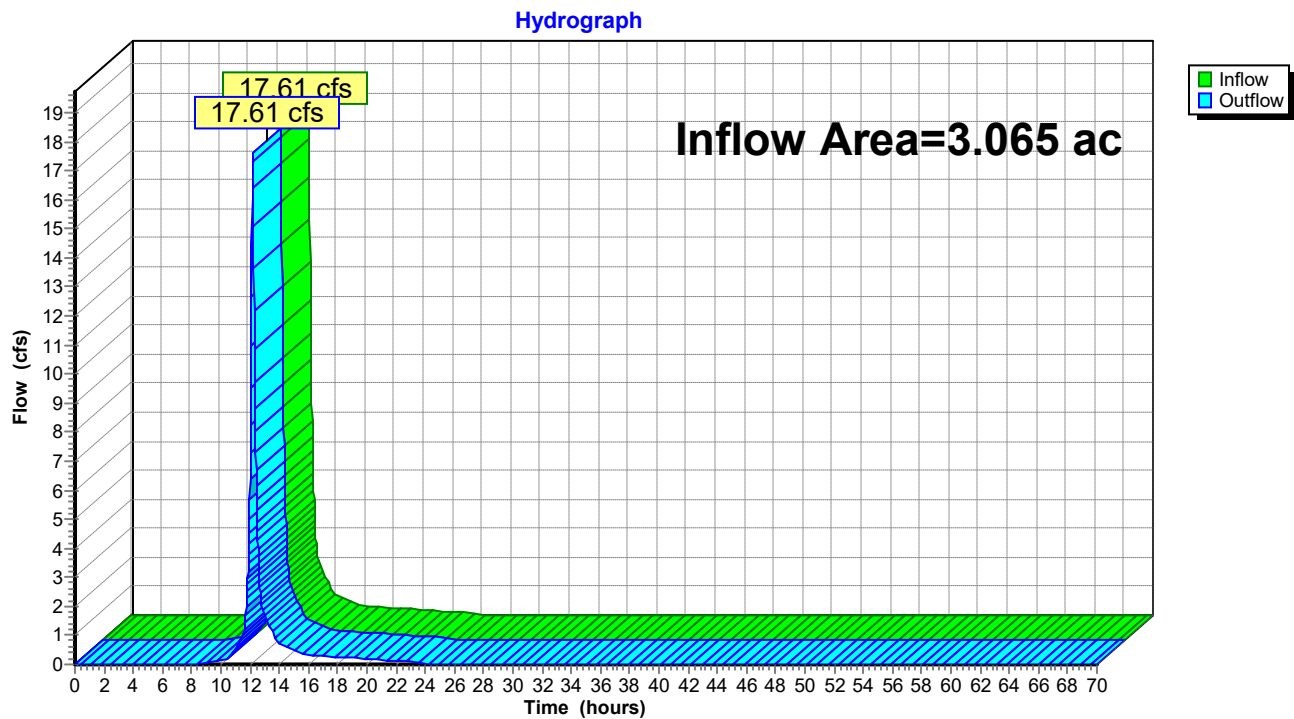
**Reach 2R: Existing Outfall**

Inflow Area = 3.065 ac, 0.00% Impervious, Inflow Depth = 3.97" for 100-year event  
Inflow = 17.61 cfs @ 12.18 hrs, Volume= 1.014 af  
Outflow = 17.61 cfs @ 12.18 hrs, Volume= 1.014 af, Atten= 0%, Lag= 0.0 min

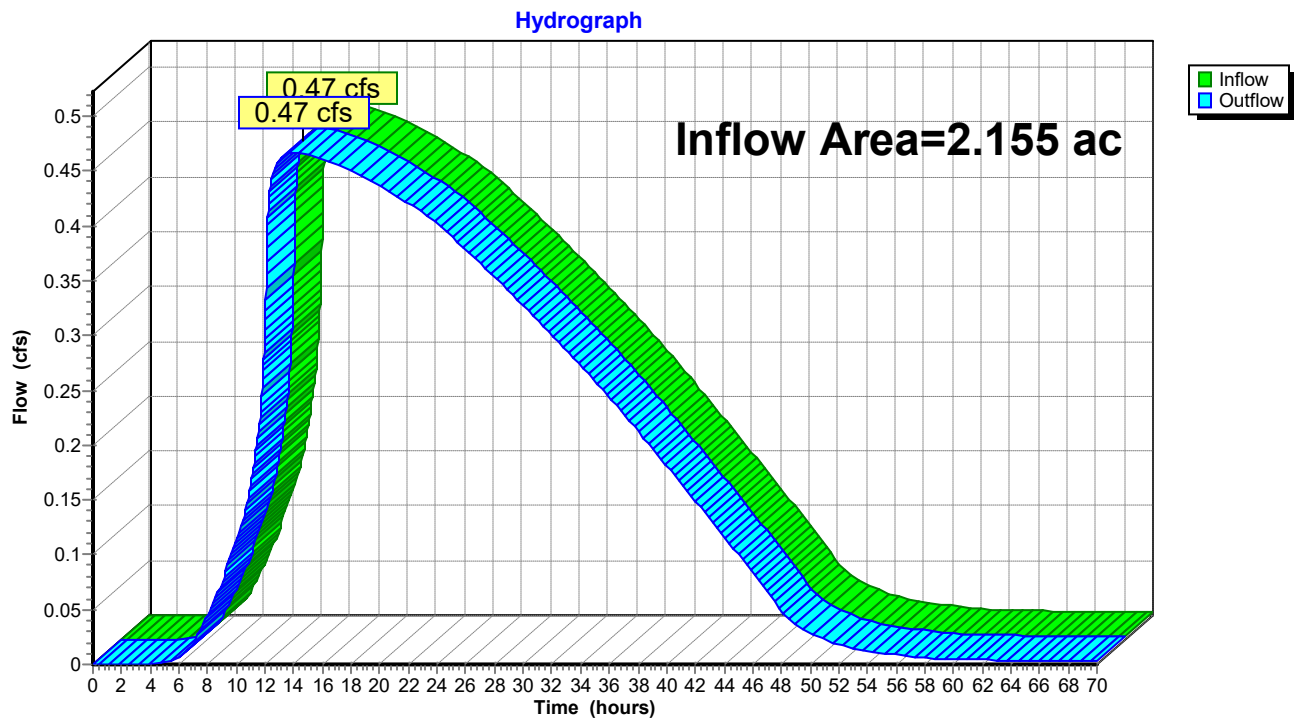
**Reach 22R: Existing Storm Sewer**

Inflow Area = 2.155 ac, 79.45% Impervious, Inflow Depth > 5.42" for 100-year event  
Inflow = 0.47 cfs @ 13.62 hrs, Volume= 0.973 af  
Outflow = 0.47 cfs @ 13.62 hrs, Volume= 0.973 af, Atten= 0%, Lag= 0.0 min

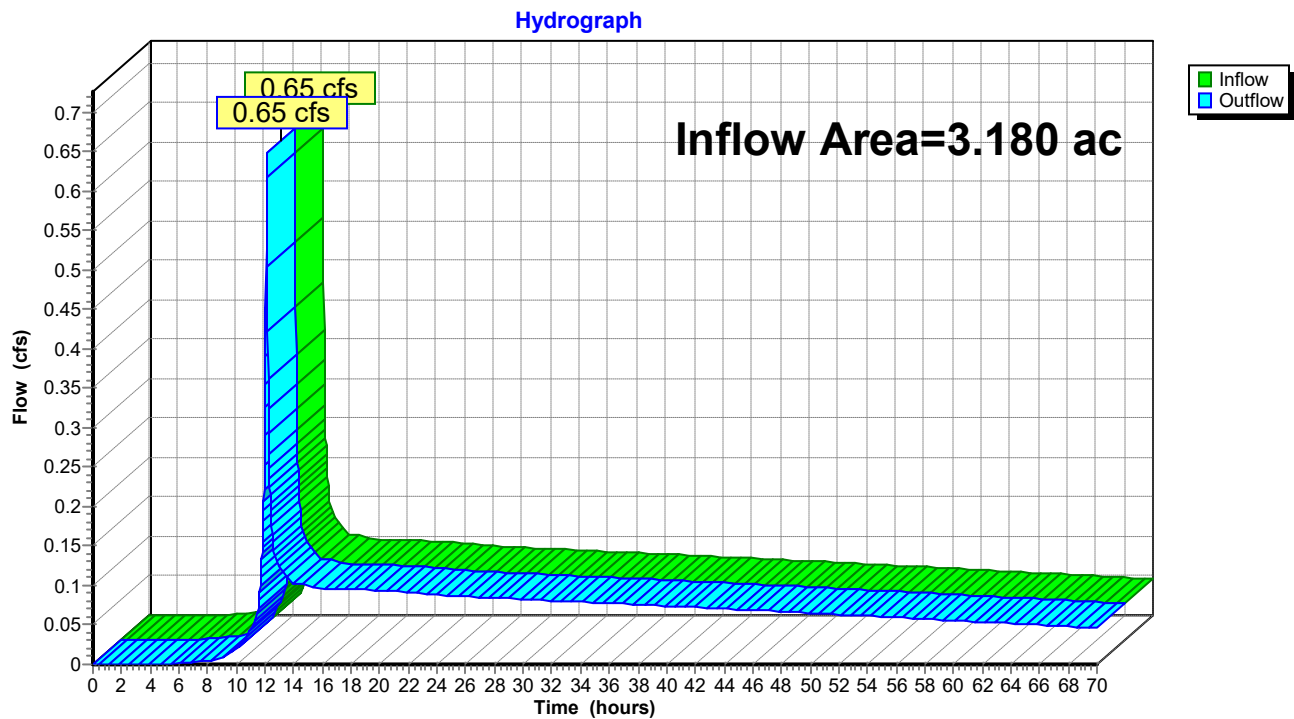
**Reach 5R: Proposed Outfall**

Inflow Area = 3.180 ac, 73.58% Impervious, Inflow Depth > 1.42" for 1-year event  
Inflow = 0.65 cfs @ 12.13 hrs, Volume= 0.376 af  
Outflow = 0.65 cfs @ 12.13 hrs, Volume= 0.376 af, Atten= 0%, Lag= 0.0 min

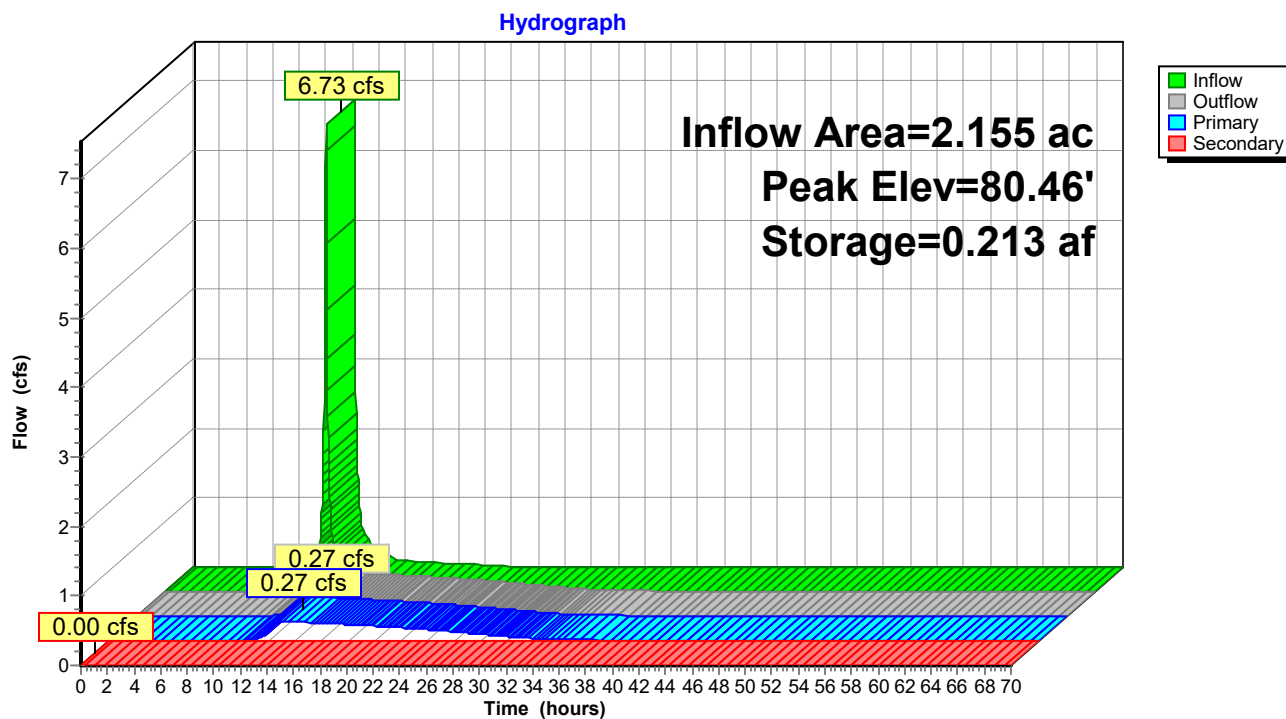
## Pond 14P: Existing North Pond

Inflow Area = 2.155 ac, 79.45% Impervious, Inflow Depth = 1.77" for 1-year event  
 Inflow = 6.73 cfs @ 12.13 hrs, Volume= 0.319 af  
 Outflow = 0.27 cfs @ 13.55 hrs, Volume= 0.318 af, Atten= 96%, Lag= 85.0 min  
 Primary = 0.27 cfs @ 13.55 hrs, Volume= 0.318 af  
     Routed to Reach 17R : Existing Storm Sewer  
 Secondary = 0.00 cfs @ 0.00 hrs, Volume= 0.000 af  
     Routed to Pond 6P : Pond 1

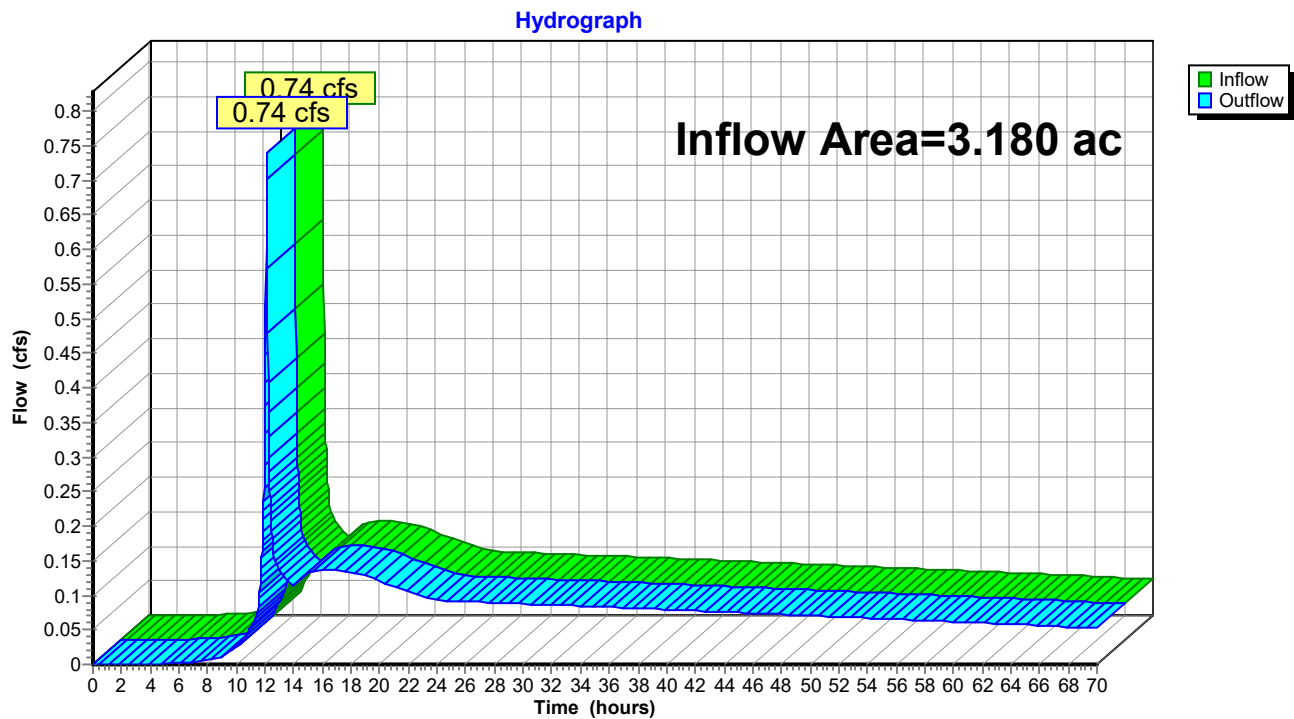
**Reach 5R: Proposed Outfall**

Inflow Area = 3.180 ac, 73.58% Impervious, Inflow Depth > 1.61" for 2-year event  
Inflow = 0.74 cfs @ 12.13 hrs, Volume= 0.425 af  
Outflow = 0.74 cfs @ 12.13 hrs, Volume= 0.425 af, Atten= 0%, Lag= 0.0 min

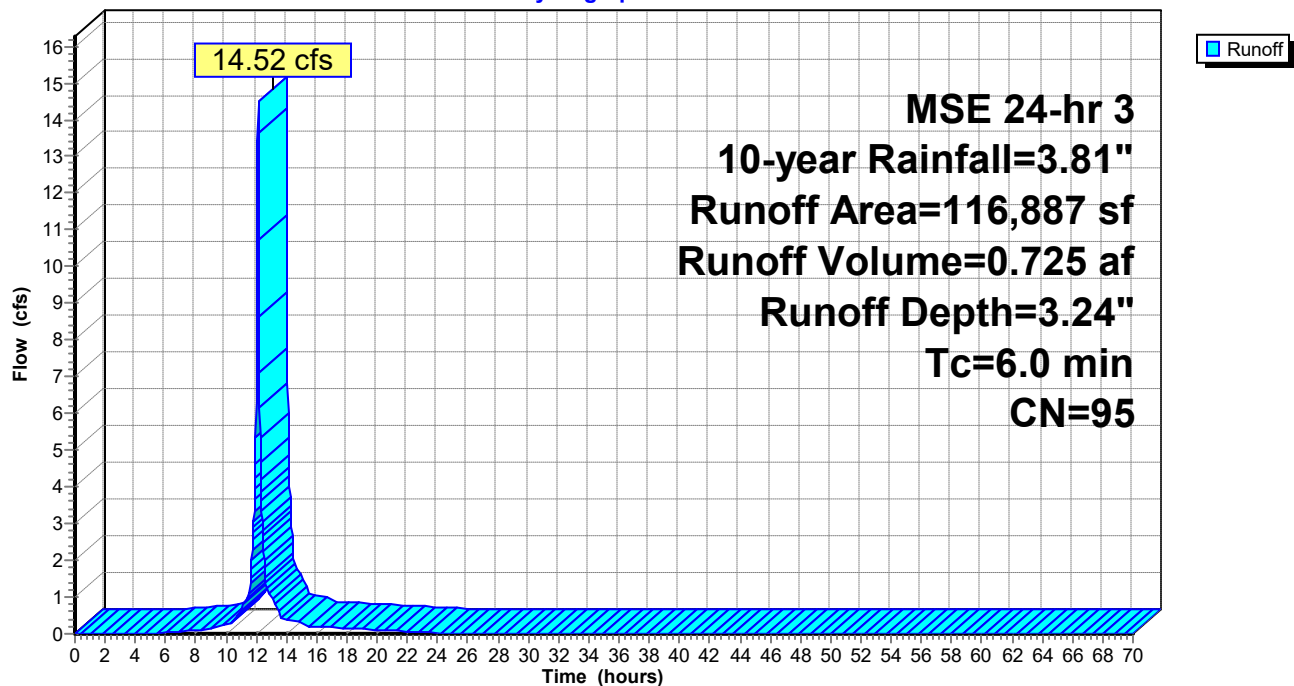
**Subcatchment 3S: P-1**

Hydrograph

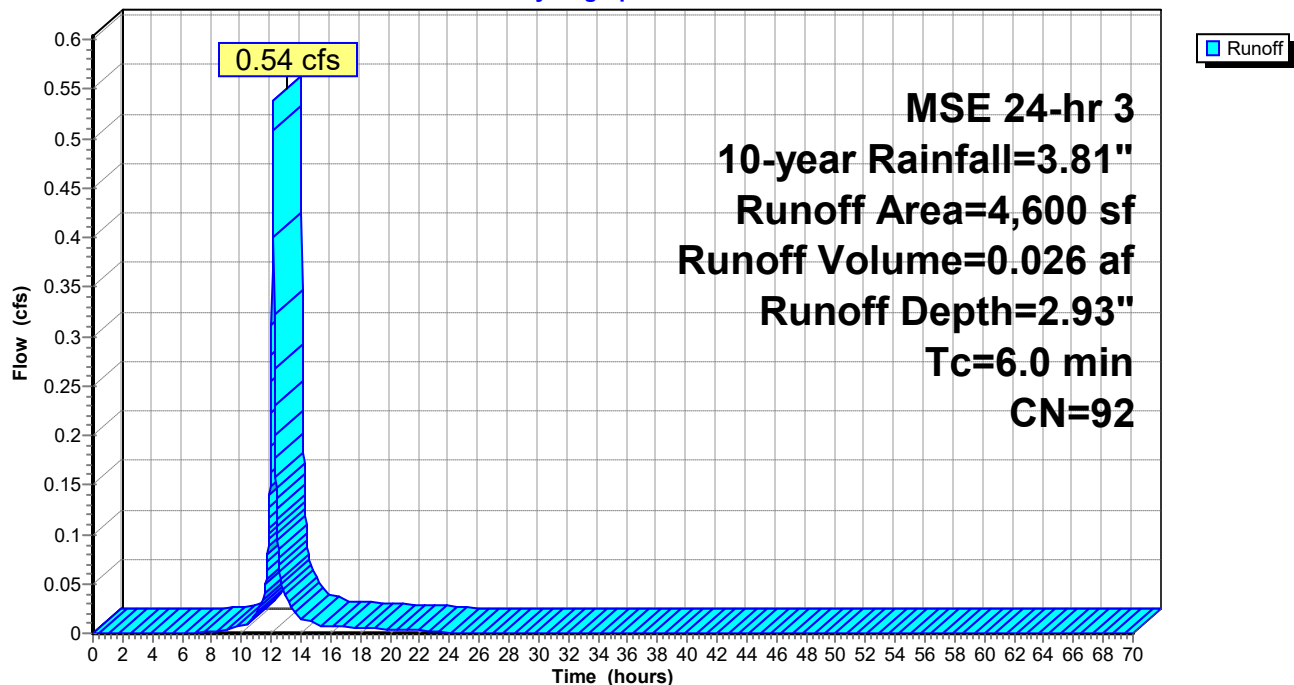
**Subcatchment 4S: P-2**

Runoff = 0.54 cfs @ 12.13 hrs, Volume= 0.026 af, Depth= 2.93"  
 Routed to Reach 5R : Proposed Outfall

Hydrograph

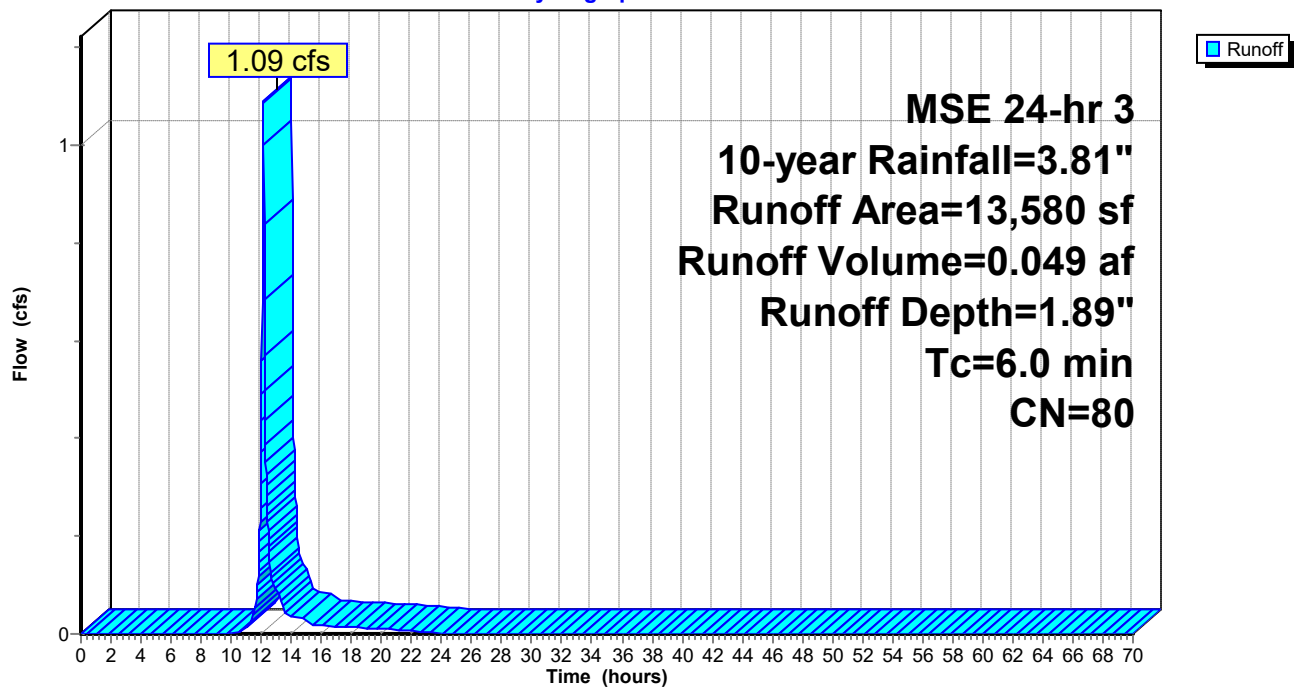
**Subcatchment 7S: O-1**

Runoff = 1.09 cfs @ 12.13 hrs, Volume= 0.049 af, Depth= 1.89"  
 Routed to Pond 6P : Pond 1

Hydrograph

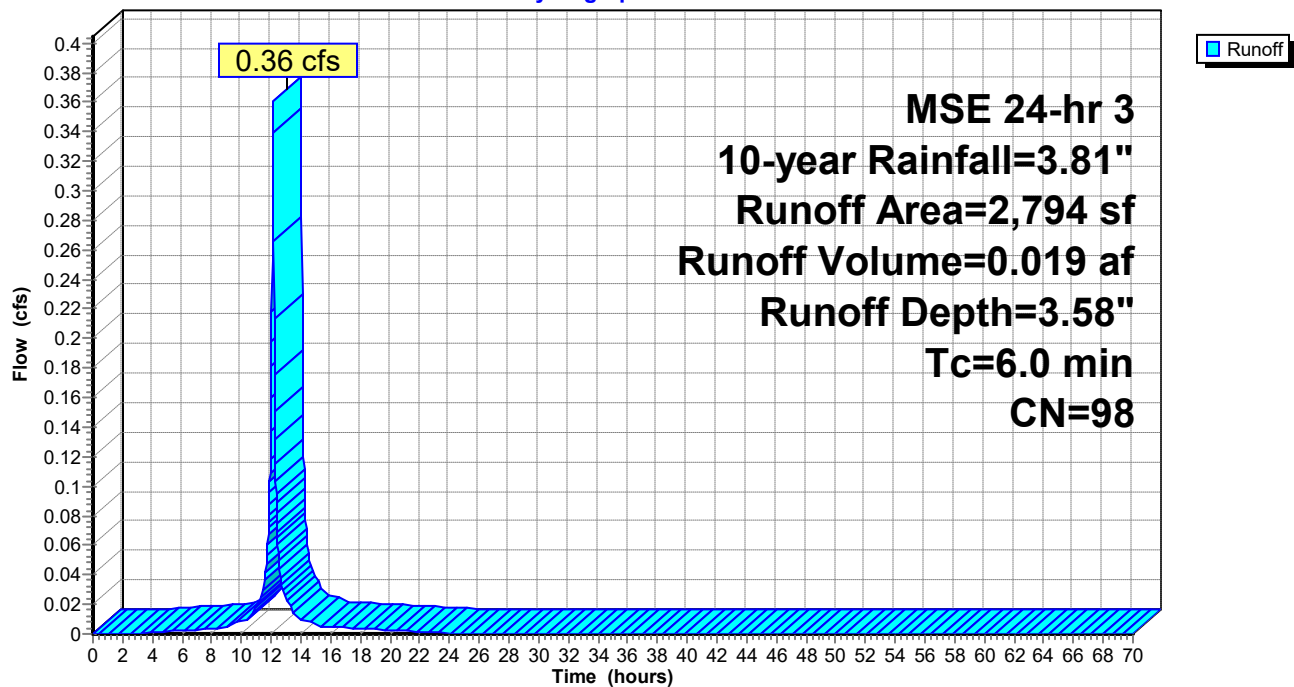
**Subcatchment 8S: P-3**

Runoff = 0.36 cfs @ 12.13 hrs, Volume= 0.019 af, Depth= 3.58"  
Routed to Reach 5R : Proposed Outfall

Hydrograph

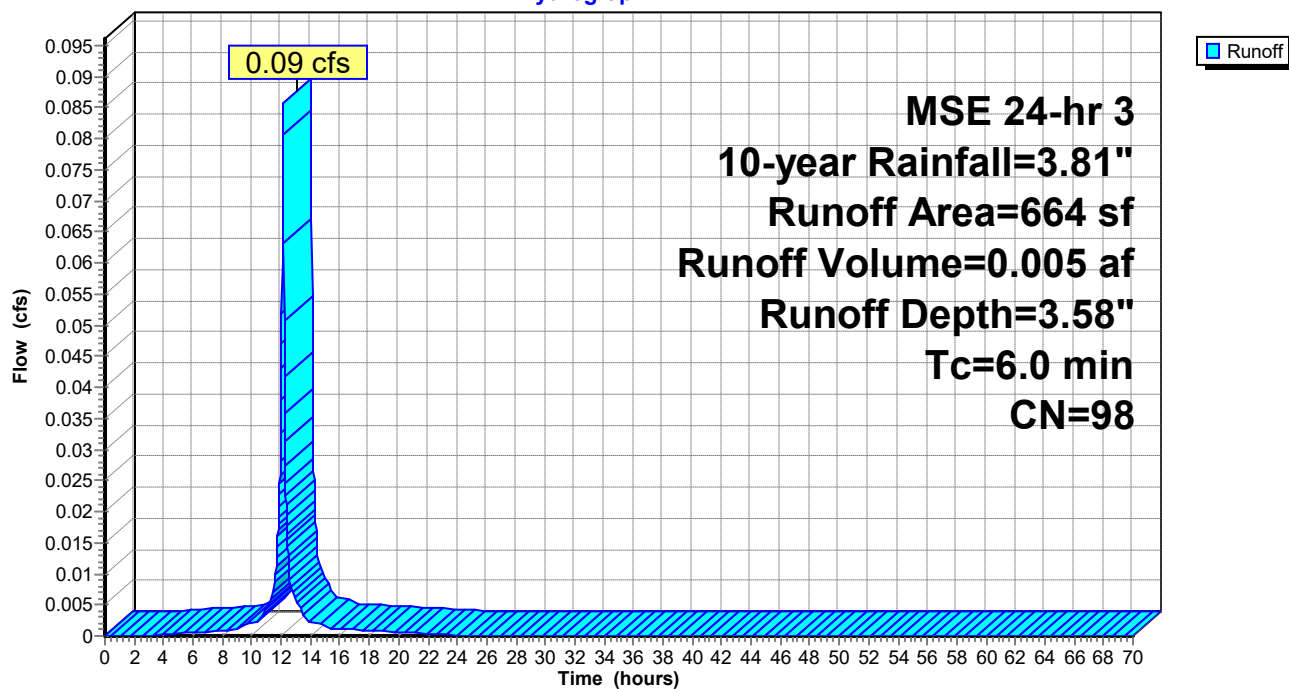
**Subcatchment 9S: P-4**

Runoff = 0.09 cfs @ 12.13 hrs, Volume= 0.005 af, Depth= 3.58"  
Routed to Reach 5R : Proposed Outfall

Hydrograph

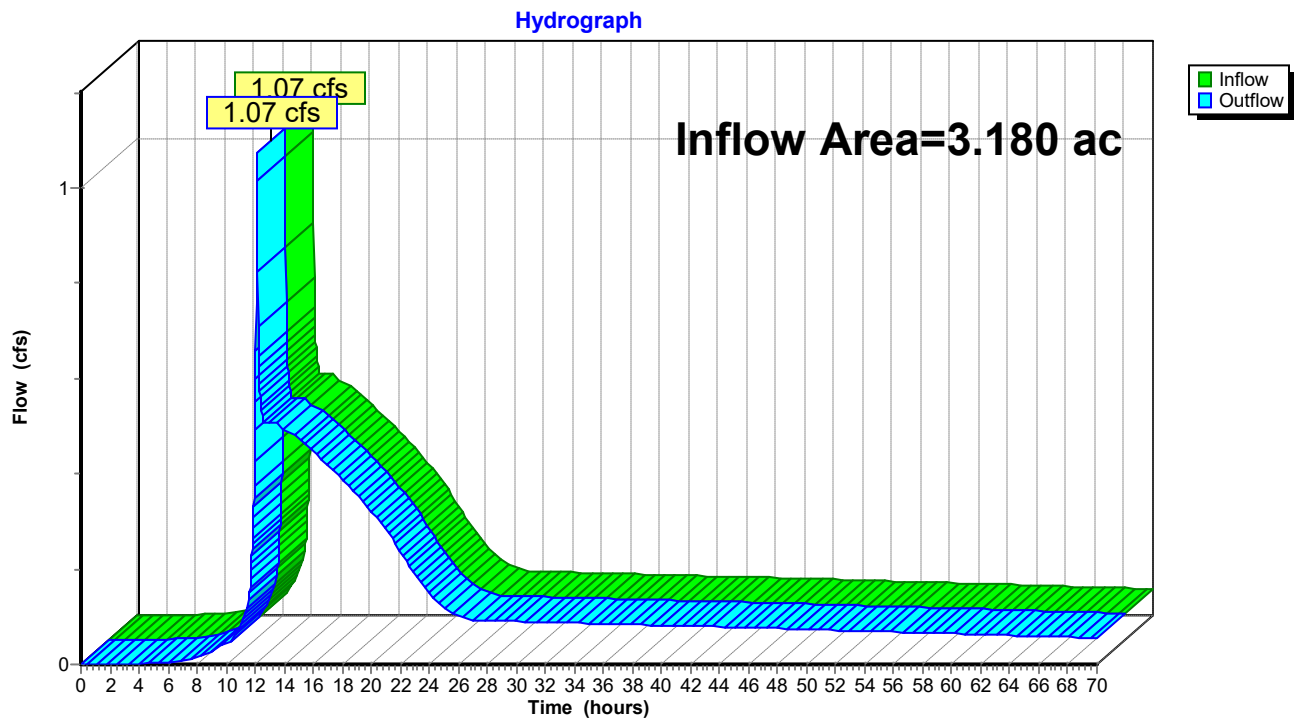
**Reach 5R: Proposed Outfall**

Routing by Stor-Ind+Trans method, Time Span= 0.00-70.00 hrs, dt= 0.02 hrs
