# Storm Water Management Plan for

## STOR-IT Right - Waukesha City of Waukesha, WI

**Project No. 3250218**

**June 23, 2026**

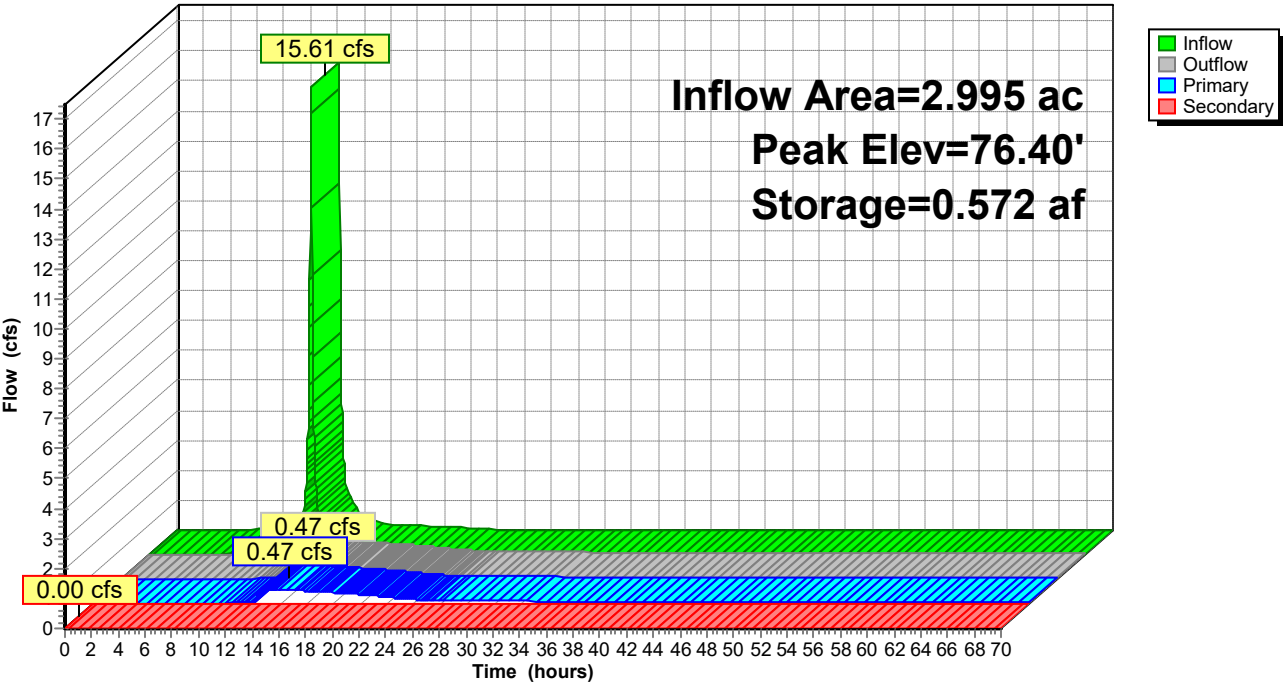
Pond 6P: Pond 1

Hydrograph

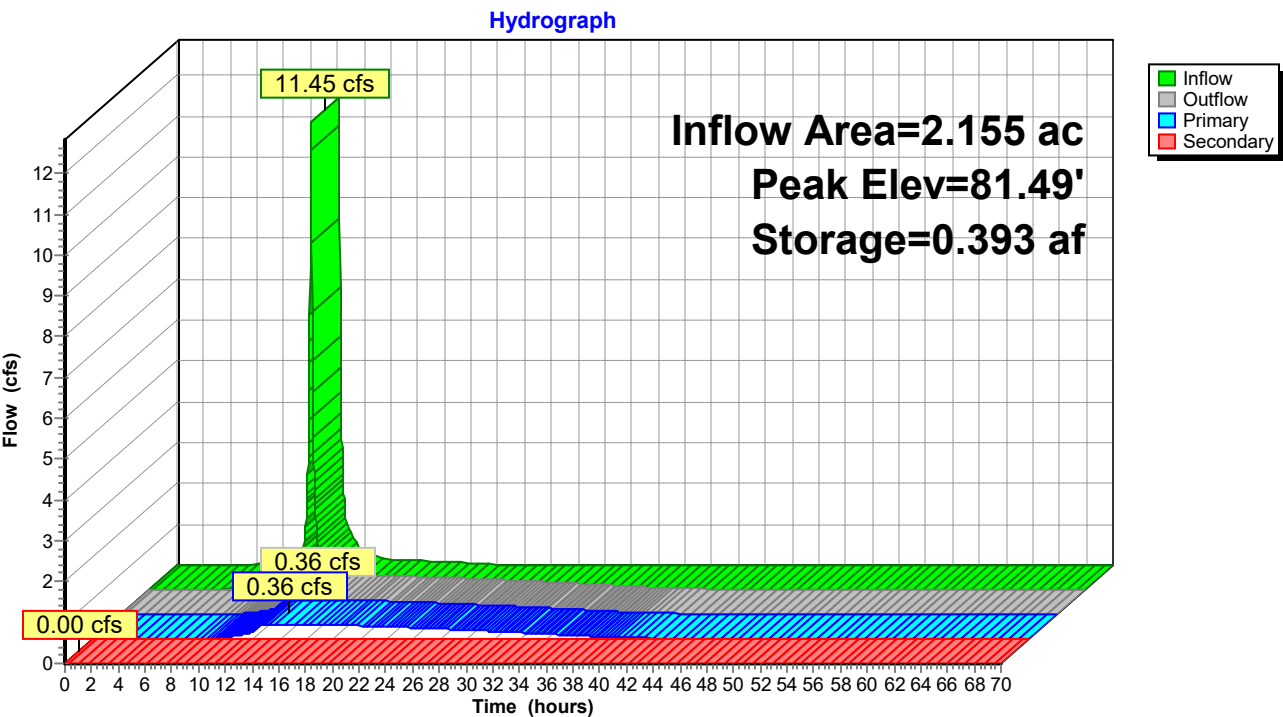
Pond 14P: Existing North Pond

Inflow Area = 2.155 ac, 79.45% Impervious, Inflow Depth = 3.14" for 10-year event  
 Inflow = 11.45 cfs @ 12.13 hrs, Volume= 0.563 af  
 Outflow = 0.36 cfs @ 13.60 hrs, Volume= 0.562 af, Atten= 97%, Lag= 88.5 min  
 Primary = 0.36 cfs @ 13.60 hrs, Volume= 0.562 af  
     Routed to Reach 17R : Existing Storm Sewer  
 Secondary = 0.00 cfs @ 0.00 hrs, Volume= 0.000 af  
     Routed to Pond 6P : Pond 1

↑ **3=Broad-Crested Rectangular Weir** ( Controls 0.00 cfs)

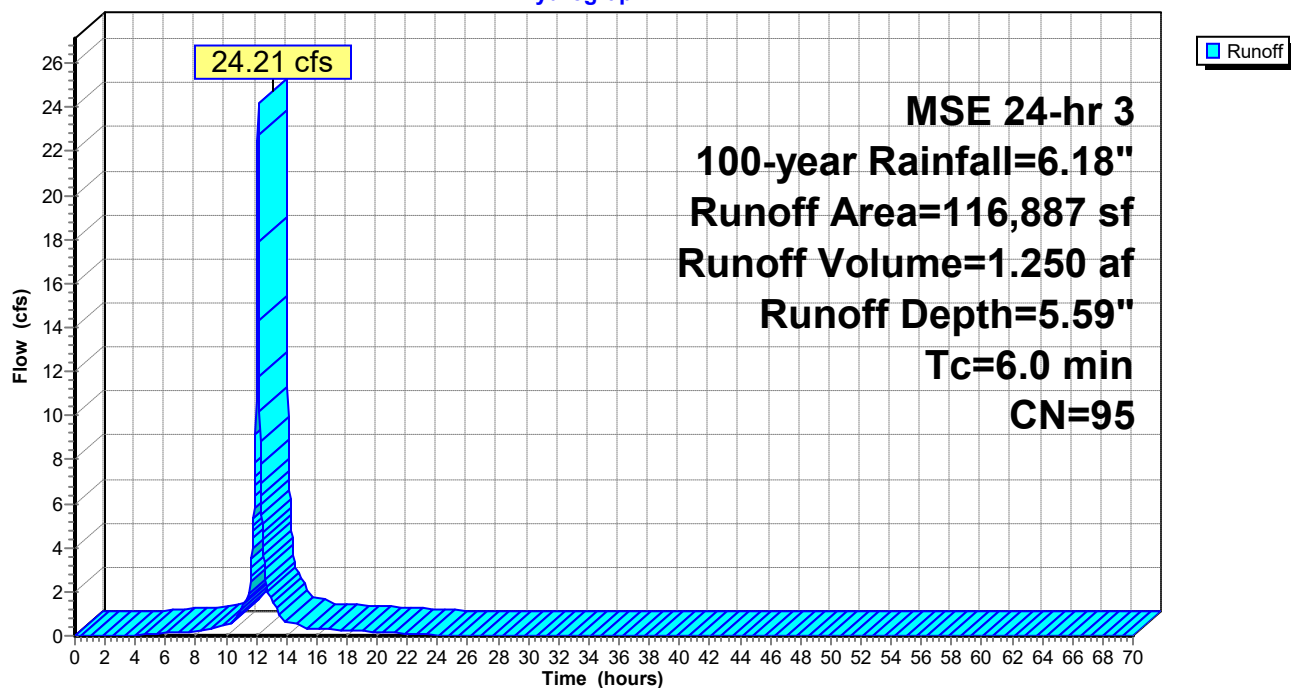
**Subcatchment 3S: P-1**

Hydrograph

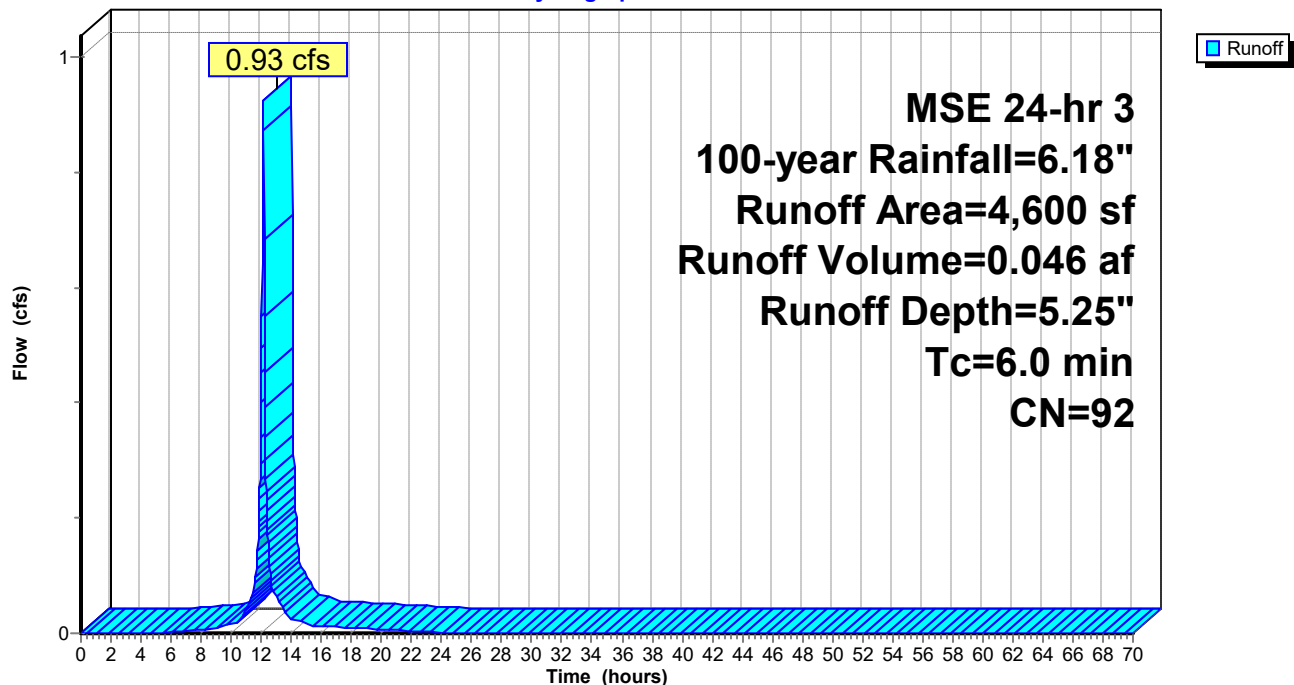
**Subcatchment 4S: P-2**

Runoff = 0.93 cfs @ 12.13 hrs, Volume= 0.046 af, Depth= 5.25"  
 Routed to Reach 5R : Proposed Outfall

Hydrograph

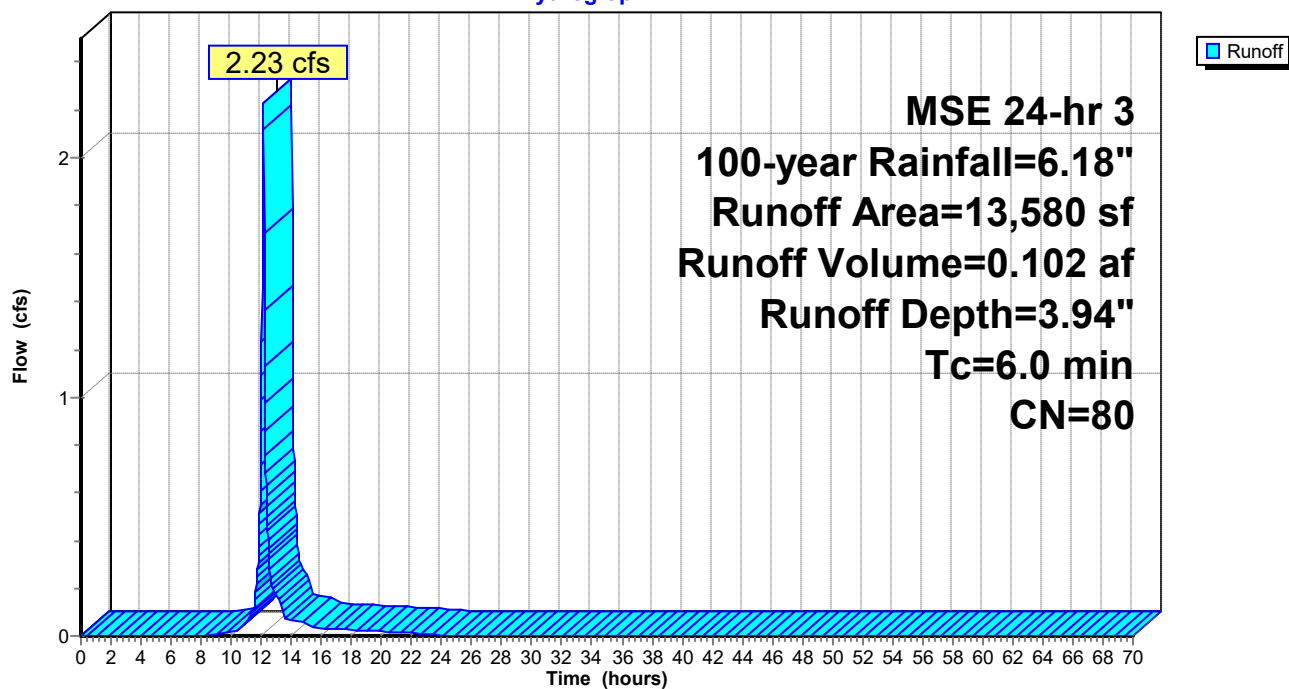
**Subcatchment 7S: O-1**

Runoff = 2.23 cfs @ 12.13 hrs, Volume= 0.102 af, Depth= 3.94"  
 Routed to Pond 6P : Pond 1

Hydrograph

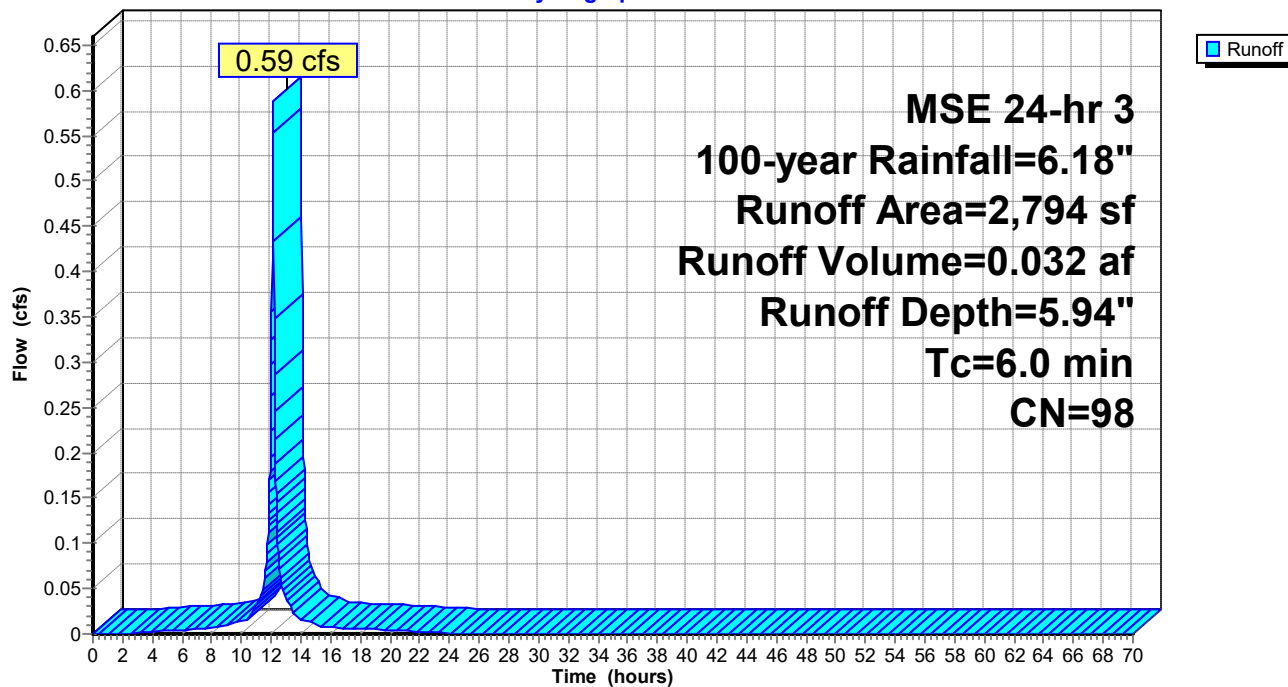
**Subcatchment 8S: P-3**

Runoff = 0.59 cfs @ 12.13 hrs, Volume= 0.032 af, Depth= 5.94"  
Routed to Reach 5R : Proposed Outfall

Hydrograph

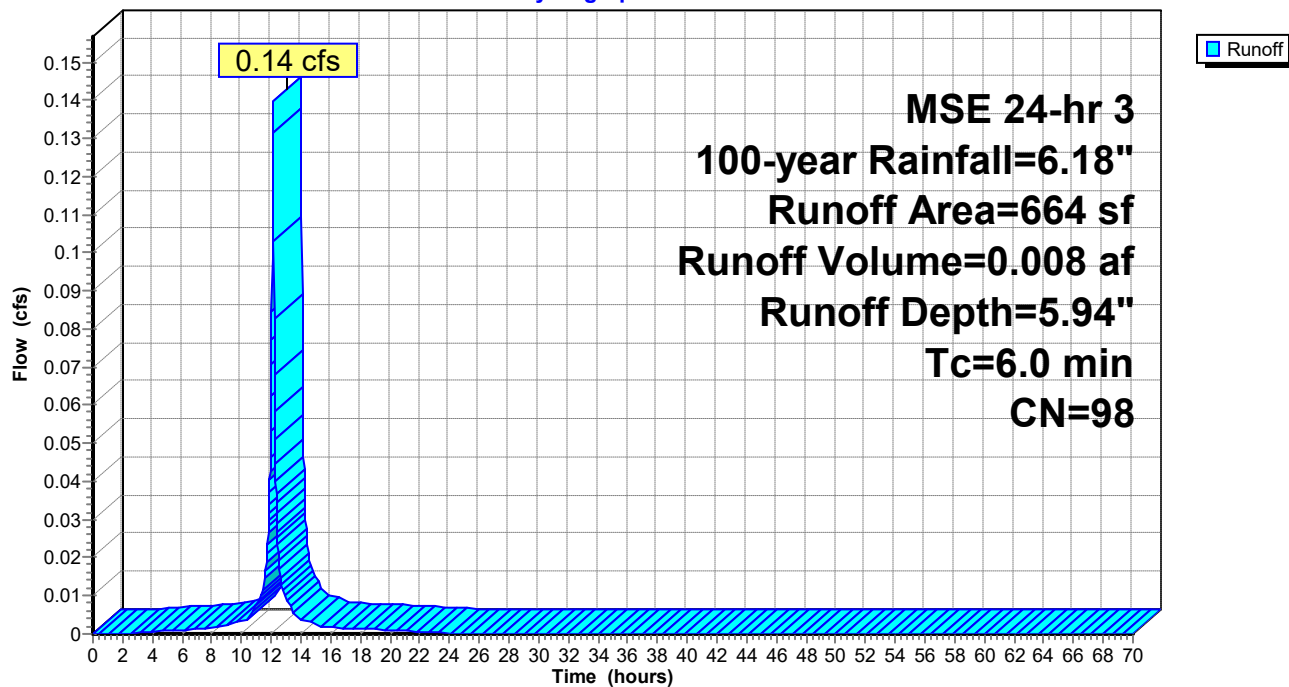
**Subcatchment 9S: P-4**

Runoff = 0.14 cfs @ 12.13 hrs, Volume= 0.008 af, Depth= 5.94"  
Routed to Reach 5R : Proposed Outfall

Hydrograph

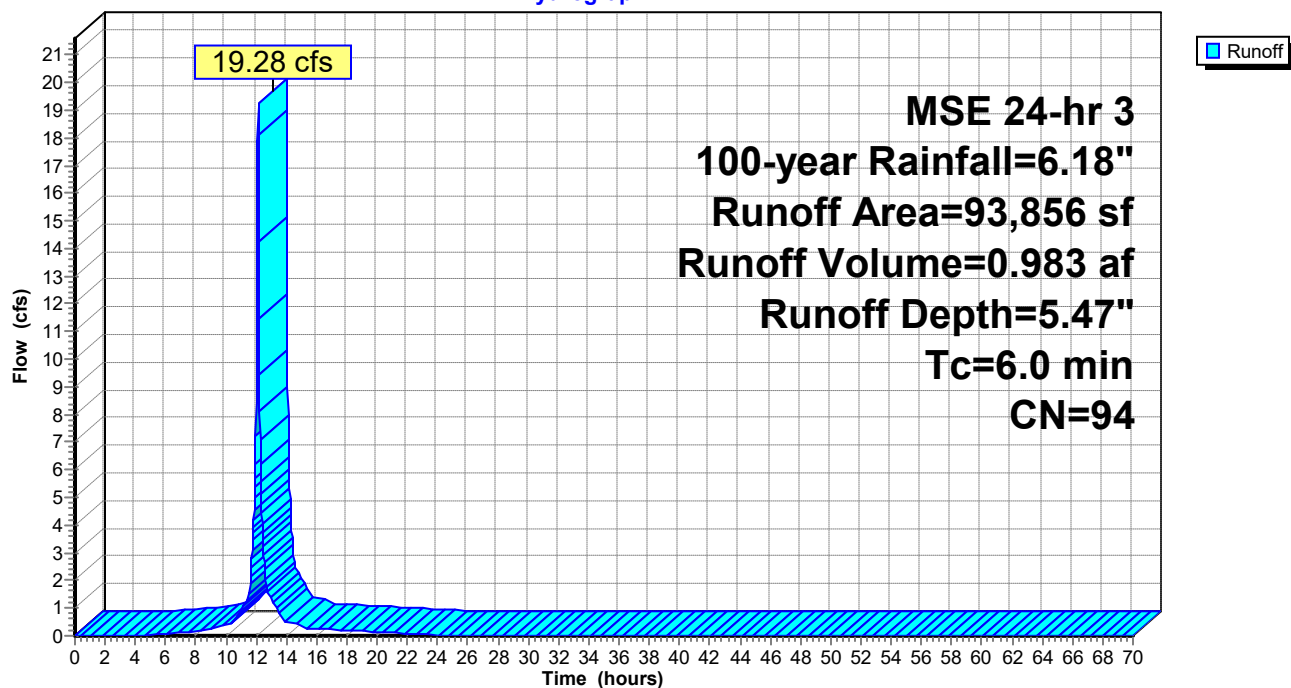
**Subcatchment 15S: O-2**

Runoff = 19.28 cfs @ 12.13 hrs, Volume= 0.983 af, Depth= 5.47"  
 Routed to Pond 14P : Existing North Pond

Hydrograph

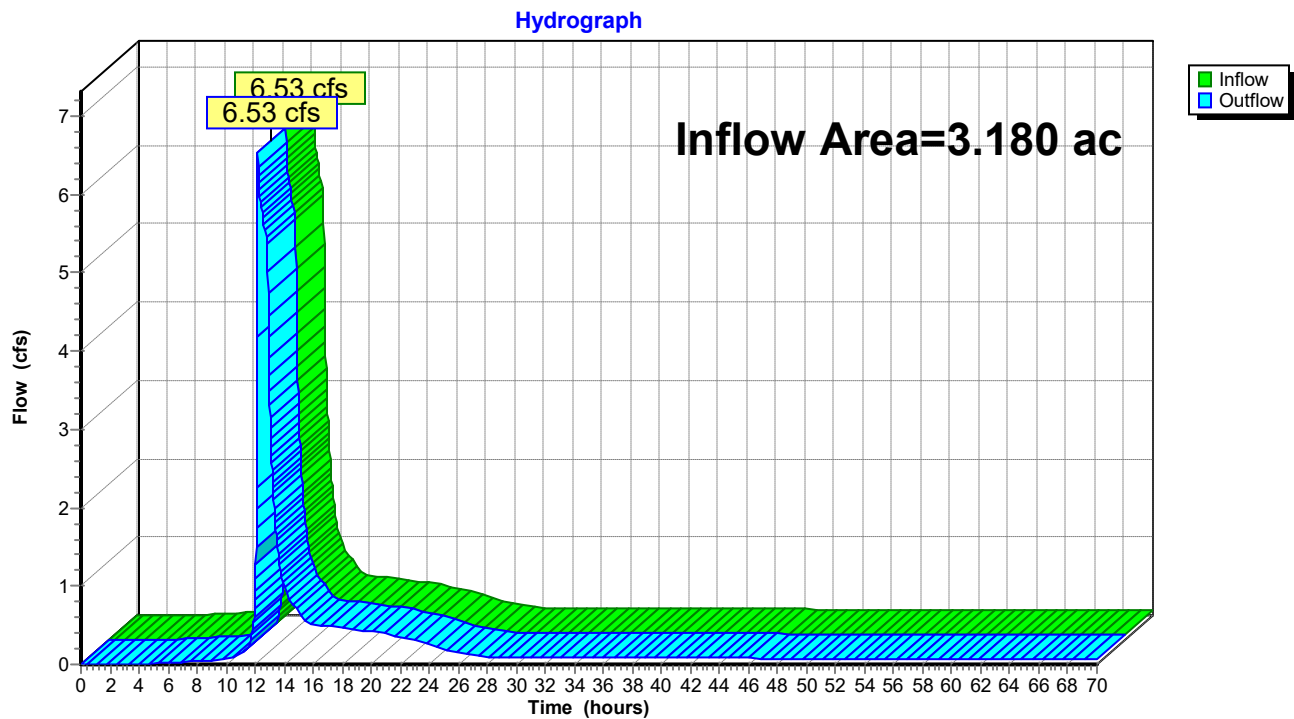
**Reach 5R: Proposed Outfall**

Inflow Area = 3.180 ac, 73.58% Impervious, Inflow Depth > 4.93" for 100-year event  
Inflow = 6.53 cfs @ 12.18 hrs, Volume= 1.306 af  
Outflow = 6.53 cfs @ 12.18 hrs, Volume= 1.306 af, Atten= 0%, Lag= 0.0 min

Routing by Stor-Ind+Trans method, Time Span= 0.00-70.00 hrs, dt= 0.02 hrs

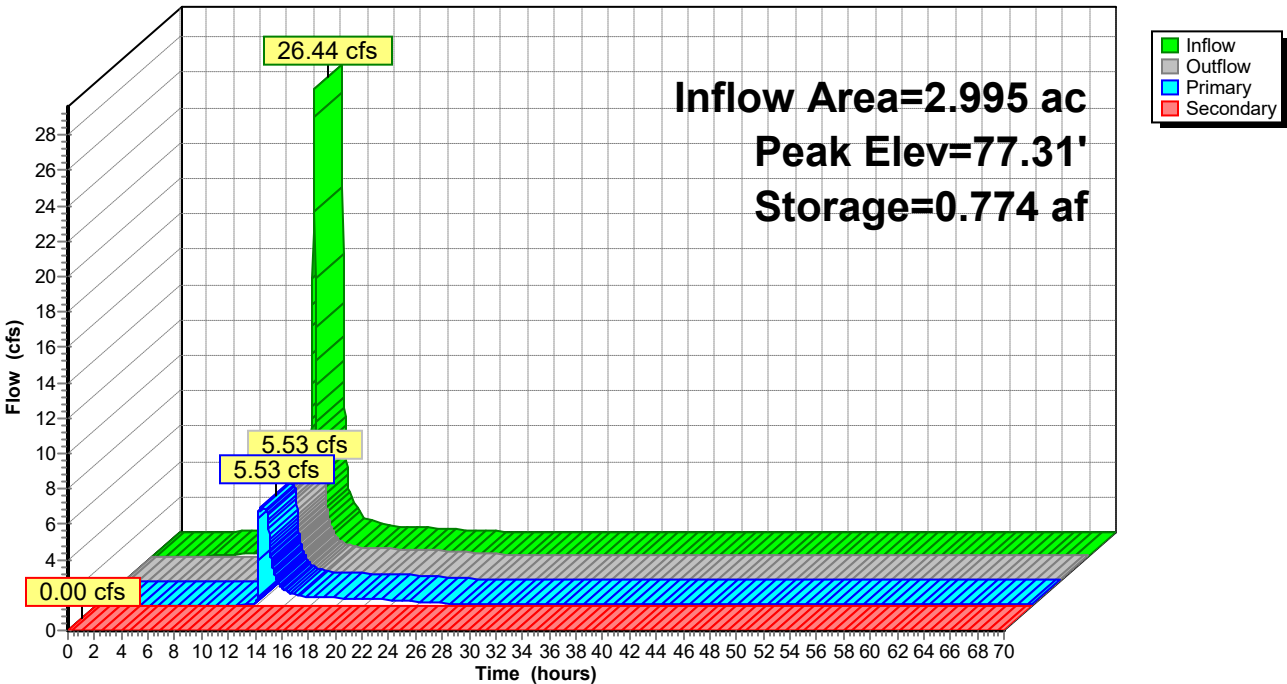
Pond 6P: Pond 1

Hydrograph

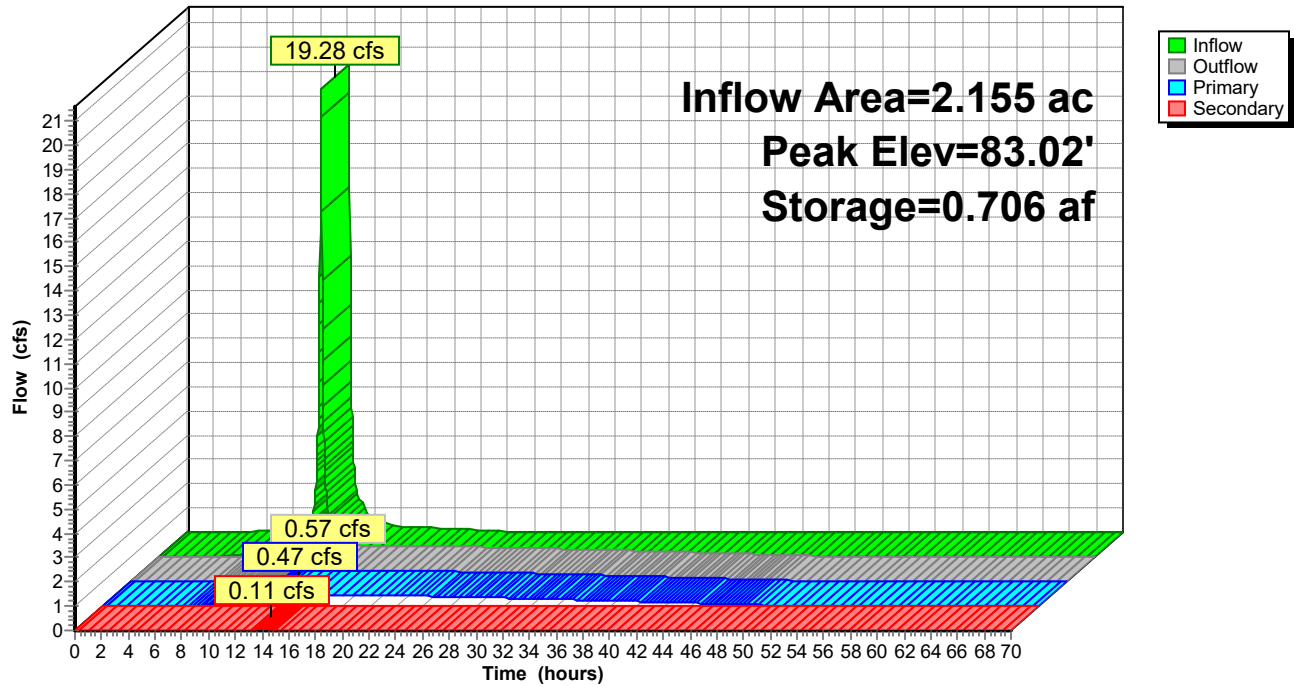
# Pond 14P: Existing North Pond

Inflow Area = 2.155 ac, 79.45% Impervious, Inflow Depth = 5.47" for 100-year event  
 Inflow = 19.28 cfs @ 12.13 hrs, Volume= 0.983 af  
 Outflow = 0.57 cfs @ 13.62 hrs, Volume= 0.980 af, Atten= 97%, Lag= 89.4 min  
 Primary = 0.47 cfs @ 13.62 hrs, Volume= 0.973 af  
     Routed to Reach 17R : Existing Storm Sewer  
 Secondary = 0.11 cfs @ 13.62 hrs, Volume= 0.007 af  
     Routed to Pond 6P : Pond 1

## Hydrograph

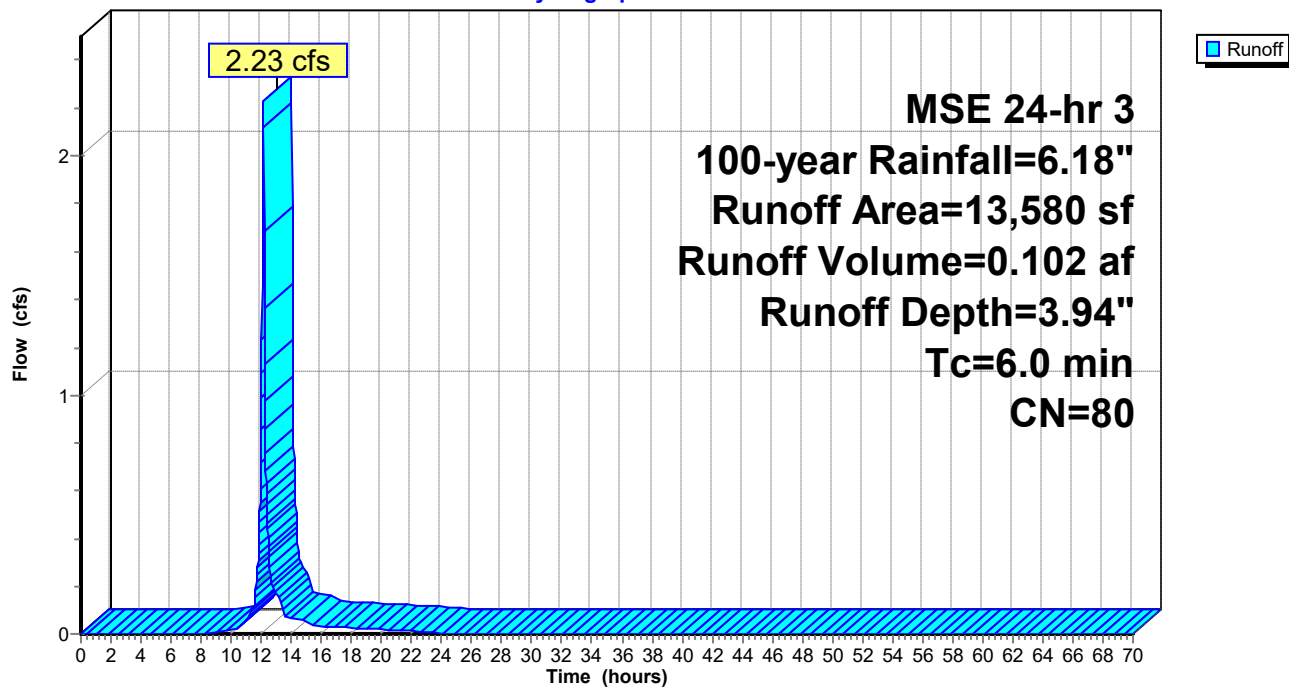
**Subcatchment 12S: O-1**

Runoff = 2.23 cfs @ 12.13 hrs, Volume= 0.102 af, Depth= 3.94"  
 Routed to Pond 13P : Pond 1

Hydrograph

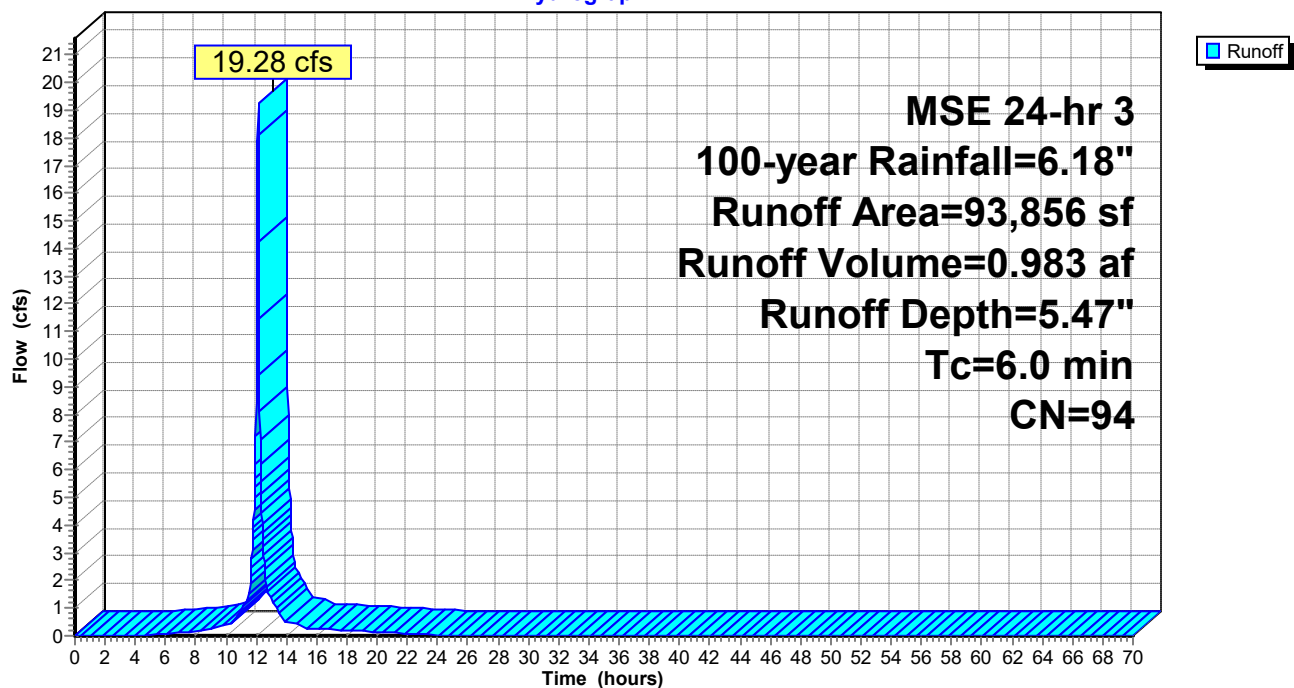
**Subcatchment 18S: O-2**

Runoff = 19.28 cfs @ 12.13 hrs, Volume= 0.983 af, Depth= 5.47"  
 Routed to Pond 20P : Existing North Pond

Hydrograph

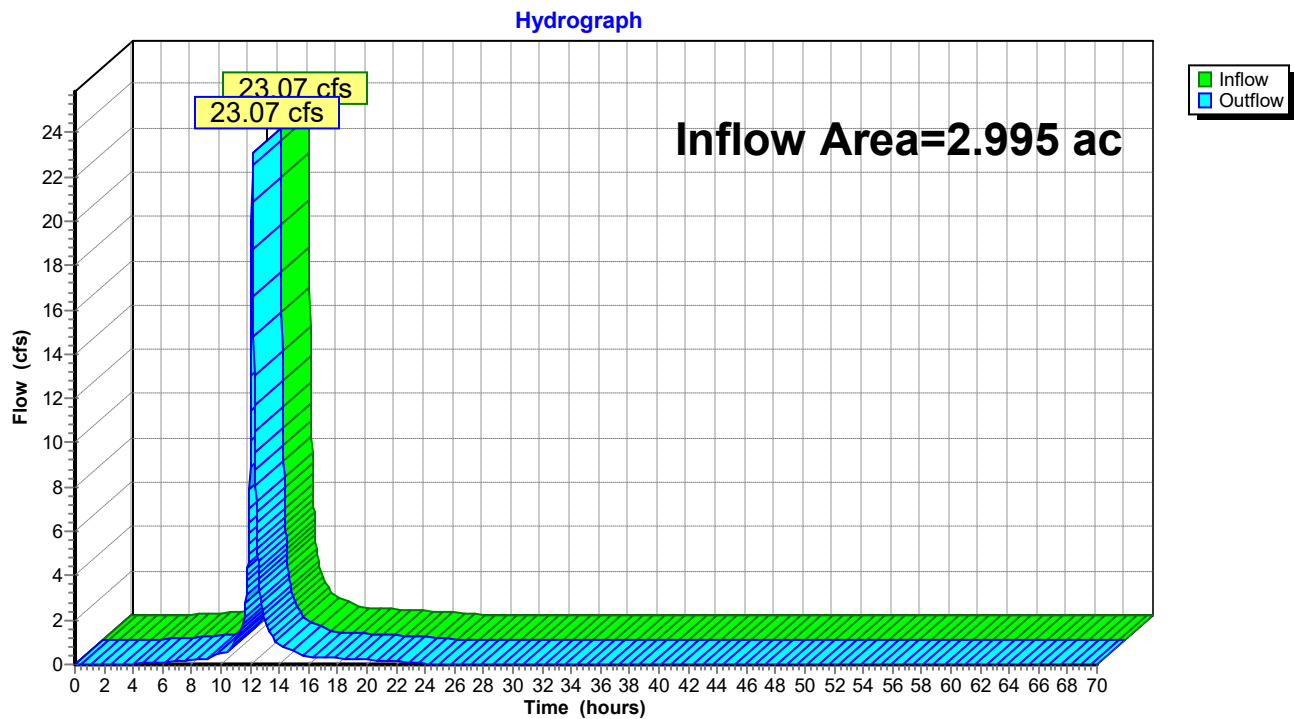
**Reach 14R: Proposed Outfall**

Inflow Area = 2.995 ac, 73.19% Impervious, Inflow Depth = 5.45" for 100-year event  
Inflow = 23.07 cfs @ 12.16 hrs, Volume= 1.359 af  
Outflow = 23.07 cfs @ 12.16 hrs, Volume= 1.359 af, Atten= 0%, Lag= 0.0 min

Routing by Stor-Ind+Trans method, Time Span= 0.00-70.00 hrs, dt= 0.02 hrs

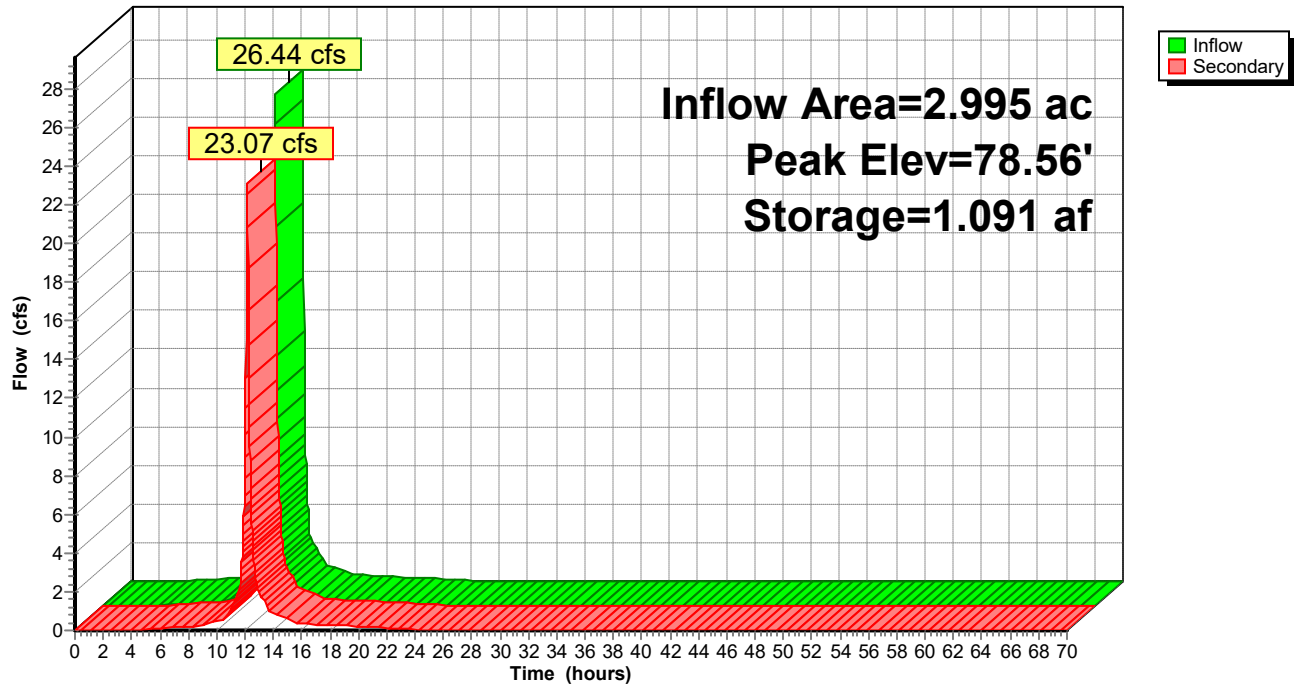
Pond 13P: Pond 1

Hydrograph

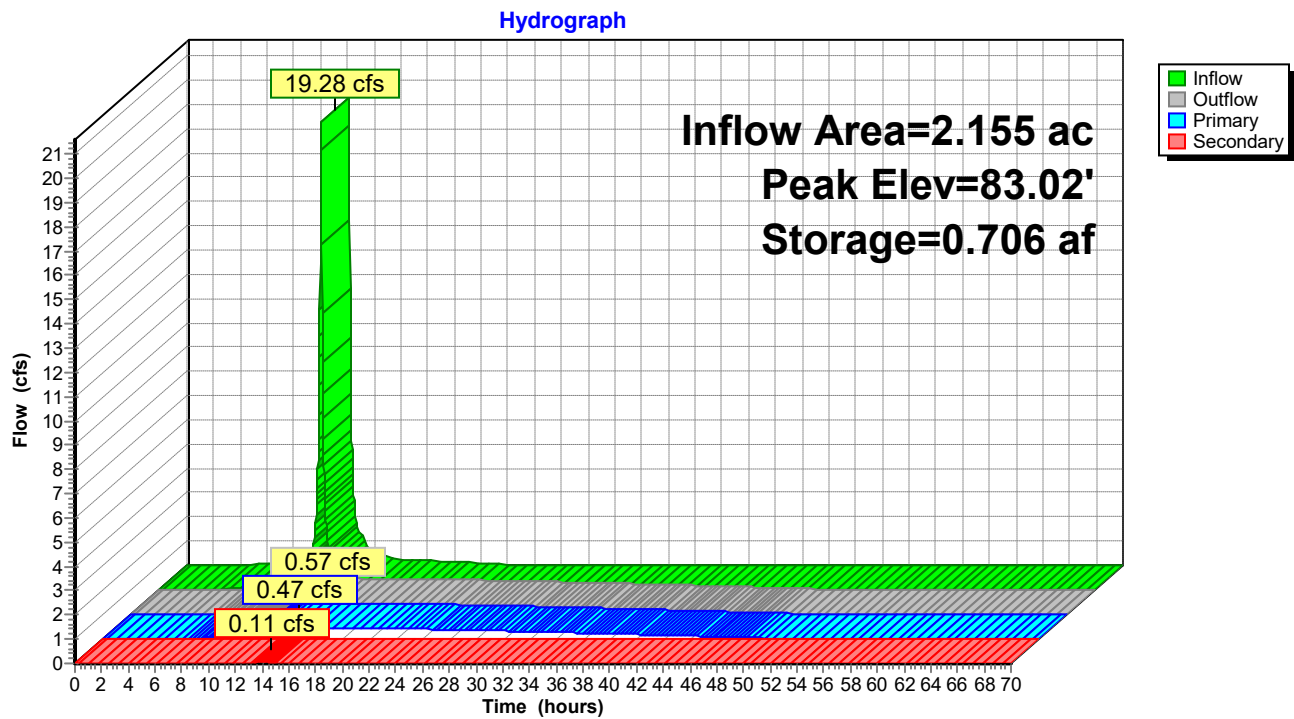
**Pond 20P: Existing North Pond**

Inflow Area = 2.155 ac, 79.45% Impervious, Inflow Depth = 5.47" for 100-year event  
 Inflow = 19.28 cfs @ 12.13 hrs, Volume= 0.983 af  
 Outflow = 0.57 cfs @ 13.62 hrs, Volume= 0.980 af, Atten= 97%, Lag= 89.4 min  
 Primary = 0.47 cfs @ 13.62 hrs, Volume= 0.973 af  
     Routed to Reach 19R : Existing Storm Sewer  
 Secondary = 0.11 cfs @ 13.62 hrs, Volume= 0.007 af  
     Routed to Pond 13P : Pond 1

↑ **3=Broad-Crested Rectangular Weir** (Weir Controls 0.07 cfs @ 0.34 fps)

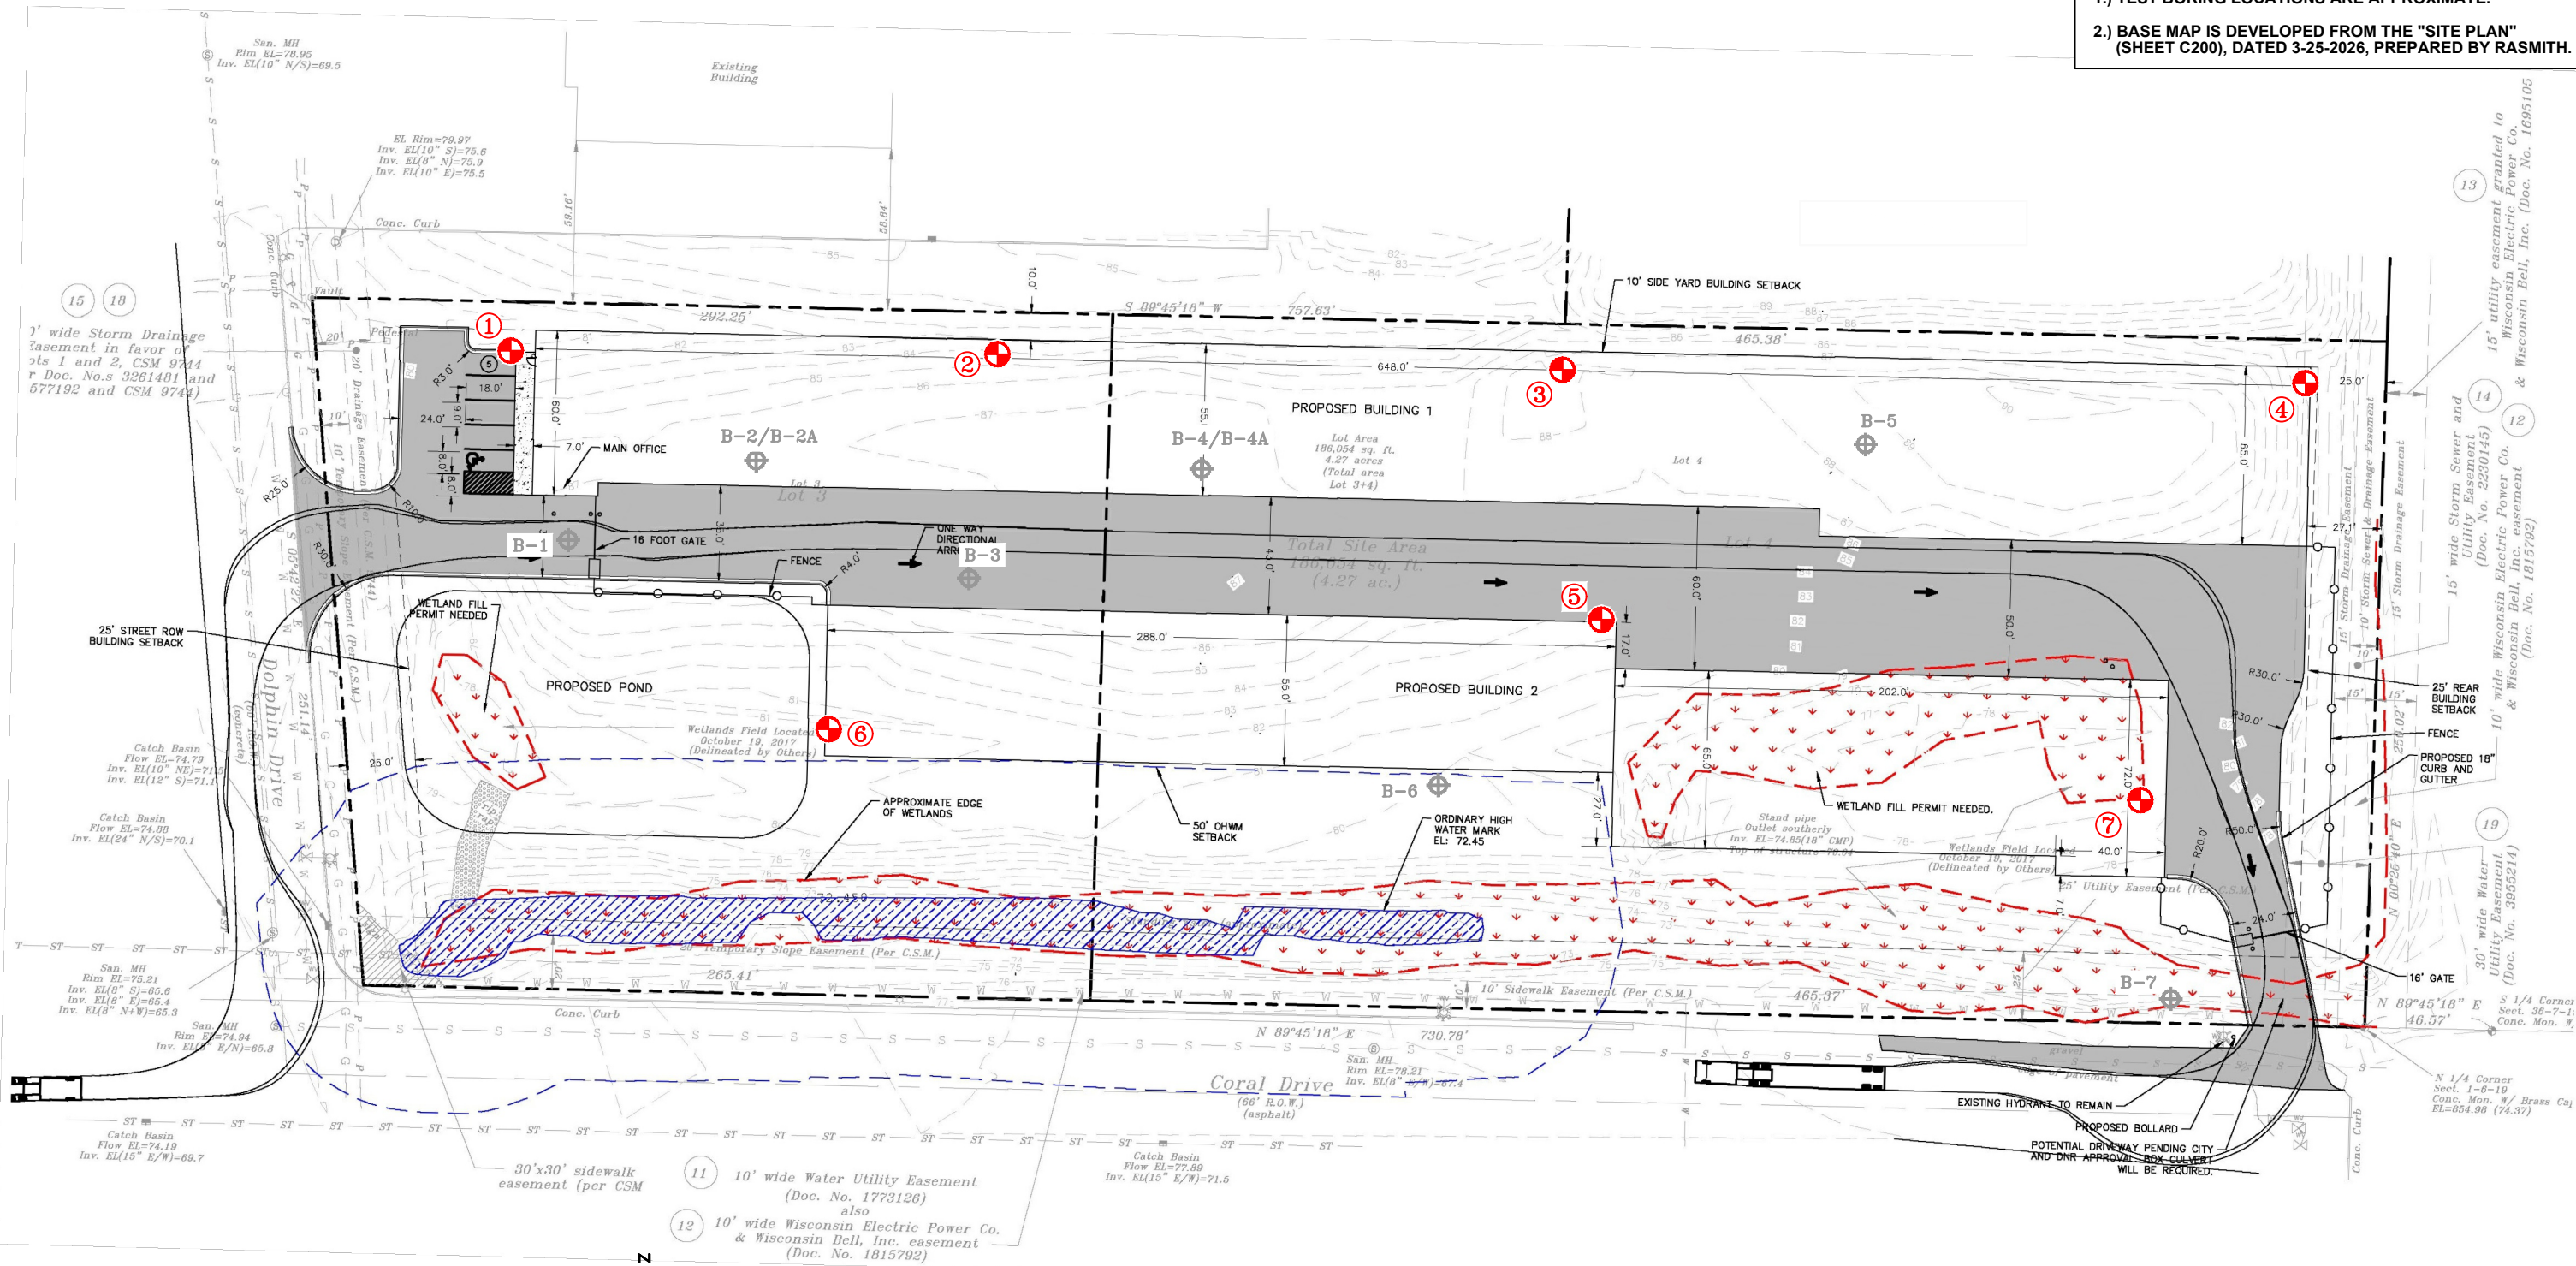
- NOTES:
- 1.) TEST BORING LOCATIONS ARE APPROXIMATE.
  - 2.) BASE MAP IS DEVELOPED FROM THE "SITE PLAN" (SHEET C200), DATED 3-25-2026, PREPARED BY RASMITH.

To explore subsurface conditions, seven geotechnical test borings were conducted at the site using a mechanical drill-rig. The test borings were drilled in or near the proposed storage buildings. Test Borings 1, 2, 3, 6, and 7 were advanced to  $\pm 26$  feet below-ground and Test Borings 4 and 5 were advanced to  $\pm 41$  feet below-ground, as planned. Giles positioned the test boring locations using a Trimble® R2 receiver. The approximate locations of the test borings are shown on the *Test Boring Location Plan*. Previous test borings by PSI Intertek were completed at the site in 2018 for a different development but were reviewed as part of this report.

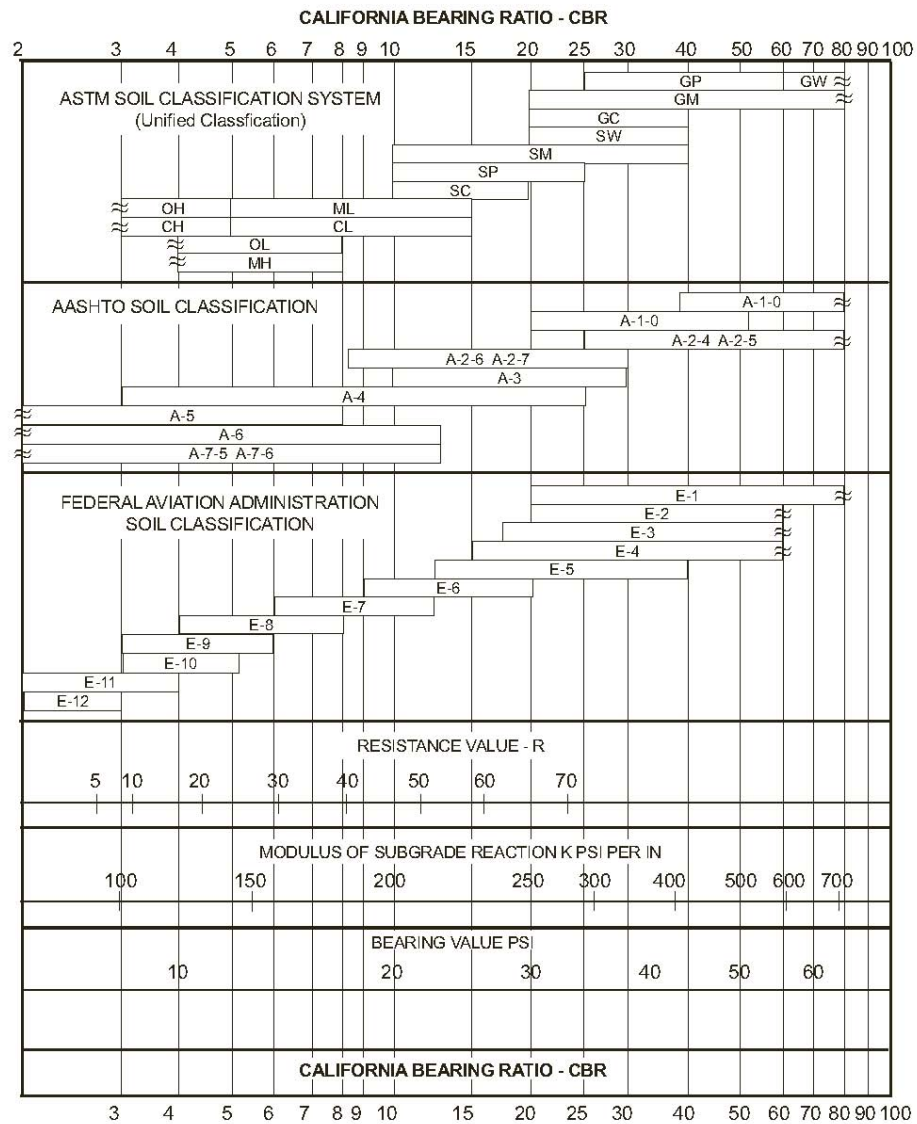
Unless a CBR test has been specifically requested by the client, the CBR is estimated from published charts, based on soil classification and strength characteristics. A typical correlation chart is below.

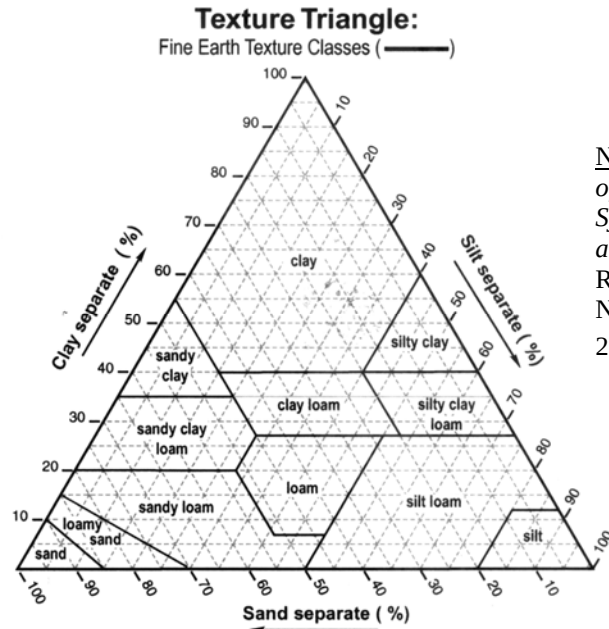
## SOIL CLASSIFICATION NOTES

Note: Texture Triangle and Comparison of Particle Size Classes in Different Systems from *Field Book for Describing and Sampling Soil*, USDA Natural Resources Conservation Service National Soil Survey Center (September 2002).

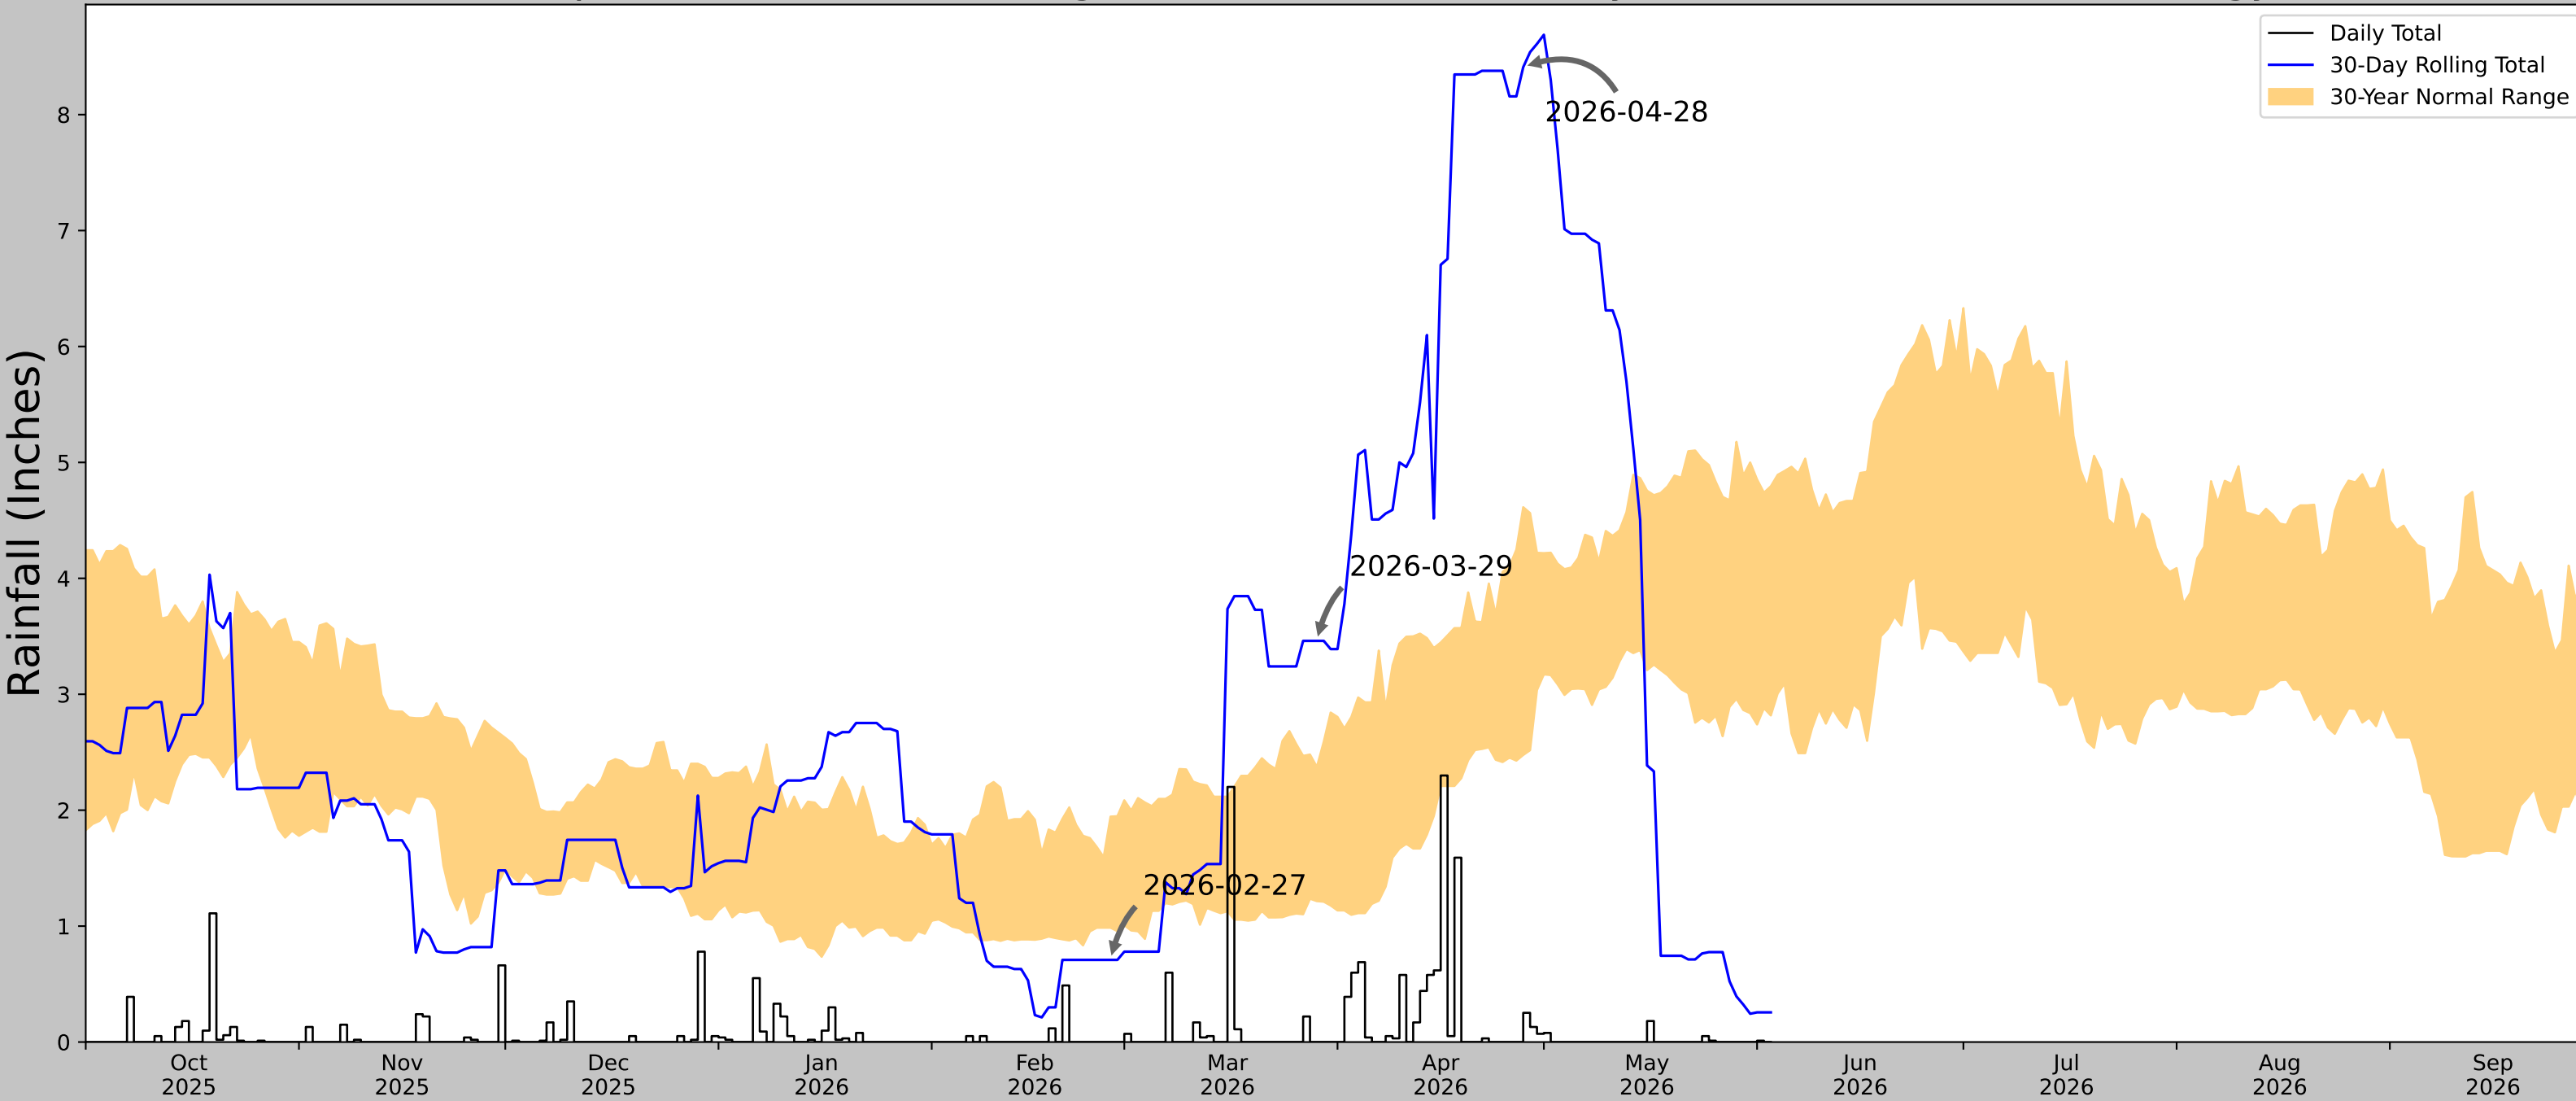
Antecedent Precipitation vs Normal Range based on NOAA's Daily Global Historical Climatology Network
