# Storm Water Management Plan for

## STOR-IT Right - Waukesha City of Waukesha, WI

**Project No. 3250218**

**June 23, 2026**

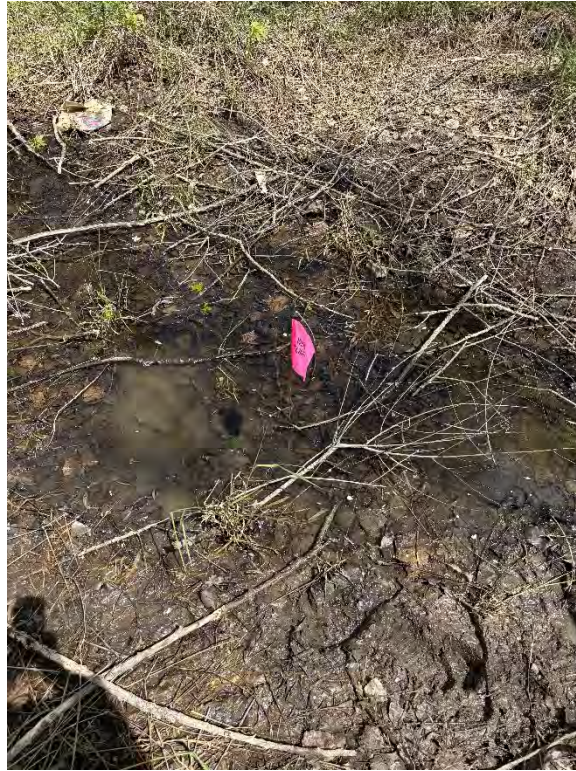
*Photo 1: DP1-WET*

**DP is located in an excavated depression as a result of historic grading and site disturbance.**  
**\*Climatic conditions are considered "wetter than normal"**

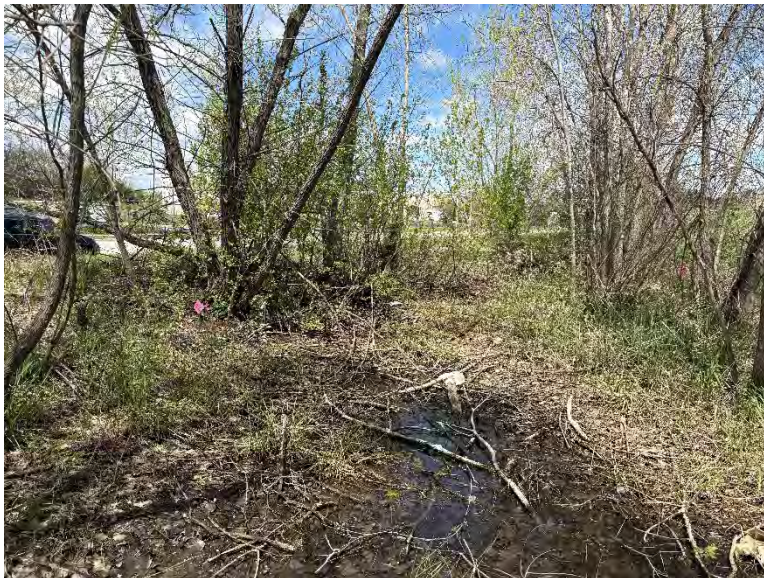
*Photo 2: Wetland W-1 facing northwest*

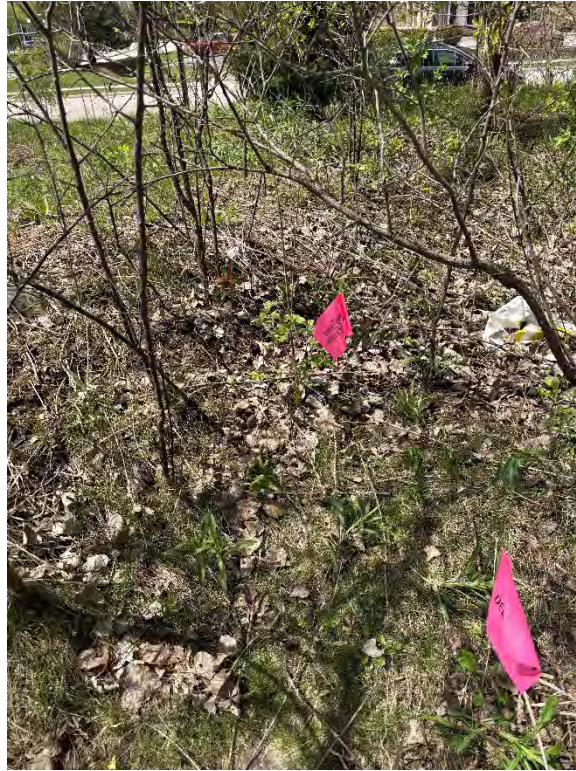
*Photo 3: DP 2-UPL*

**Climate Conditions are considered wetter than normal according to APT WETS Analysis. DP is located on an upland berm of sidecasted spoils.**

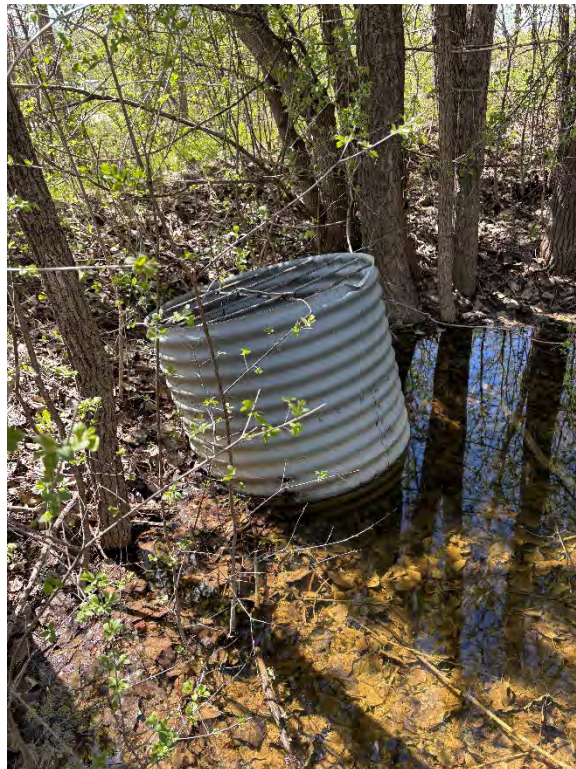
*Photo 4: Culvert Pipe located on the south end of W-2; connecting to W-3*

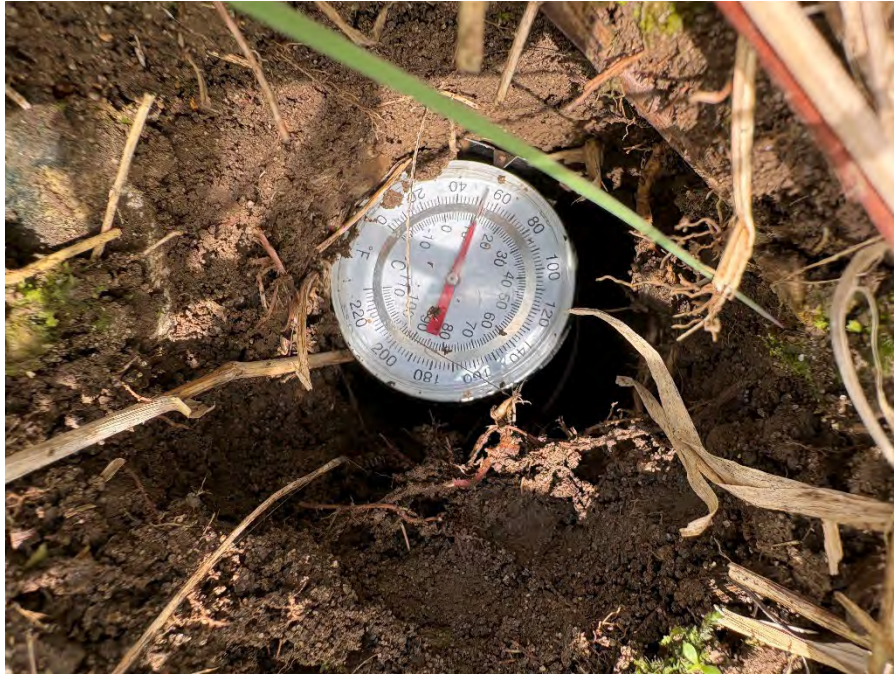
*Photo 5: Soil temp at 50 degrees*

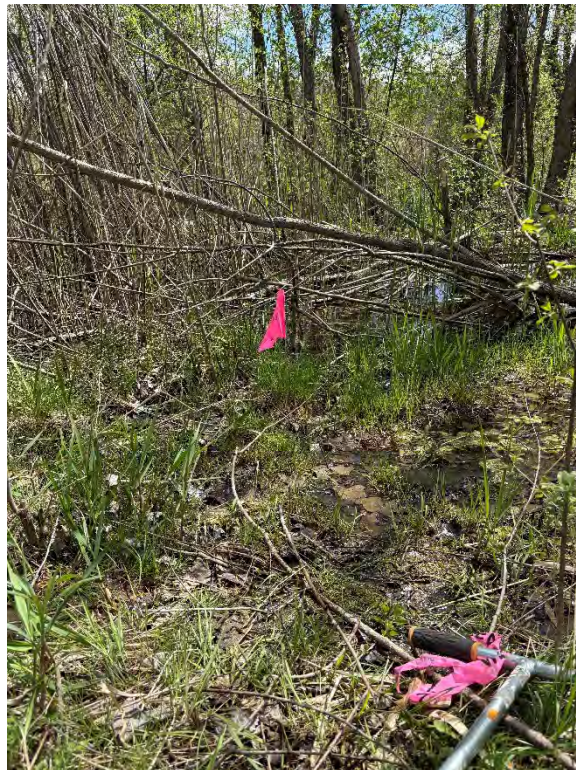
*Photo 6: DP 3-WET*

**DP is located in an excavated depression as a result of historic grading and site disturbance.**  
**\*Climatic conditions are considered "wetter than normal"**

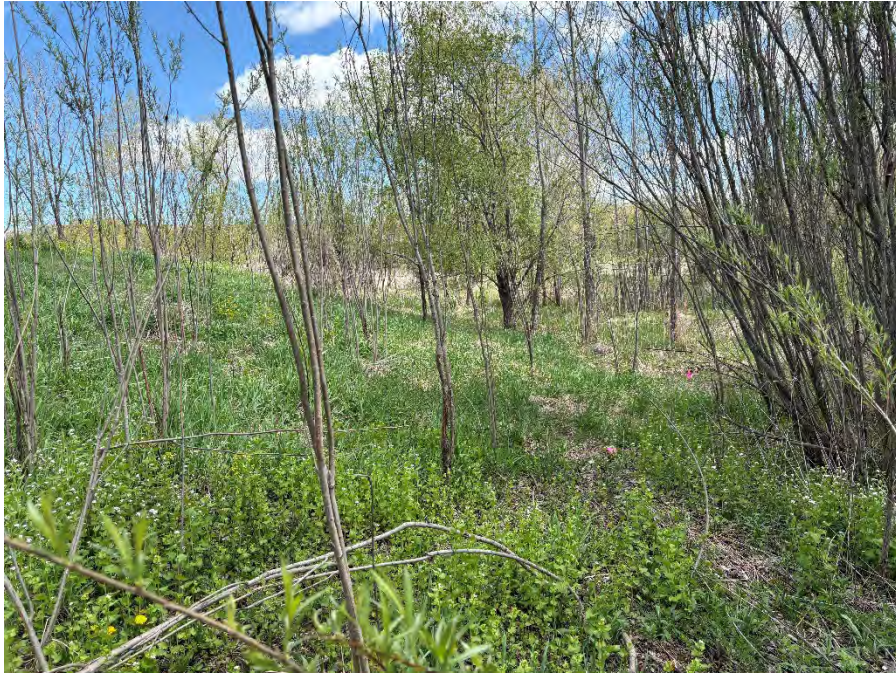
*Photo 7: Wetland W-2 facing east.*

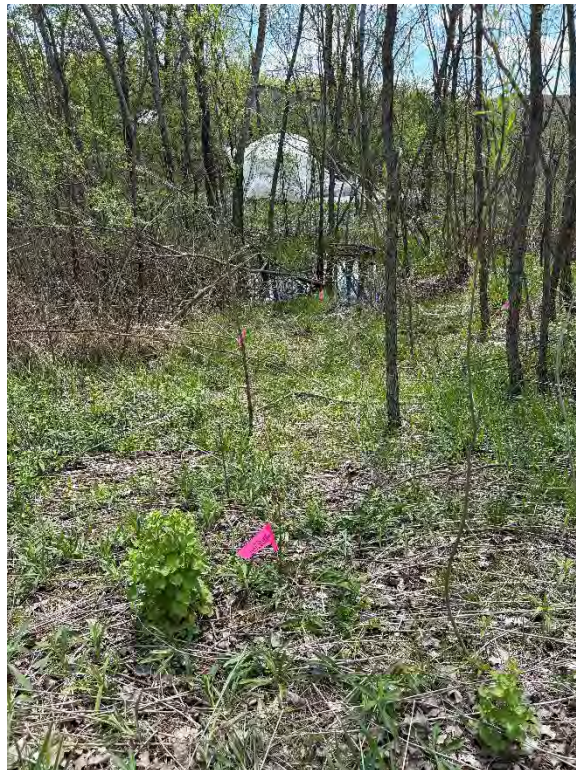
*Photo 8: W-2 facing south.*

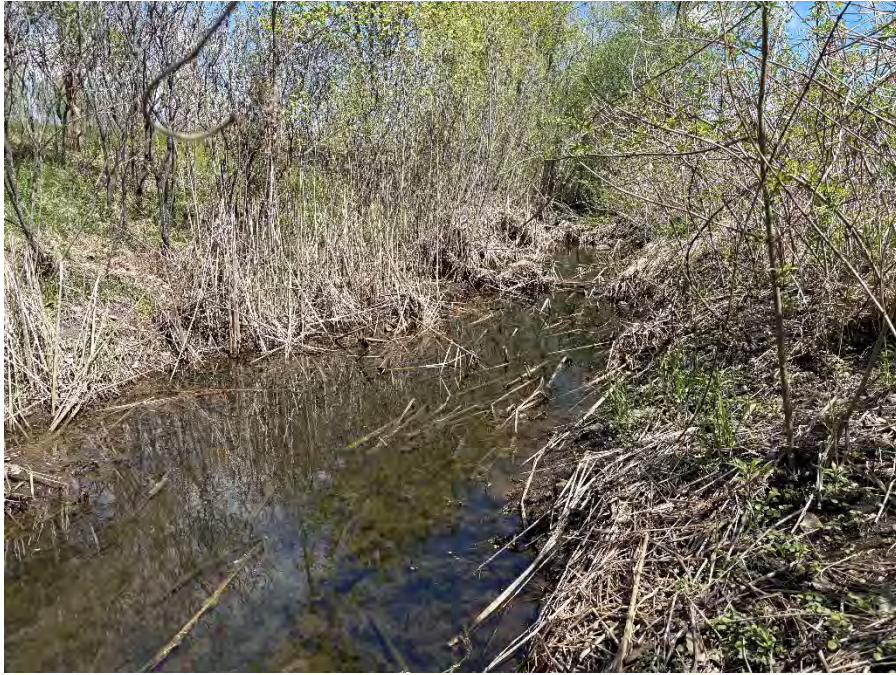
*Photo 9: Wetland W-3 facing east*

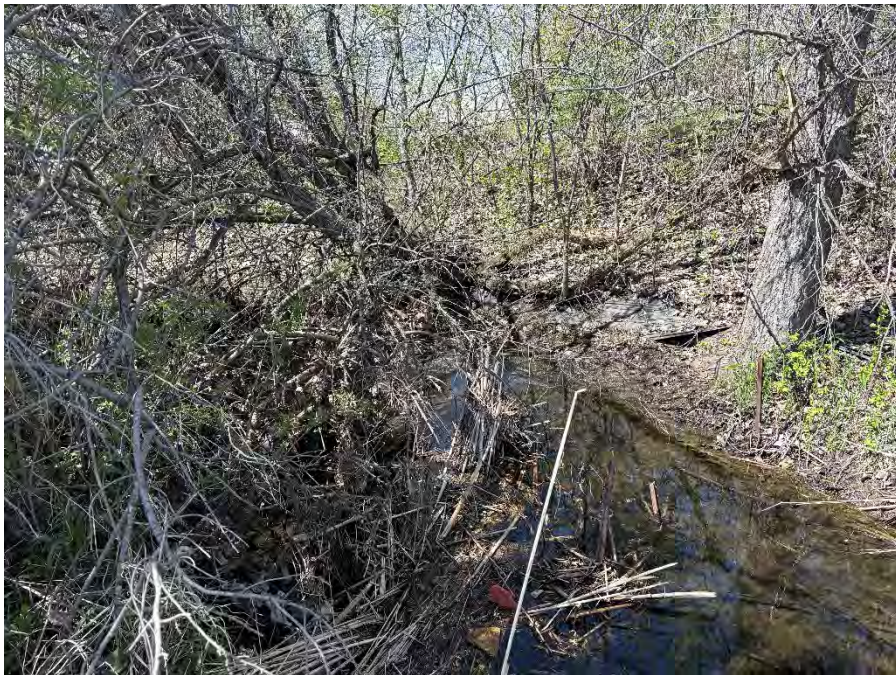
*Photo 10: W-3 facing west*

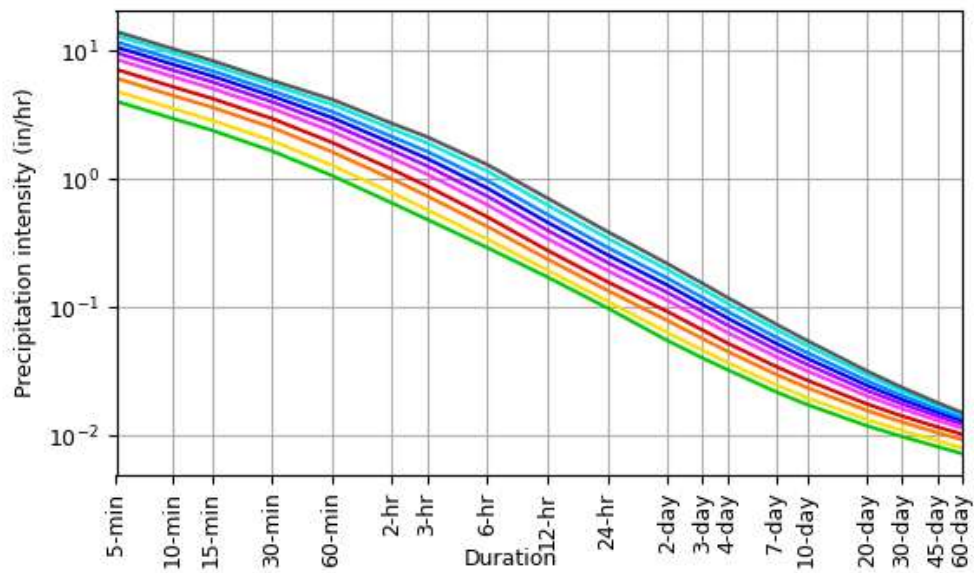
## PDS-based intensity-duration-frequency (IDF) curves

Latitude: 43.0180°, Longitude: -88.1978°

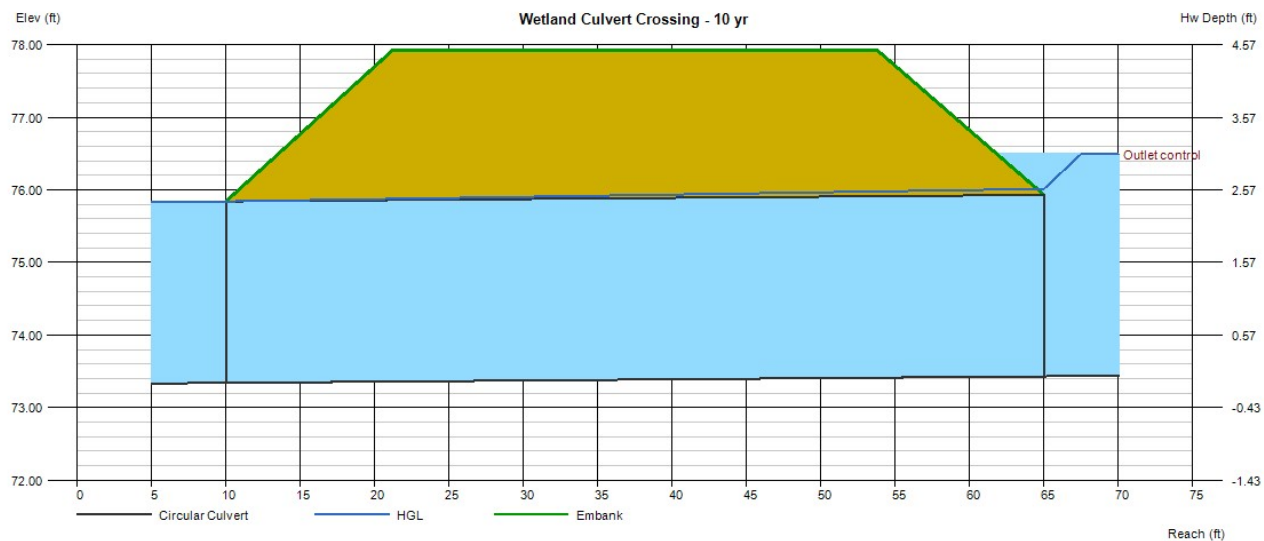
Qtotal (cfs) = 49.80  
Qpipe (cfs) = 49.80  
Qovertop (cfs) = 0.00  
Veloc Dn (ft/s) = 5.07  
Veloc Up (ft/s) = 5.07  
HGL Dn (ft) = 75.84  
HGL Up (ft) = 76.01  
Hw Elev (ft) = 76.49  
Hw/D (ft) = 1.23  
Flow Regime = Outlet Control
