**CITY OF WAUKESHA ENGINEERING DIVISION  
REQUEST FOR PROPOSALS**

**SARATOGA LAKE DREDGING STUDY**

**Key Sequence No. 630**

# **Saratoga Survey and Sampling Report**

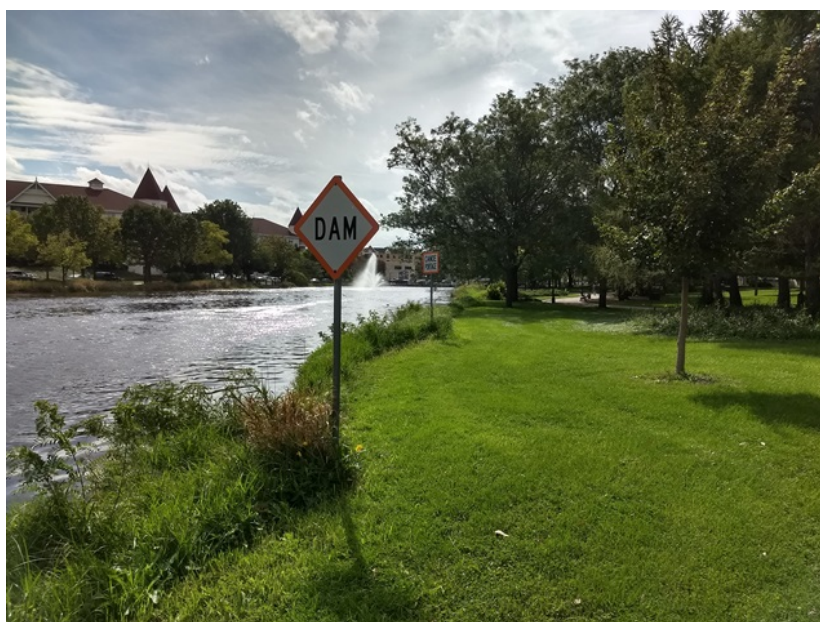
**Saratoga Mill Dam**  
0063010031801.jpg  
Dam Warning Sign and Portage Route
