# MEMORANDUM

Re: Pewaukee Road & Gascoigne Drive  
Flashing Pedestrian Crossing Sign Request

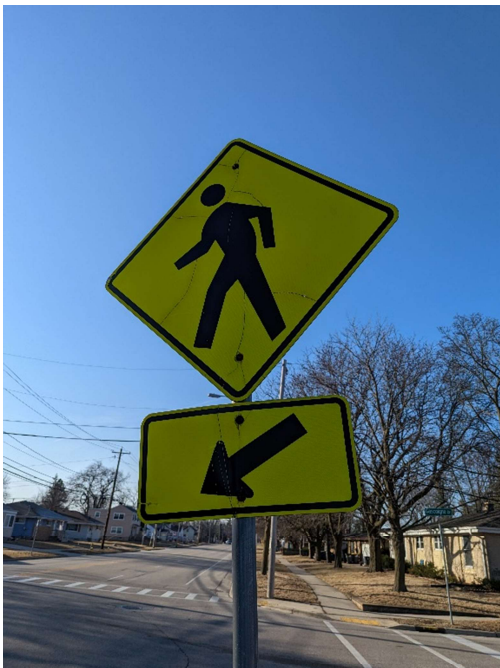
Figure 1: SB Pedestrian Crossing Sign

Field observations were made on Thursday, March 13, 2025. It was noted that the pedestrian crossing signs are beginning to show surface cracking within the reflective sheeting and the sign on the northbound approach showed significant fading.

With that in mind, there is an opportunity to improve the quality of the existing signing by replacing fading signs and adding advance warning and crossing signs at this location. It is recommended that the existing W11-2 signs and their associated diagonal downward arrows be replaced with new fluorescent yellow-green signs. An additional sign could be added to the left side of Pewaukee Road in both directions to draw additional attention to the crossing, especially given two lanes are provided in the southbound direction. Also, an advanced warning W11-2 sign with an "Ahead" plaque could be added in the northbound direction, approximately 150 feet in advance of the crosswalk. Figure 3 illustrates the recommended sign improvements.
